**2006 FIRST SEMIANNUAL POST-CLOSURE  
INSPECTION AND MAINTENANCE REPORT**

**June 19, 2006**

**INSTALLATION RESTORATION PROGRAM SITE 7  
(FORMER STATION LANDFILL)  
NAVAL WEAPONS STATION SEAL BEACH  
SEAL BEACH, CALIFORNIA**

**DCN: FWSD-RAC-06-0957**

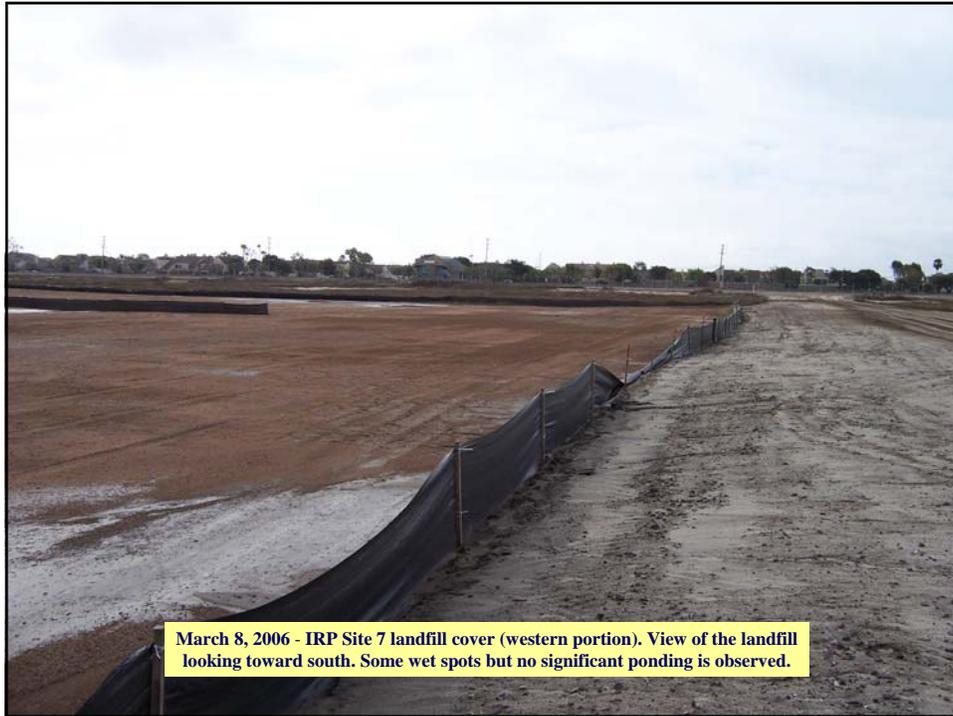
March 8, 2006 - IRP Site 7 landfill cover (western portion). View of the landfill looking toward south. Some wet spots but no significant ponding is observed.

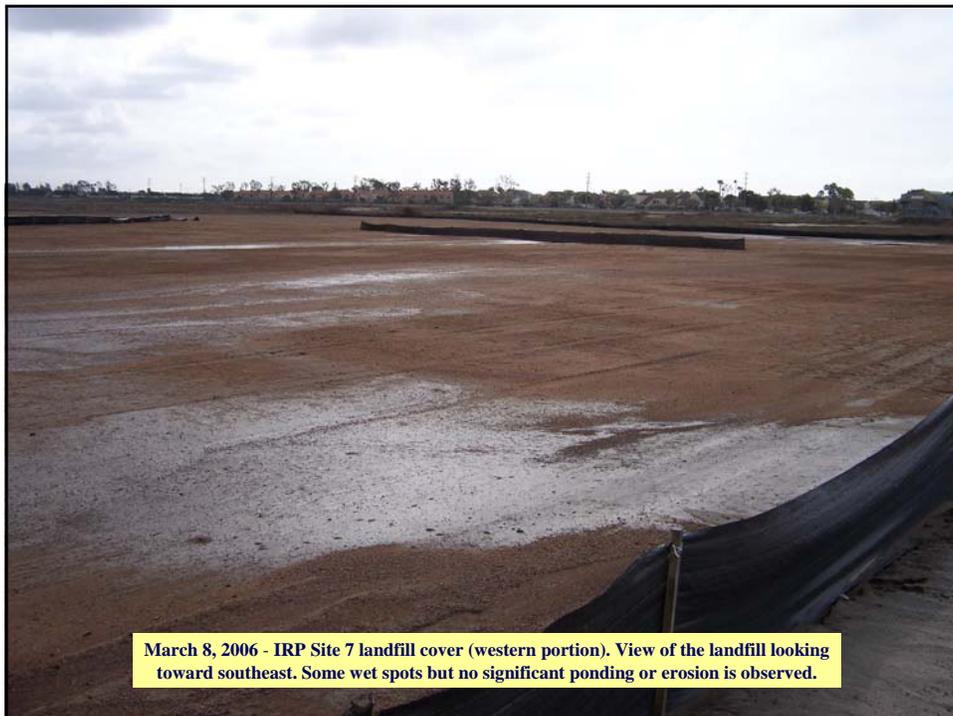
March 8, 2006 - IRP Site 7 landfill cover (western portion). View of the landfill looking toward southeast. Some wet spots but no significant ponding or erosion is observed.

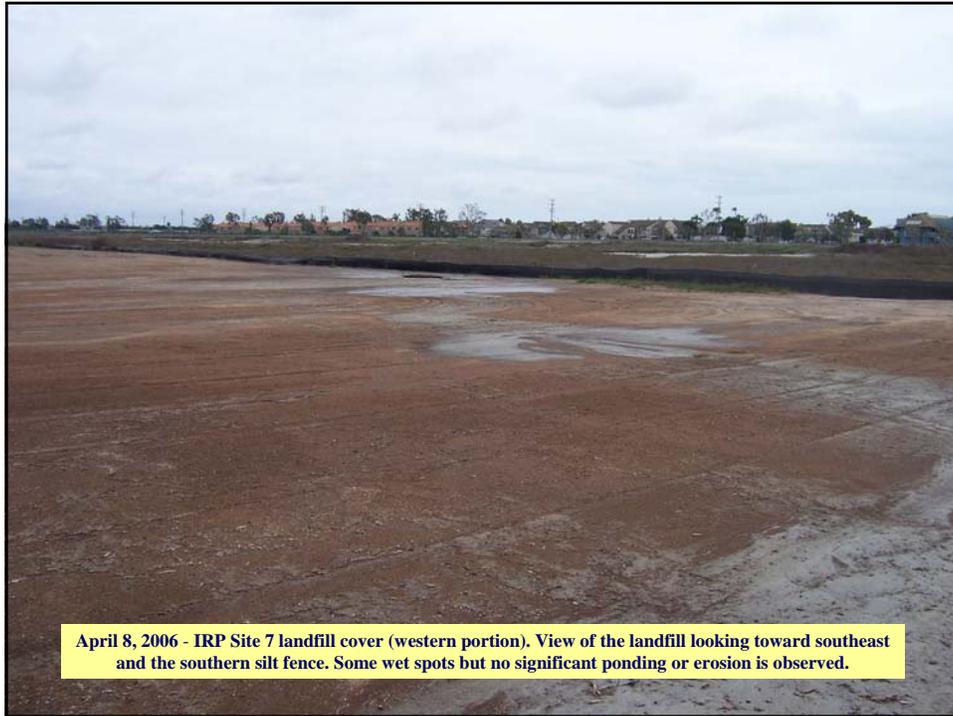
April 8, 2006 - IRP Site 7 landfill cover (western portion). View of the landfill looking toward southeast and the southern silt fence. Some wet spots but no significant ponding or erosion is observed.

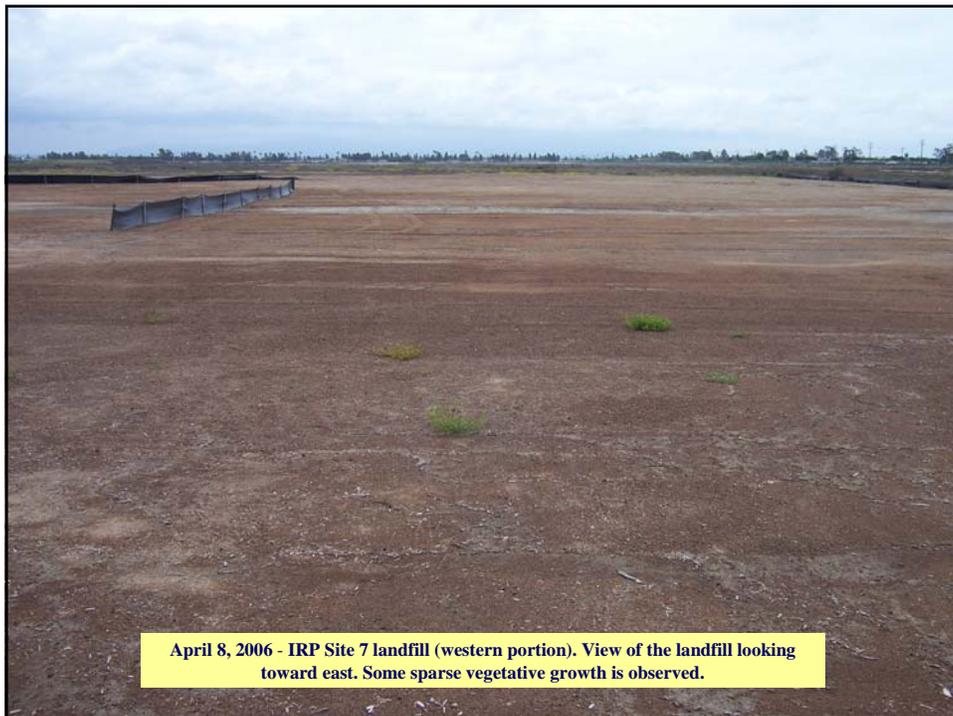
April 8, 2006 - IRP Site 7 landfill (western portion). View of the landfill looking toward east. Some sparse vegetative growth is observed.

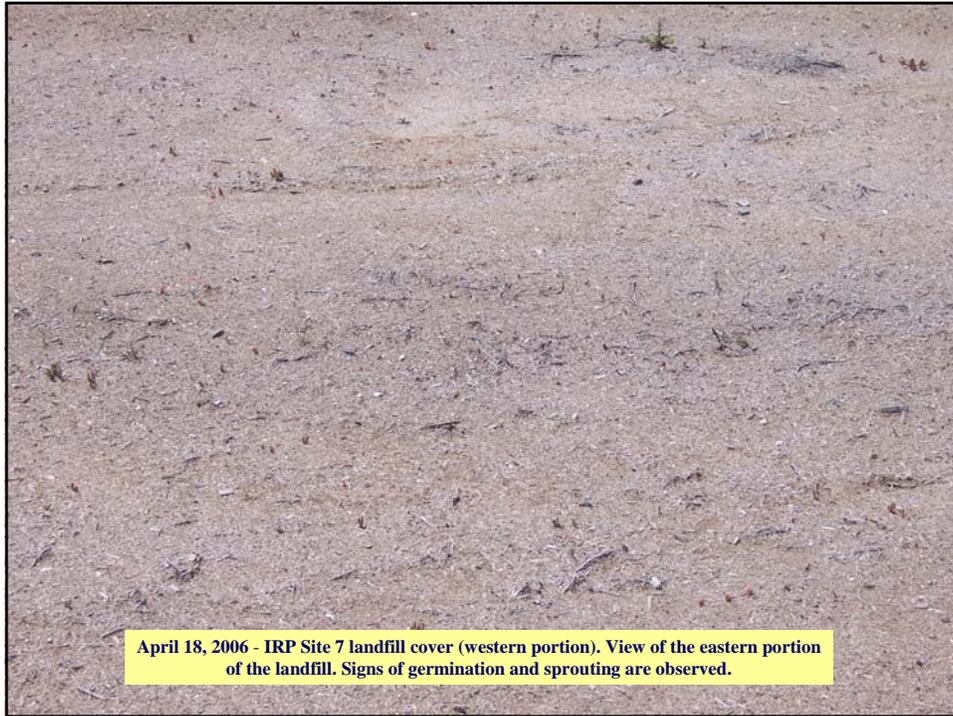
April 18, 2006 - IRP Site 7 landfill cover (western portion). View of the eastern portion of the landfill. Signs of germination and sprouting are observed.

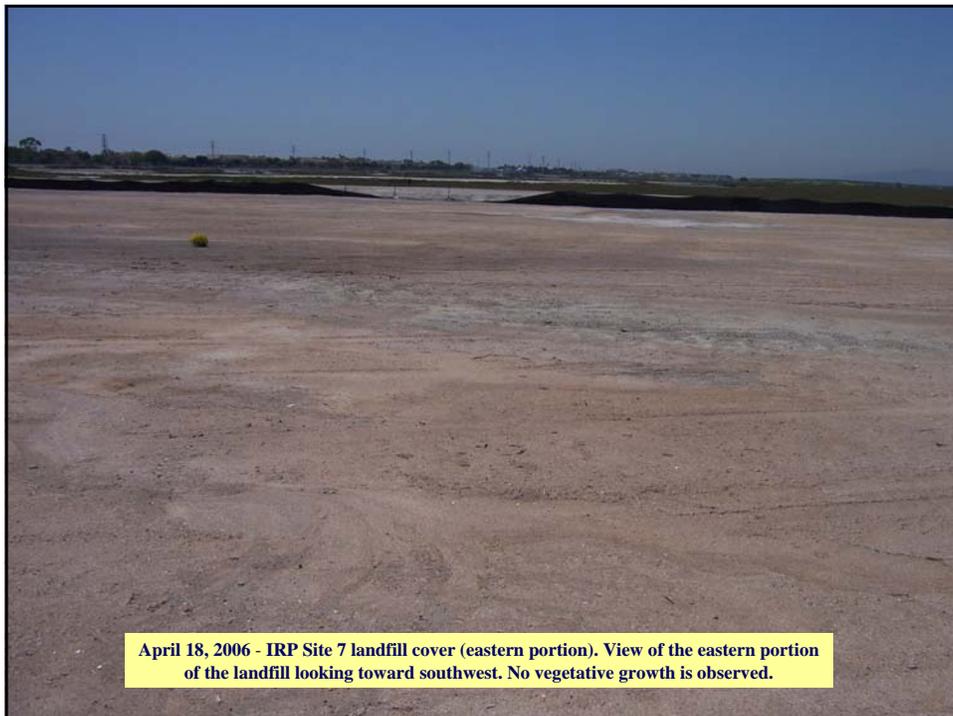
April 18, 2006 - IRP Site 7 landfill cover (eastern portion). View of the eastern portion of the landfill looking toward southwest. No vegetative growth is observed.
