**ENGINEERING SURVEY OF
U.S. NAVY PETROLEUM FACILITIES
AT PEARL HARBOR**

BECHTEL CORPORATION

12, May 1949

Subj: Engineering Survey of U. S. Navy Petroleum Facilities
at Pearl Harbor, Report on

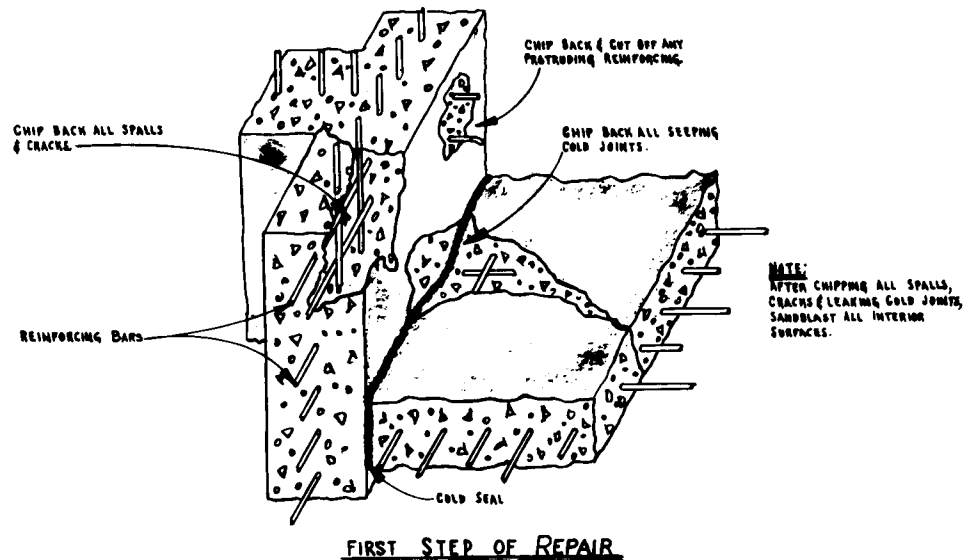
SECT. VI
TANK INSPECTION SKETCH 5
REPAIRS TO
REINFORCED CONCRETE
UNDERGROUND RESERVOIR
MIDDLE TANK FARM

The underground 195,000 barrel reinforced reservoir located in the Middle Tank Farm was constructed about 1920. Inspection revealed that the concrete was cracked in numerous places, and when empty the leakage rate back into the reservoir from the oil soaked ground was several barrels per day. This unit appears to be one of the major sources contributing to the oil underlying the Merry Point area of the Navy Yard.

It is recommended that this reservoir be repaired as follows:

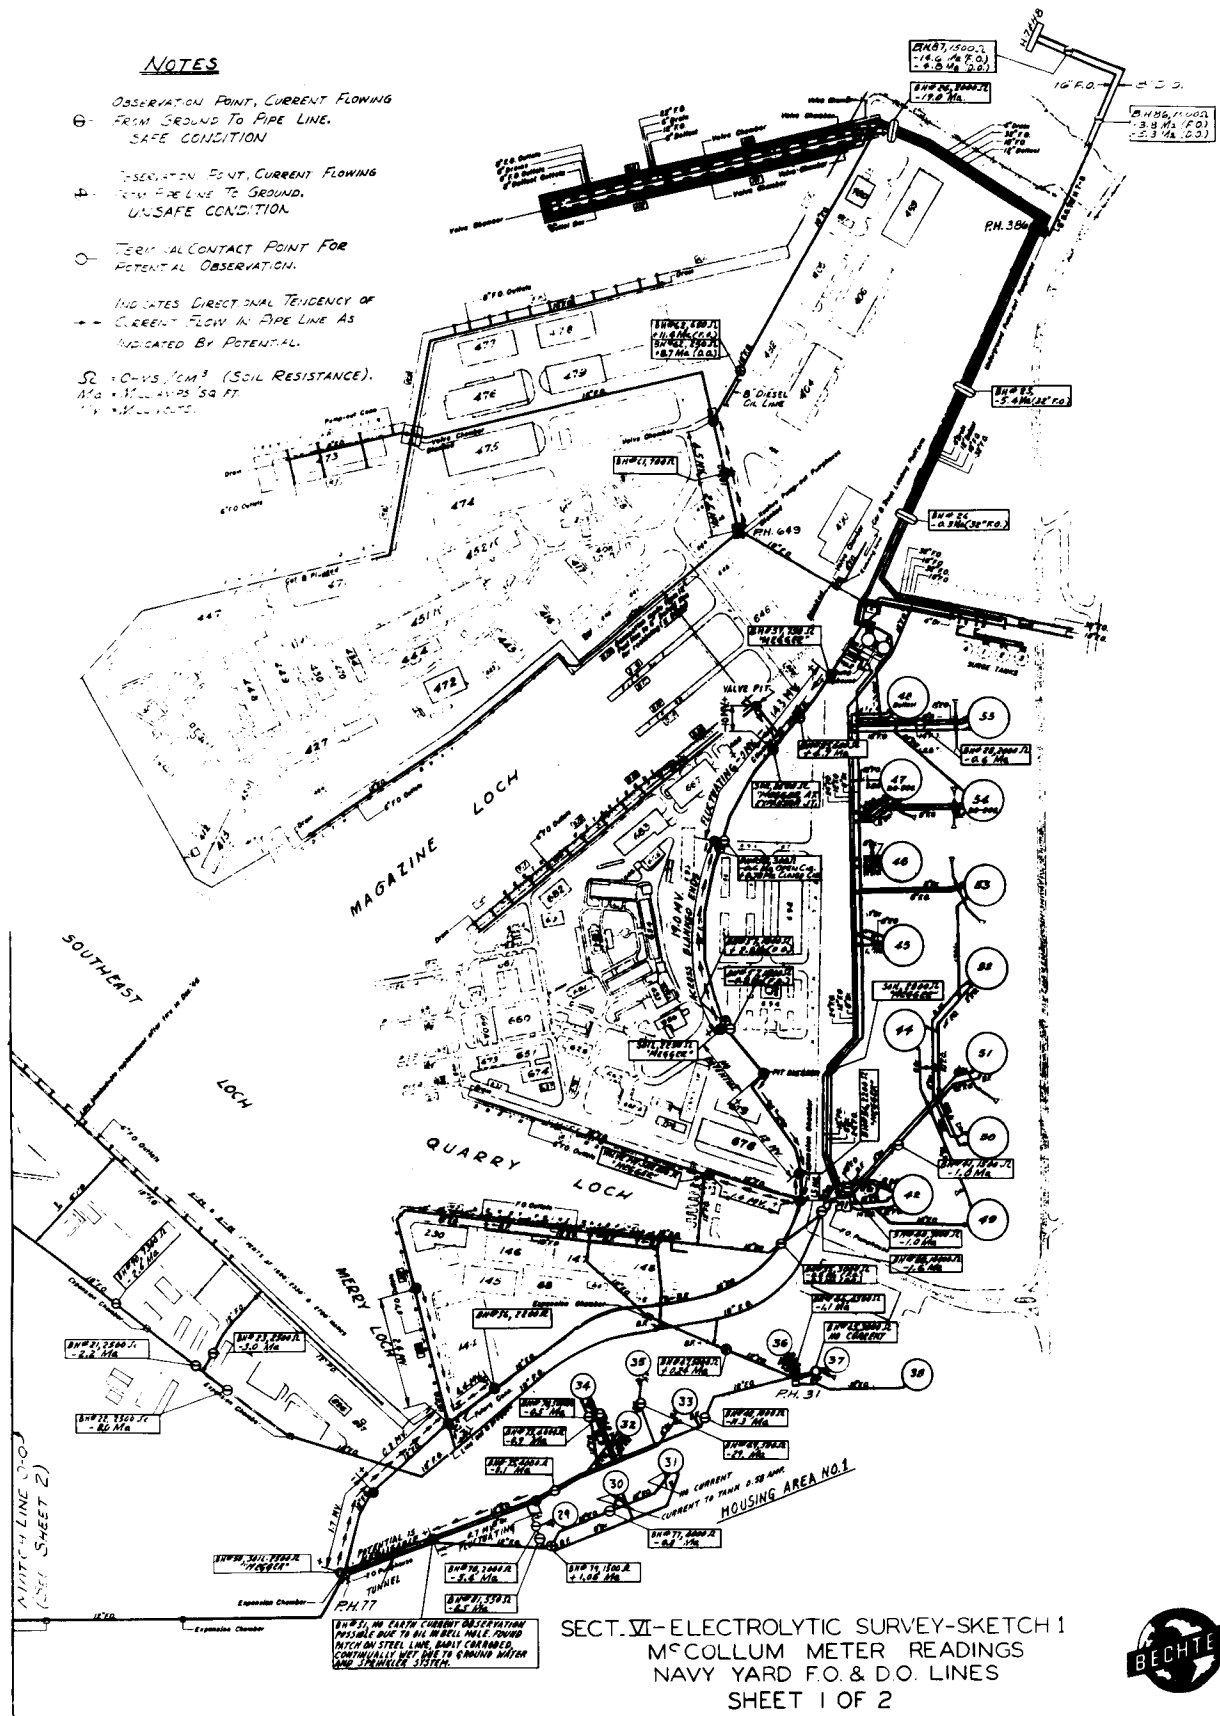
SECT. VI-ELECTROLYTIC SURVEY-SKETCH 1
M^C COLLUM METER READINGS
NAVY YARD F.O. & D.O. LINES
SHEET 1 OF 2

5. (a) 12" F.O. Steel No Coating General Corrosion Several Pits - 100 Mills Depth of Cover 5 Ft. Coral, Gravel & Sand - Dry	10. (a) 8" F.O. Steel No Coating Gen Corrosion 25 Mills No Pits Depth of Cover 2 Ft. Clay, Rocks & Gravel - Damp	15. (a) 2 - 8" F.O. Lines Steel No Coating or Wrapping Gen. Corrosion 30 Mills Several Pits at 77 Mills Depth of Cover 3 Ft. Coral & Volcanic Ash - Damp	20. 8" F.O. Steel No Coating or Wrapping Gen. Corrosion 23 Mills Several Pits at 41 Mills Depth of Cover 5 Ft. Coral & Lava Ash - Dry	70. 10" F.O. Cast Iron Near Bldg. 872 No Coating or Wrapping Several Pits at 12 Mills Depth of Cover 4 Ft. Coral & Sand - Damp

(b) 8" Drain Cast Iron Depth of Cover 3 Ft. Gen. Corrosion 20 Mills	(b) 8" Drain Cast Iron Good Condition	(b) 8" Drain Cast Iron General Corrosion 8 Mills
