**Testing Results for Lead in Drinking Water for
Naval Station Norfolk Hampton Boulevard CDC (Building SDA332)
(Updated 6 May 2013)**

Priority Areas Lead Testing and Corrective Actions (May 2013)
Hampton Boulevard Child Development Center
Building SDA332

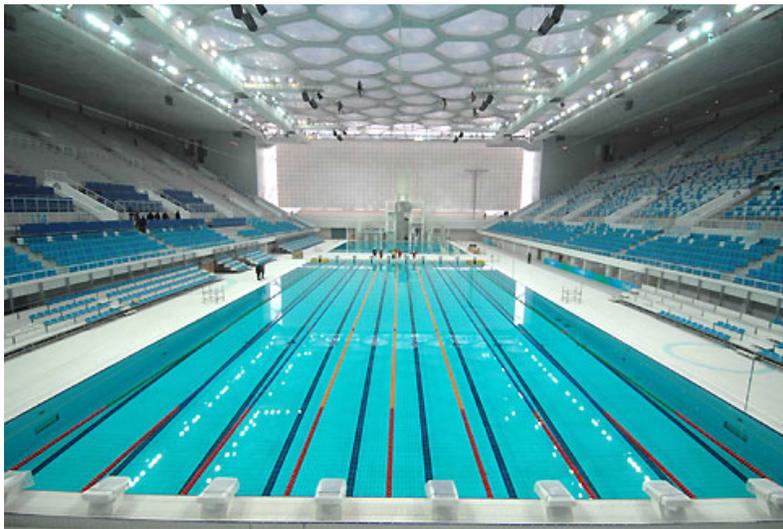
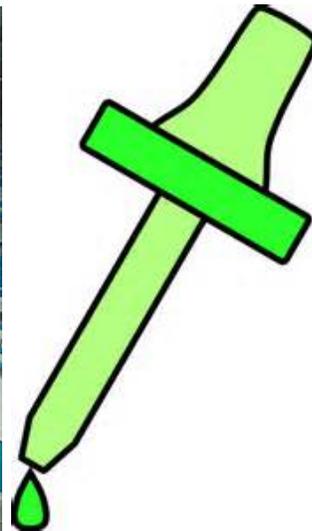
Two of the outlets that exceeded the EPA recommended level of 20 ppb were water fountains located in rooms 35B and 46B, which tested at 99 ppb and 66 ppb, respectively. Since follow-up testing indicated that the elevated levels of lead appeared to be caused by the components of the water fountains and upstream plumbing, these water fountains were disconnected and the pipes capped. New fountains and upstream plumbing have been installed. Testing conducted after implementation of these corrective measures shows that these fountains meet the EPA recommended level of 20 ppb.

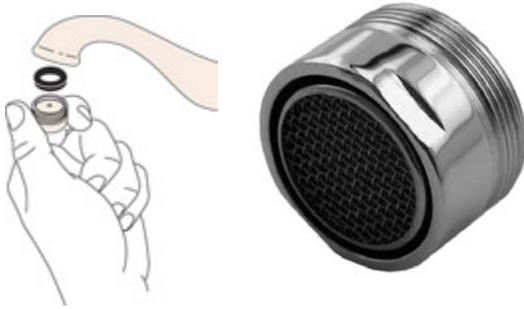
The five remaining outlets that exceeded 20 ppb were hand washing sinks and are not used for drinking or cooking. These sinks were located in rooms 23B, 26C, 35B, 61 and 71. Follow-up sampling at these five outlets was conducted after removing the faucet aerators. A **faucet aerator** (or tap aerator) is often found at the tip of modern indoor water faucets. Without an aerator, water usually flows out of a faucet as one big stream. An aerator spreads this stream into many little droplets, which helps save water and reduce splashing. However, the aerator and screen can trap debris which can accumulate lead.

After removing the faucet aerators, retesting showed that the sinks in rooms 23B, 26C, and 35B were below the EPA-recommended level. Further corrective measures (replacement of supply valves and supply piping) were implemented at the sinks in rooms 61 and 71, and follow-up sampling indicates that these sinks are also below the EPA-recommended level.

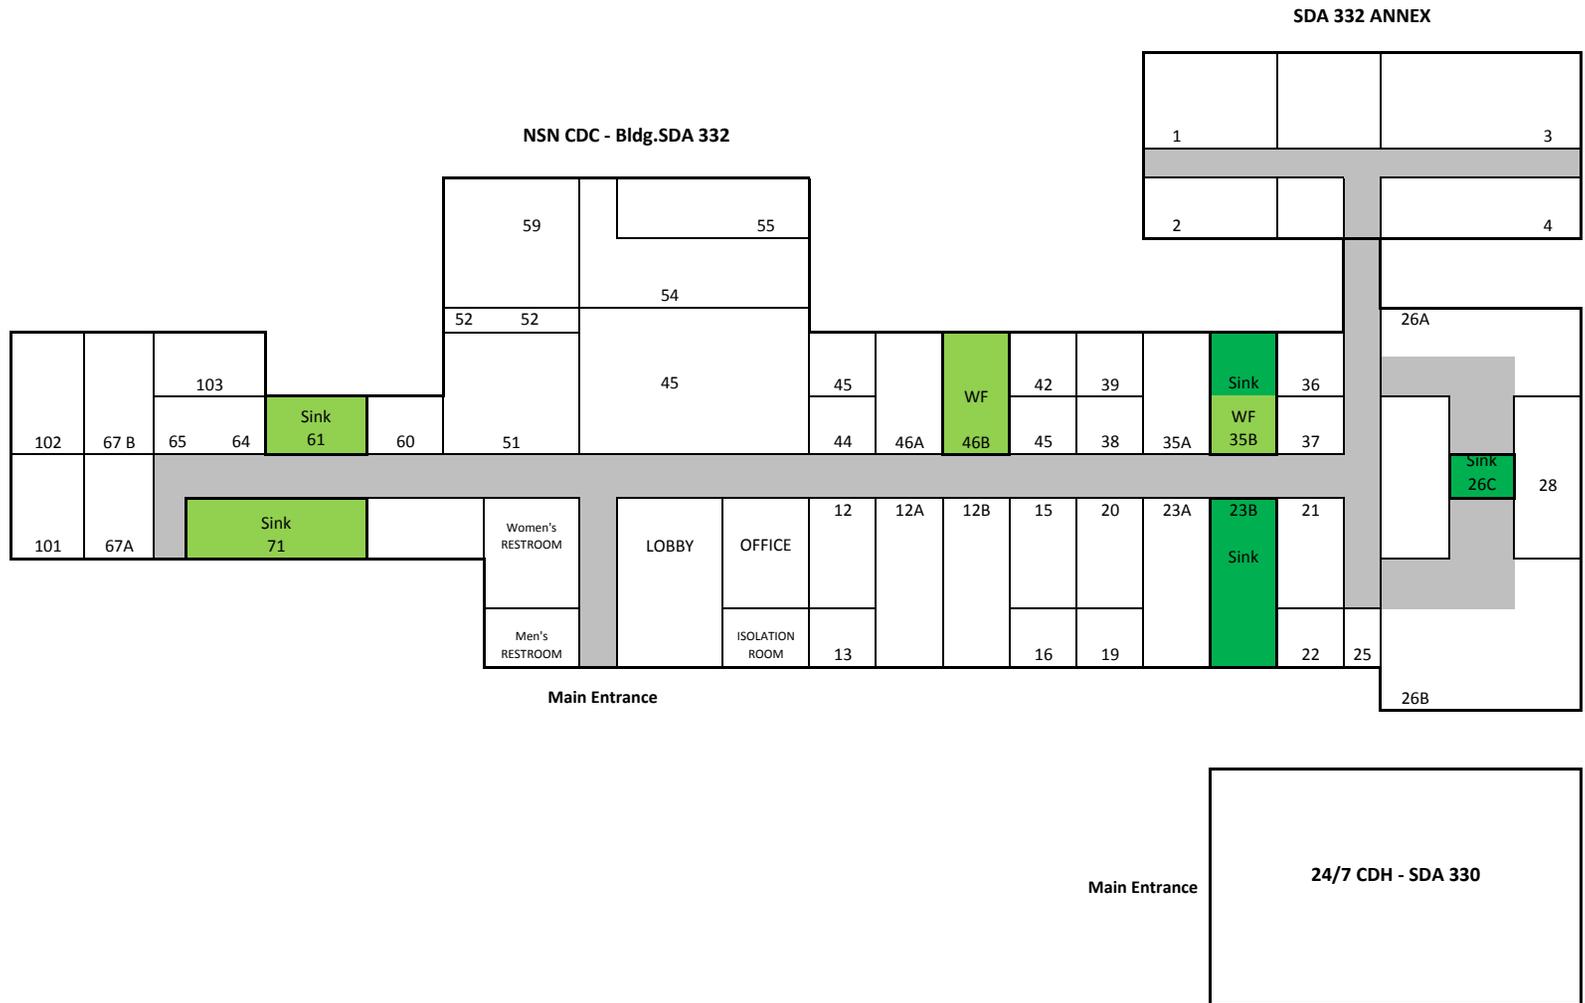
**FLOOR PLAN
CDH-SDA330 AND CDC-SDA332**

A floor plan of the Hampton Boulevard CDC (SDA-332) has also been included to show the locations for the fixtures that exceeded 20 ppb.

Screening results from all outlets showed levels below recommended level of 20ppb.
	Affected bathroom sinks and water fountains (WF) were taken out of service until completion of corrective actions (e.g., replacement of faucet, supply valve, plumbing upstream) and post-remediation sampling results were below 20ppb.
	Aerators were determined as source of lead. Aerators were removed and new aerators will be installed. Routine steps to clean/replace aerators and routine flushing has been implemented as corrective action.
