**DRAFT
WINTER 2008/2009 SEMIANNUAL POST-CLOSURE
INSPECTION AND MAINTENANCE REPORT
May 6, 2009**

**INSTALLATION RESTORATION PROGRAM SITE 7
(FORMER STATION LANDFILL)
NAVAL WEAPONS STATION SEAL BEACH
SEAL BEACH, CALIFORNIA**

DCN: ECSD-3211-0008-0004

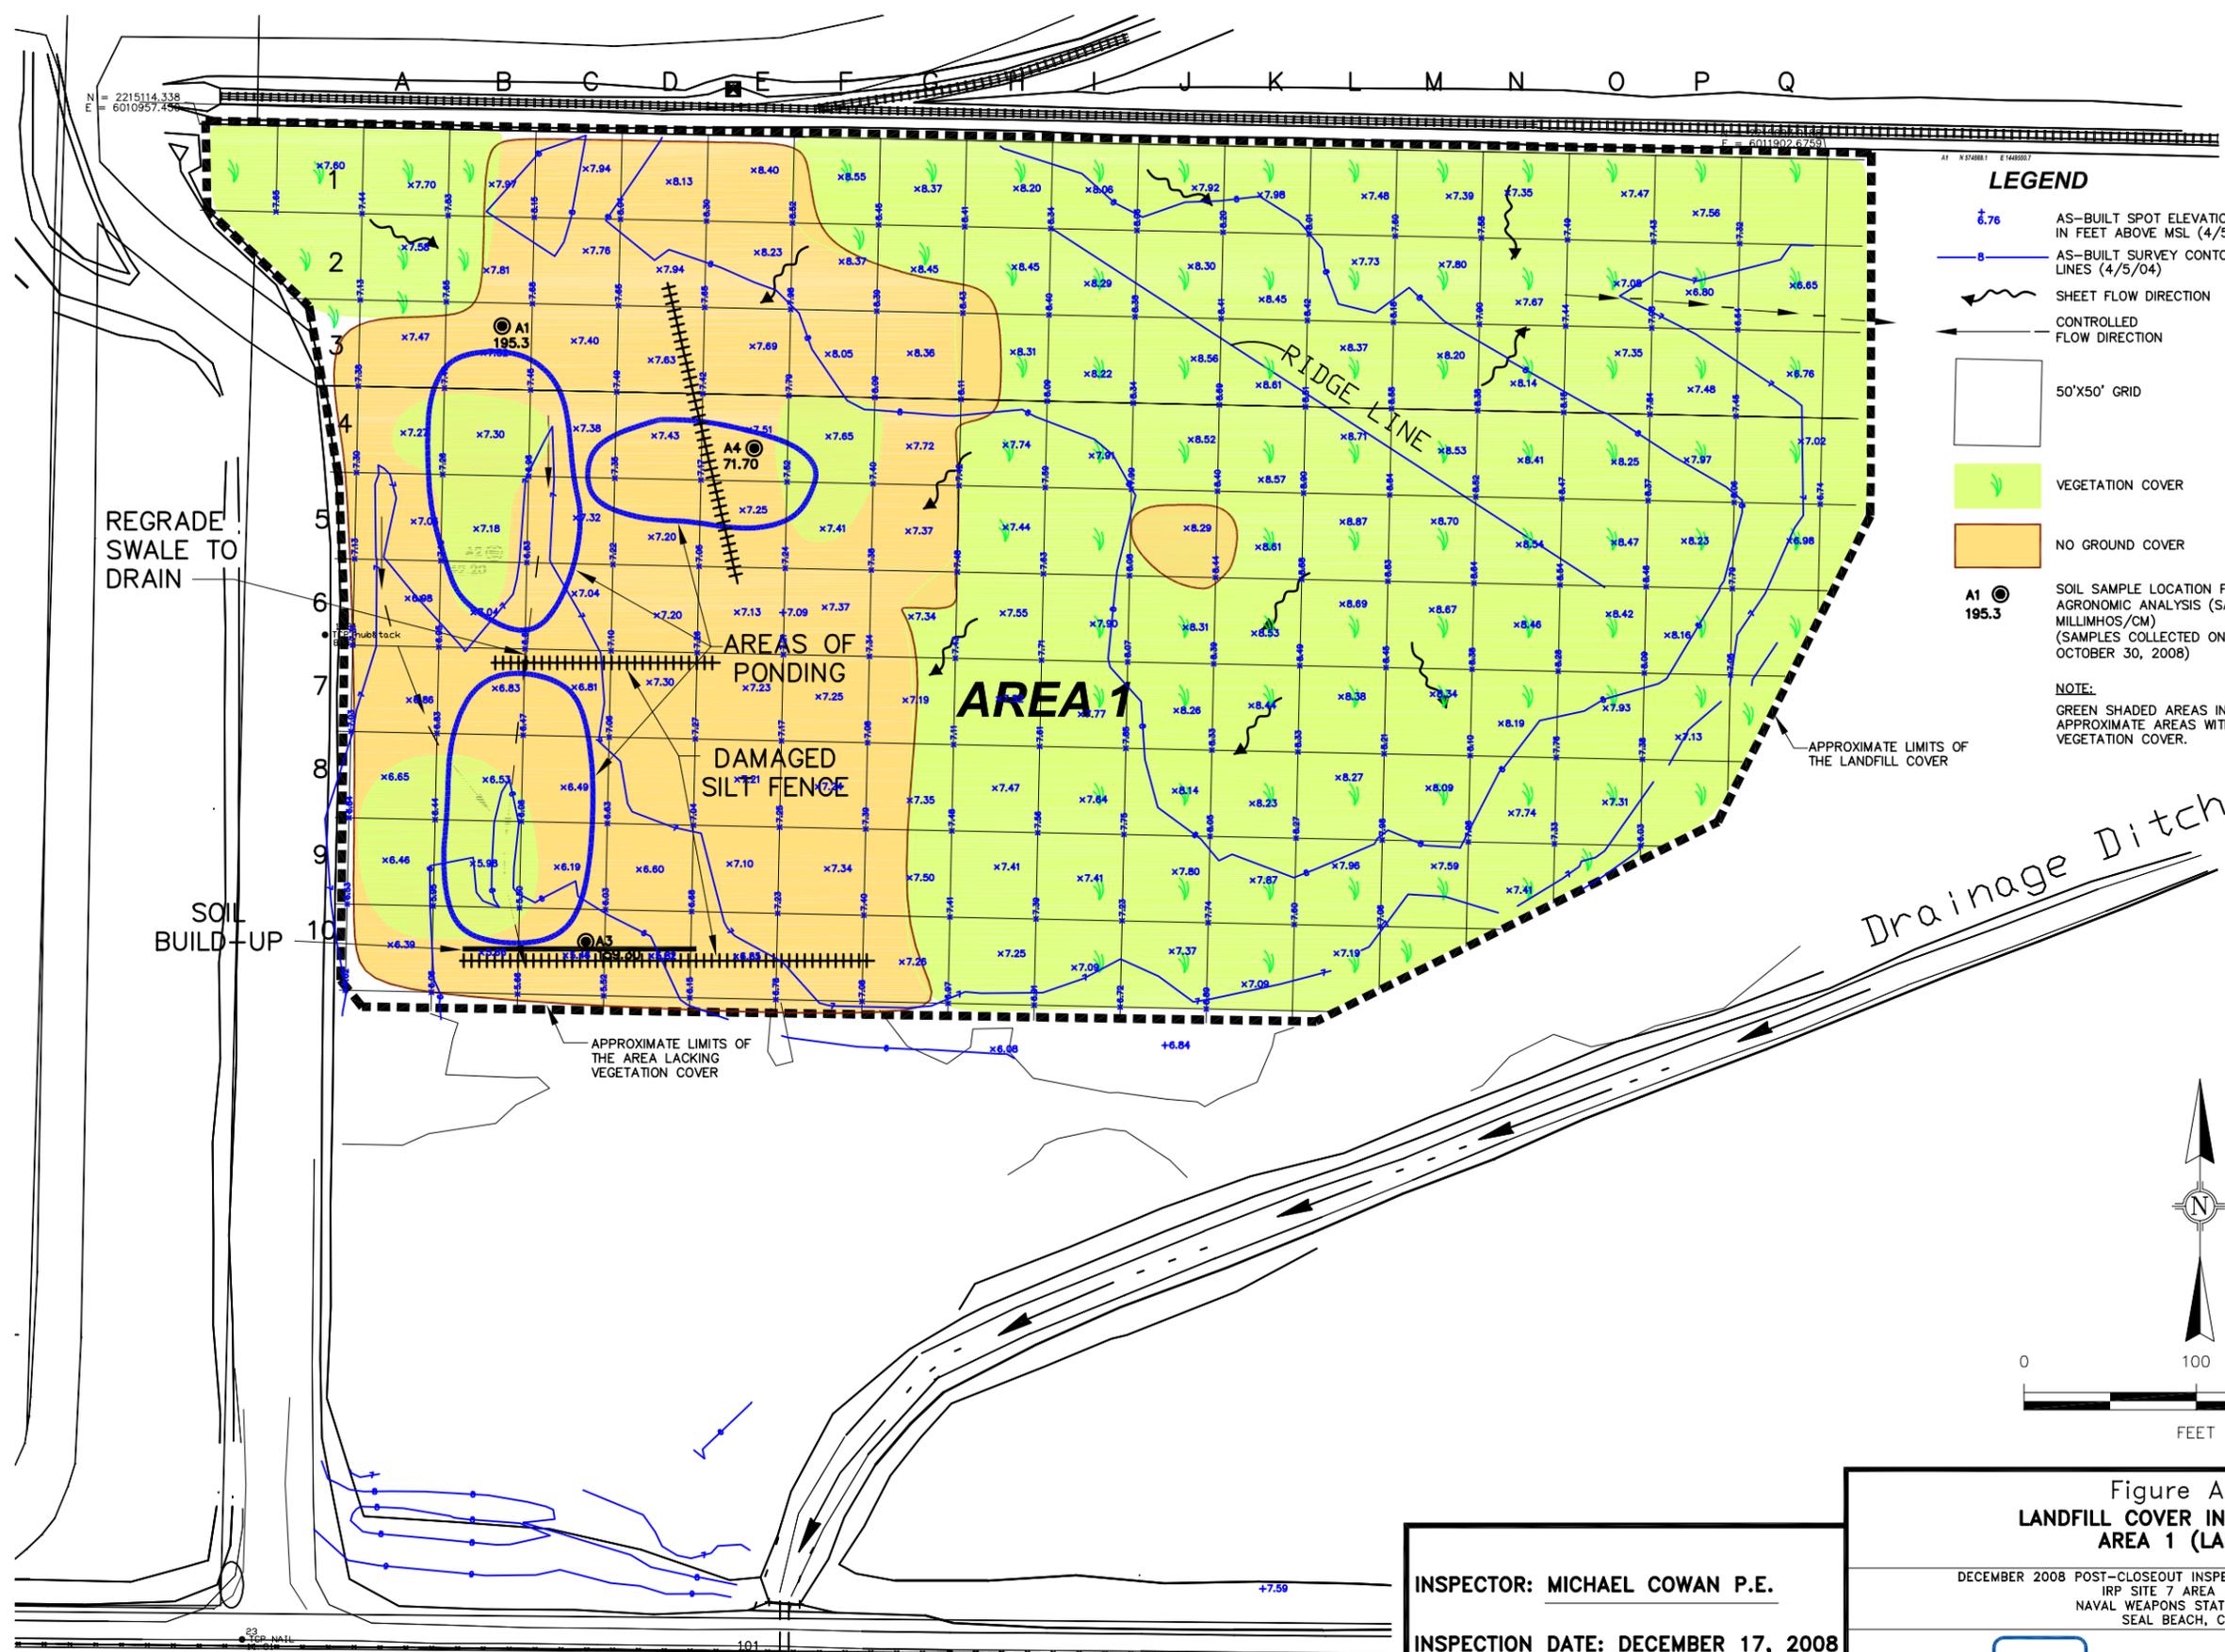
Figure A-1b
**LANDFILL COVER INSPECTION MAP
 AREA 1 (LANDFILL)**

Ponding noted as shown on Figure A-1b attached.

Minimal grade of the landfill cover causes ponding. No soil erosion was noted.

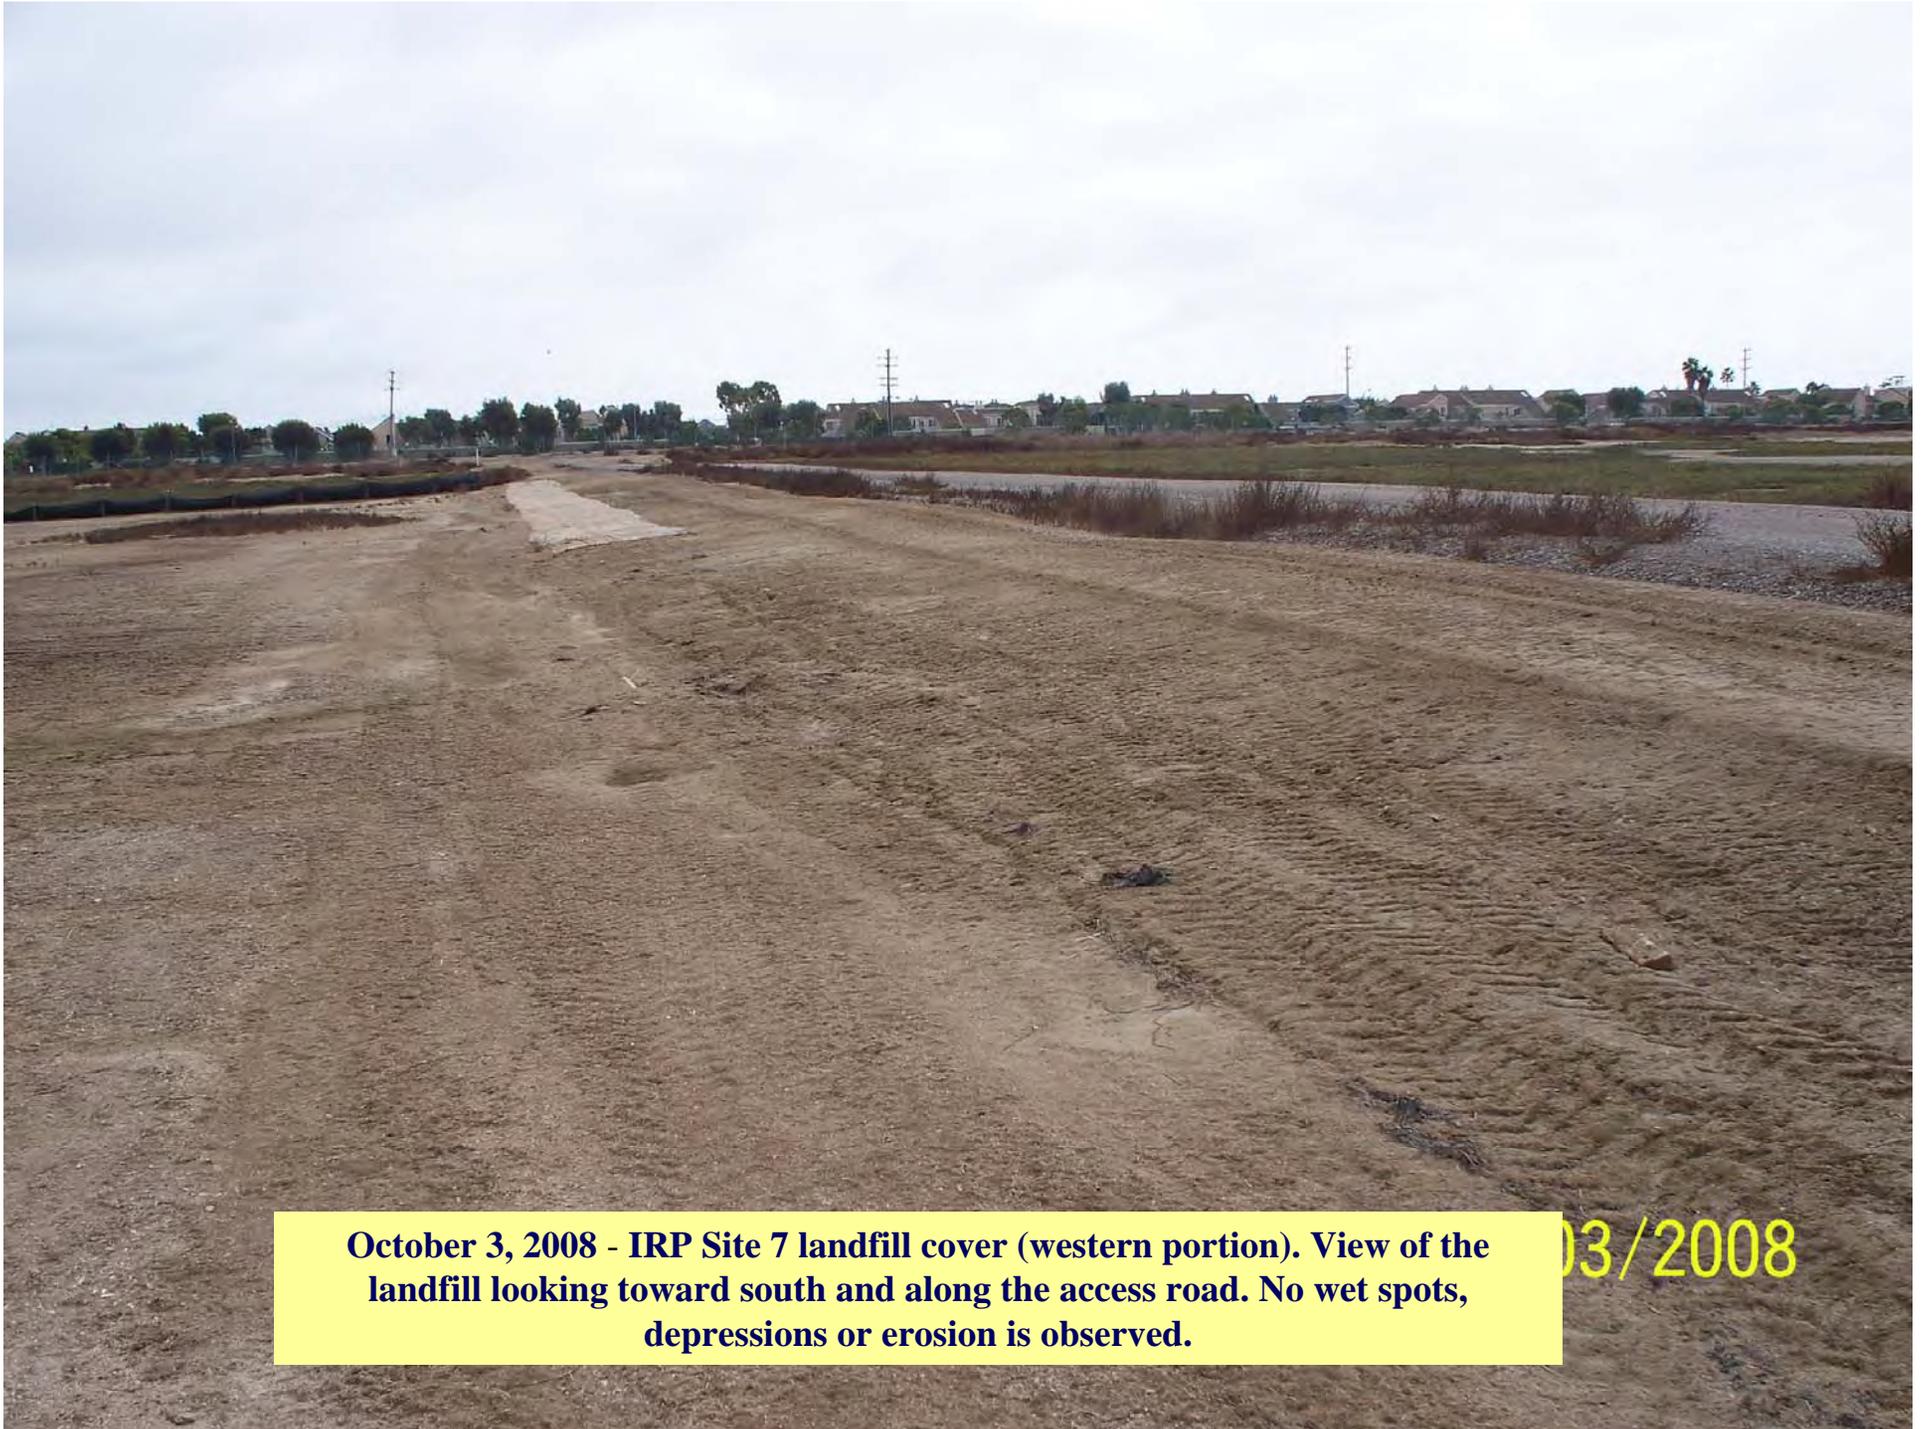
10/03/2008

October 3, 2008 - IRP Site 7 landfill cover (western portion). View of the landfill looking toward south and along the access road. No wet spots, depressions or erosion is observed.

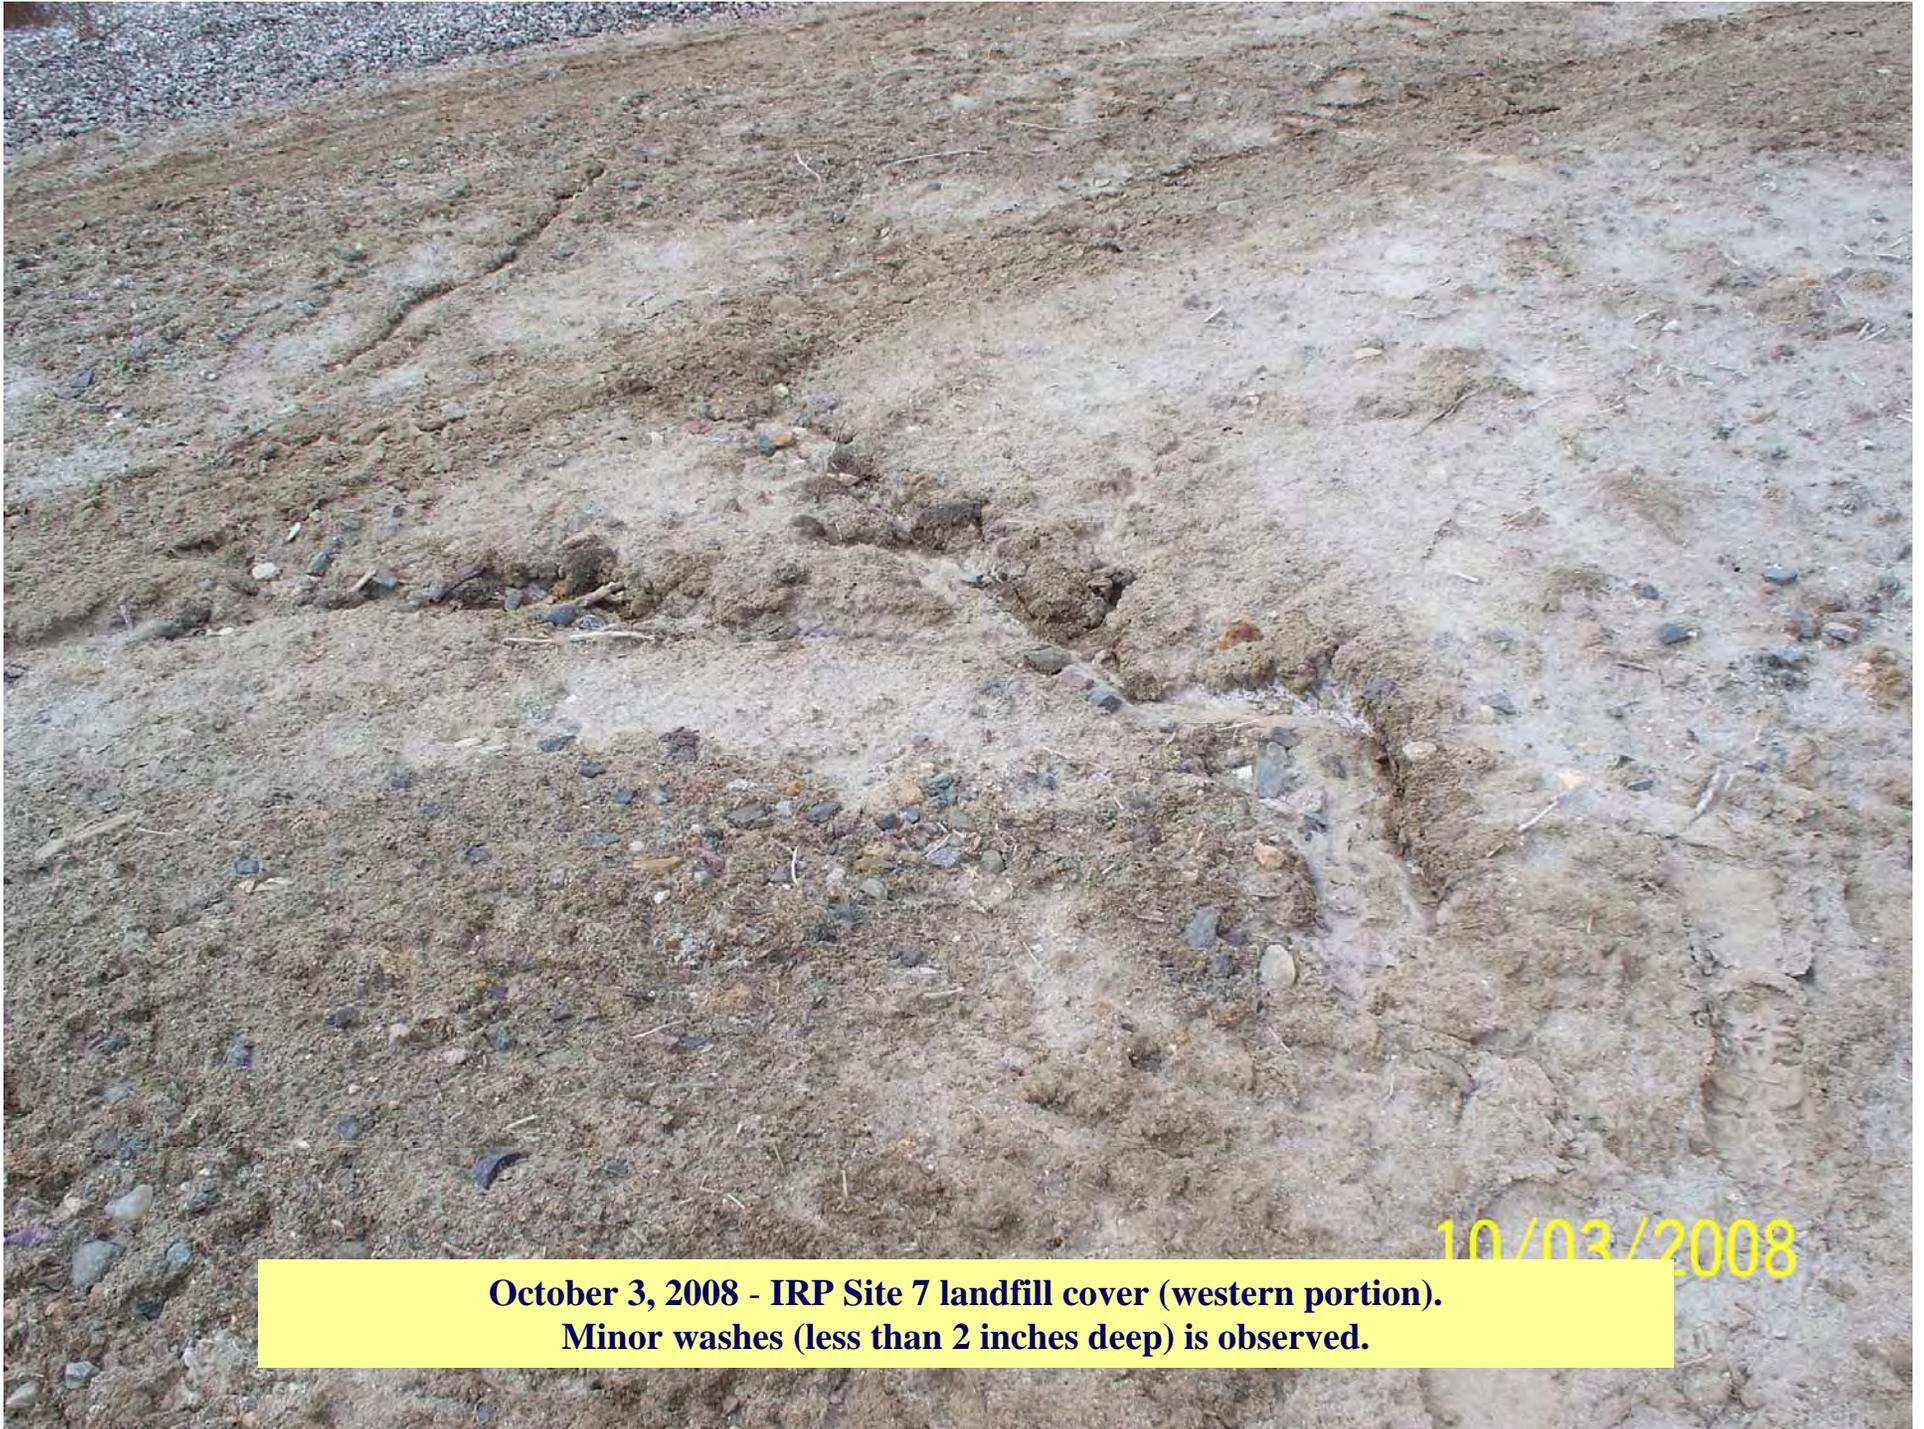
**October 3, 2008 - IRP Site 7 landfill cover (western portion).
Minor washes (less than 2 inches deep) is observed.**

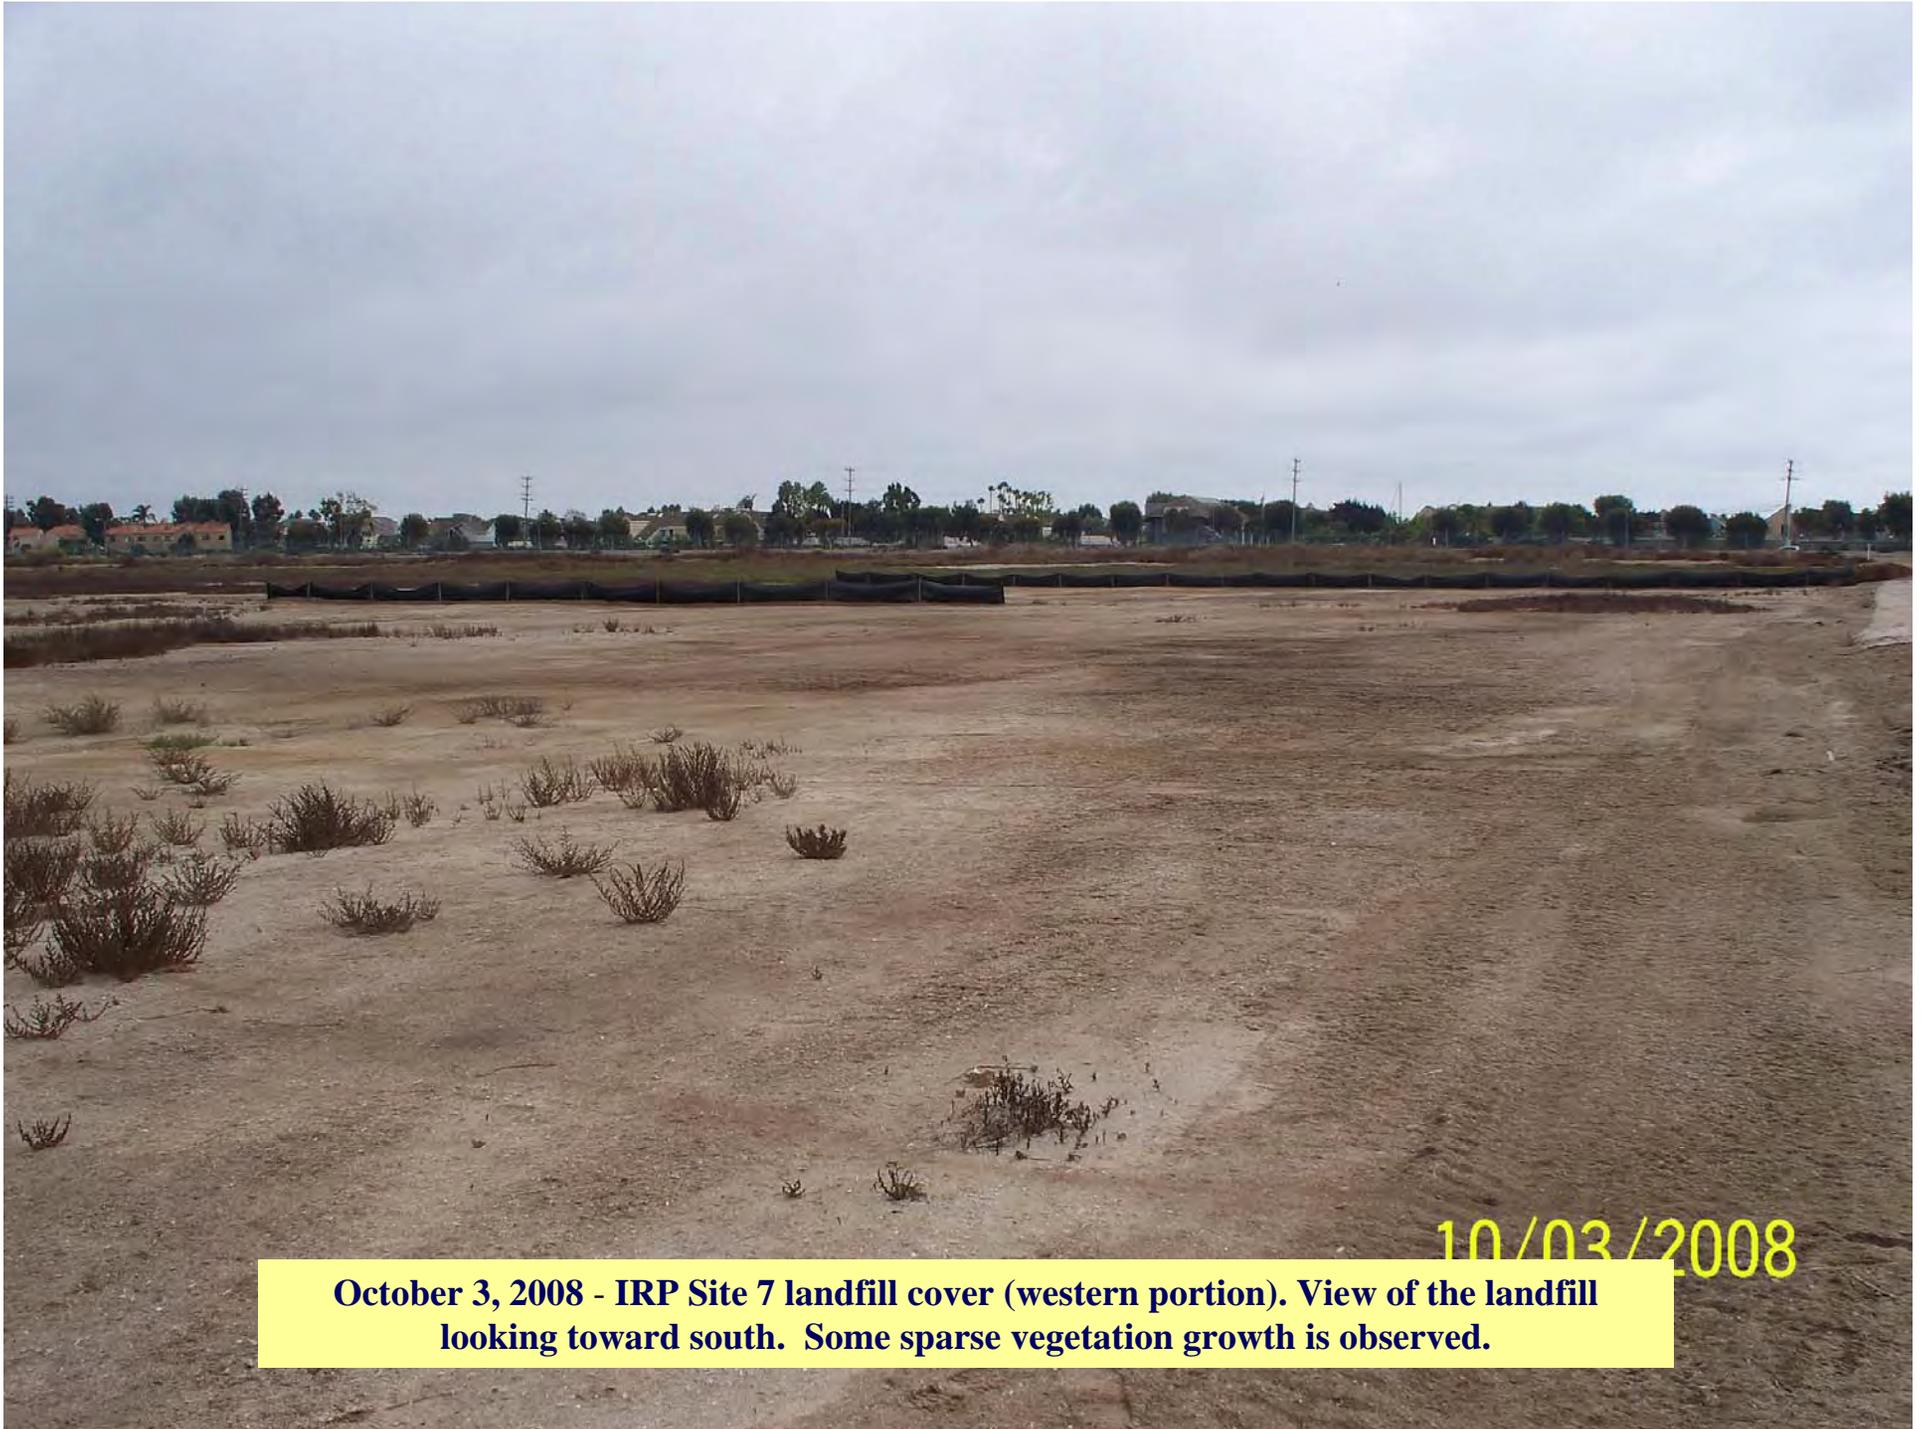
10/03/2008

October 3, 2008 - IRP Site 7 landfill cover (western portion). View of the landfill looking toward south. Some sparse vegetation growth is observed.

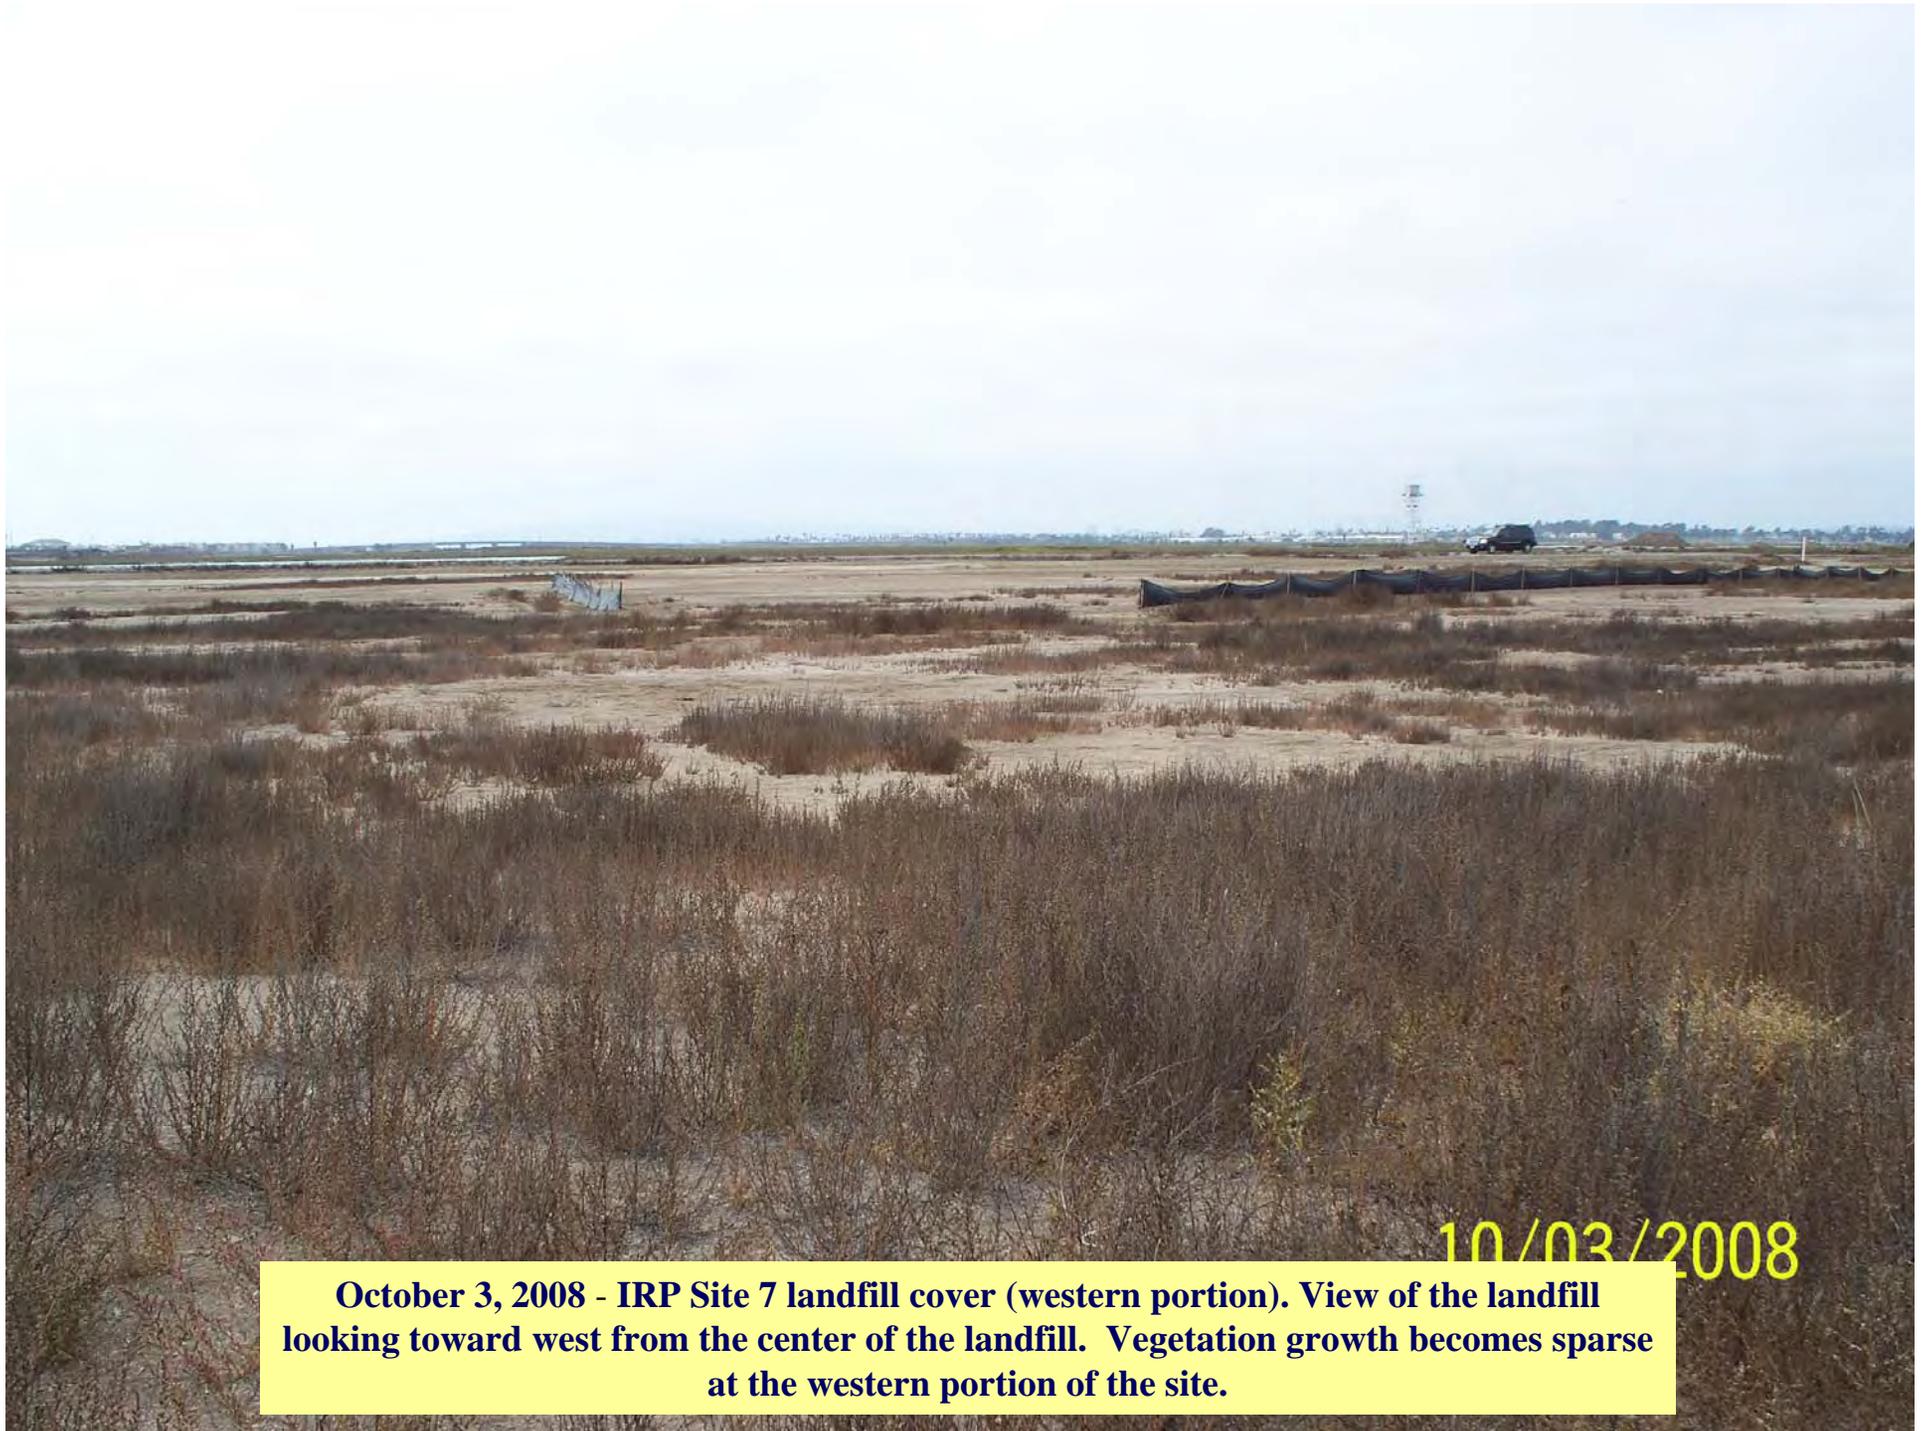
10/03/2008

October 3, 2008 - IRP Site 7 landfill cover (western portion). View of the landfill looking toward west from the center of the landfill. Vegetation growth becomes sparse at the western portion of the site.

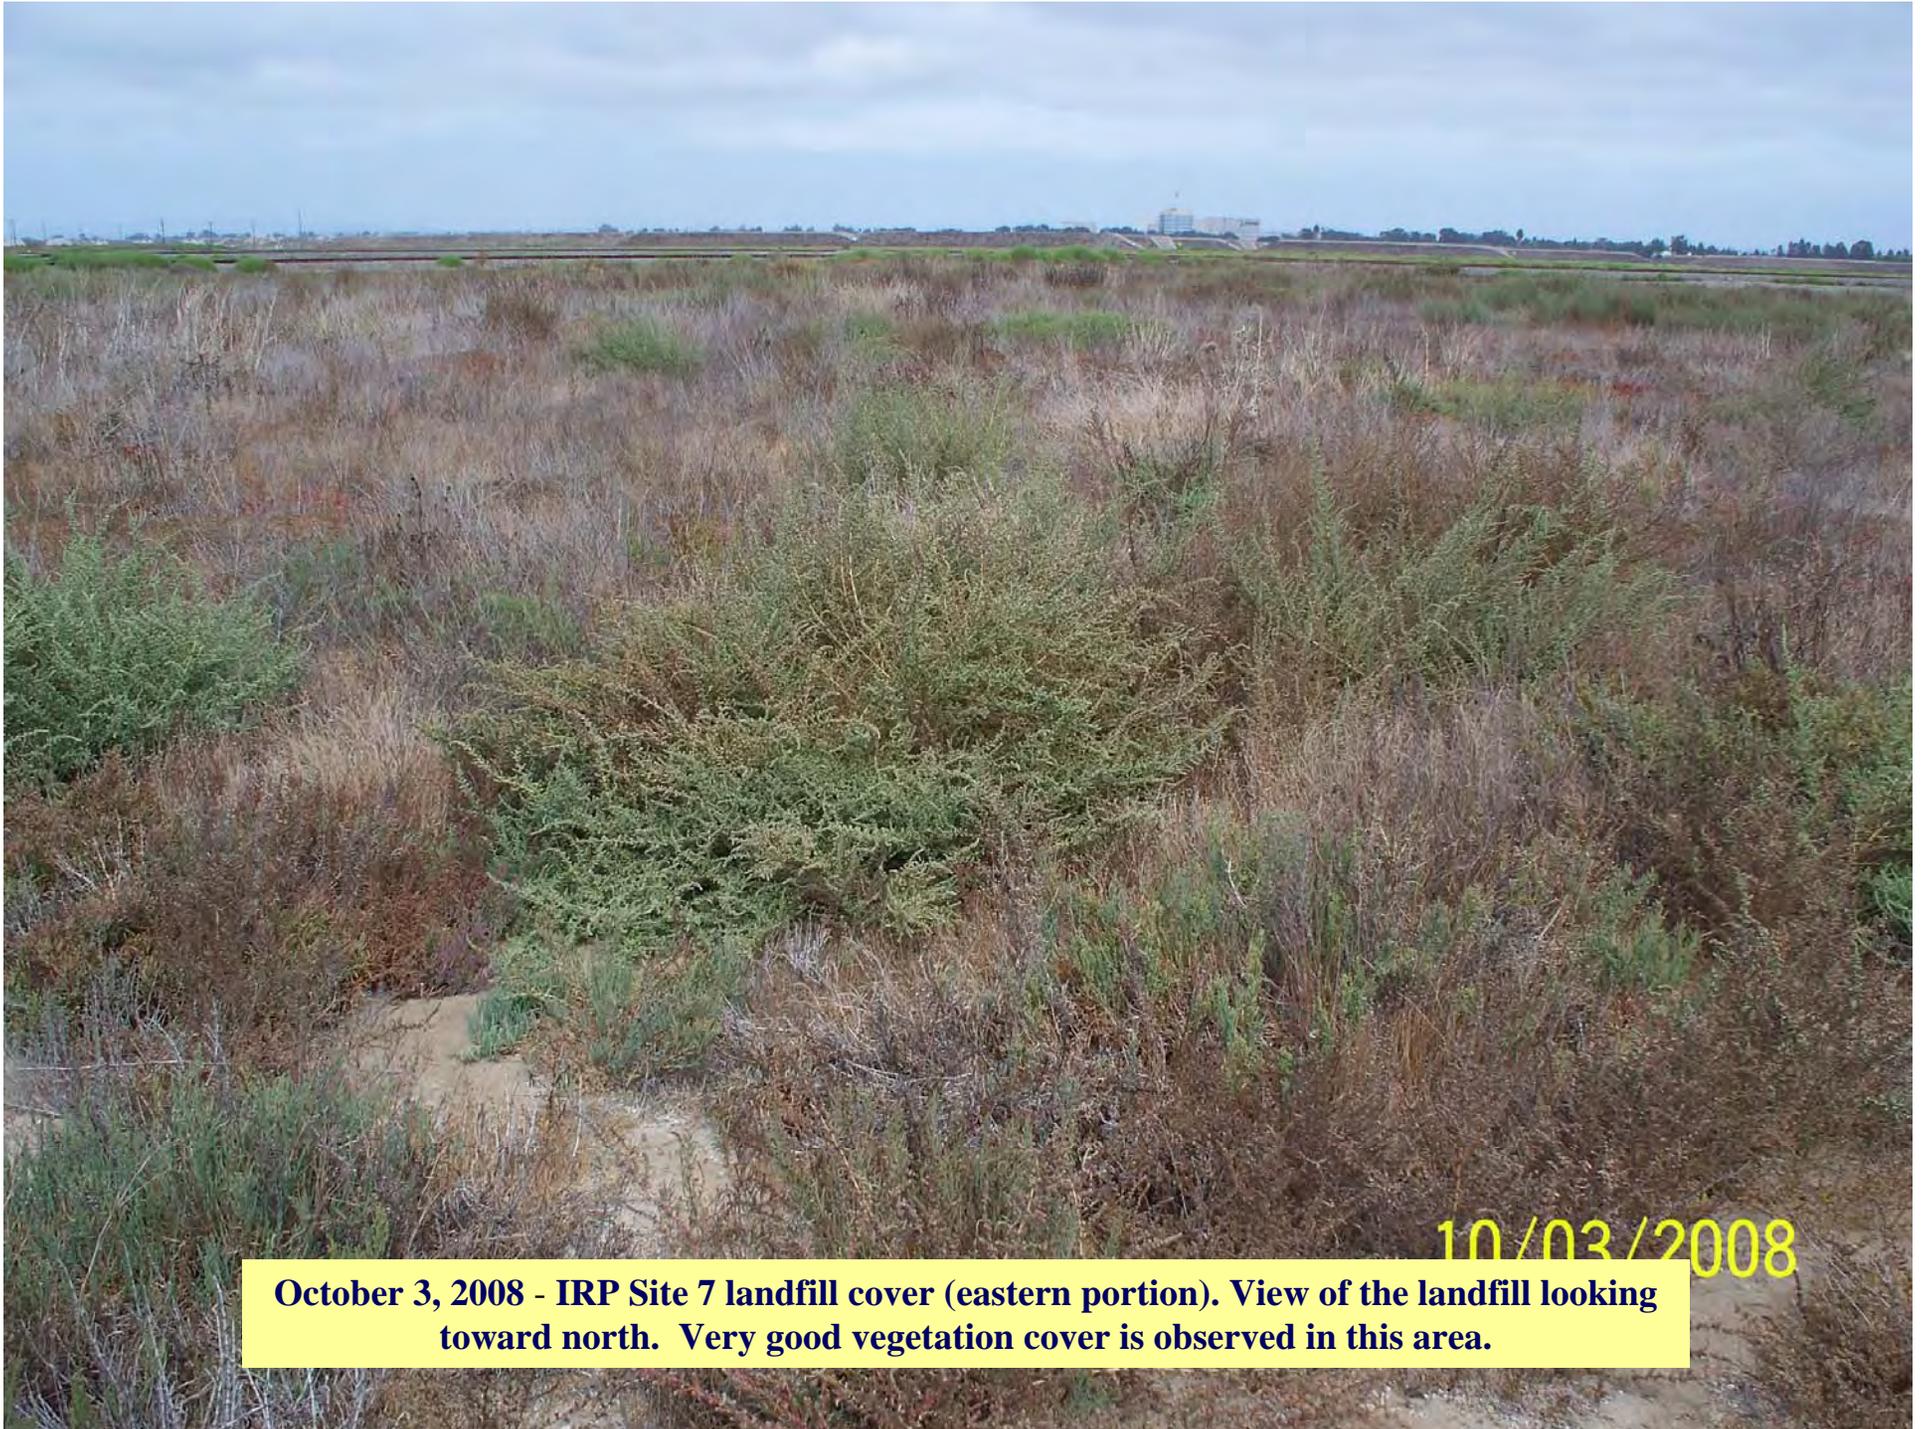
10/03/2008

October 3, 2008 - IRP Site 7 landfill cover (eastern portion). View of the landfill looking toward north. Very good vegetation cover is observed in this area.

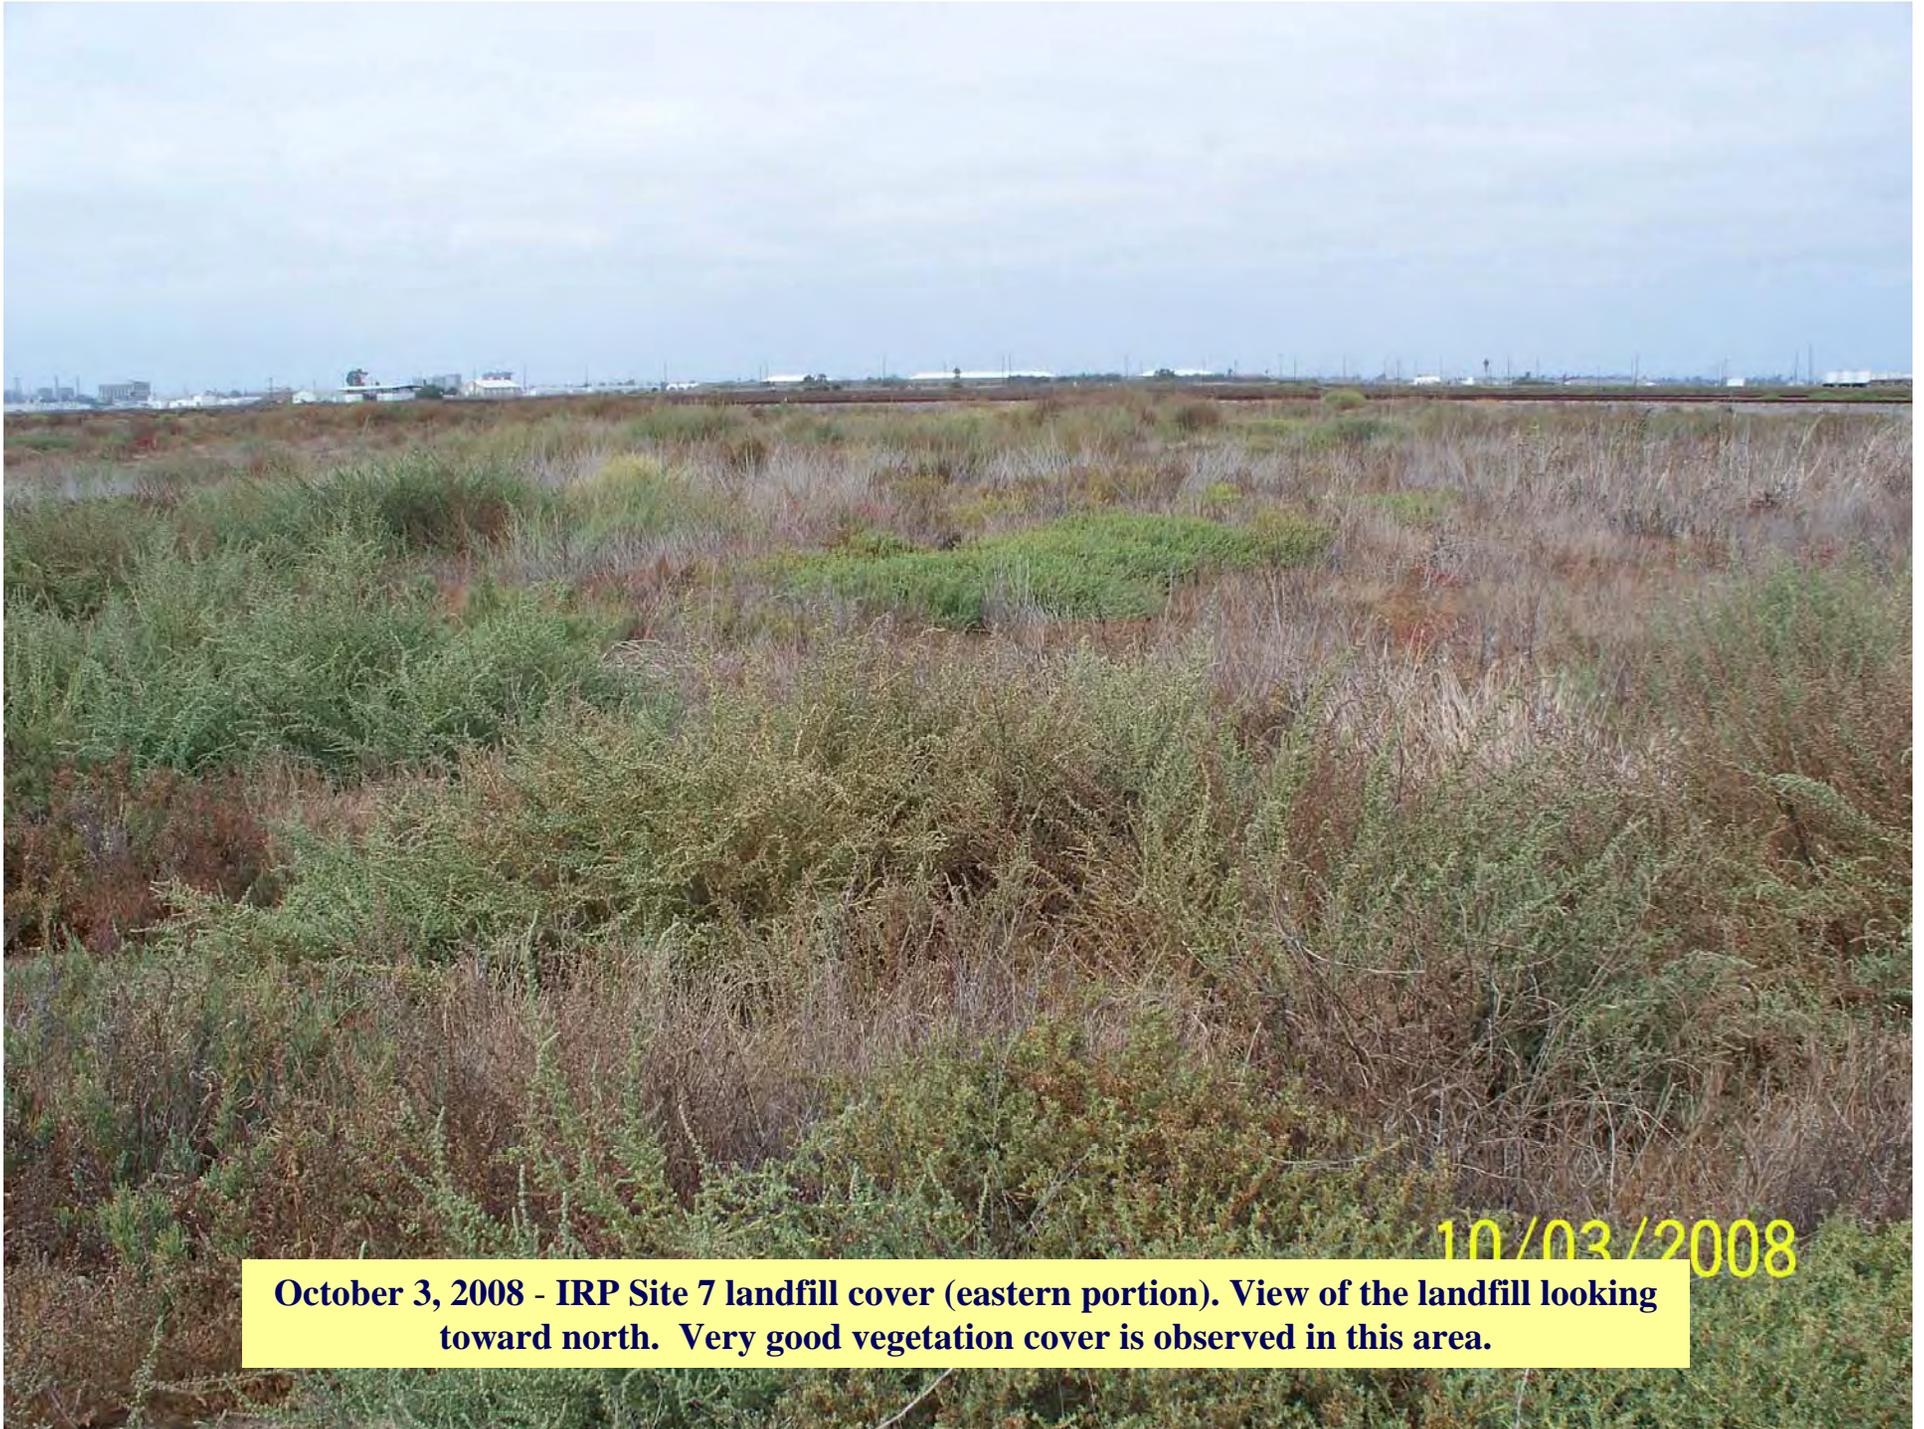
10/03/2008

October 3, 2008 - IRP Site 7 landfill cover (eastern portion). View of the landfill looking toward north. Very good vegetation cover is observed in this area.

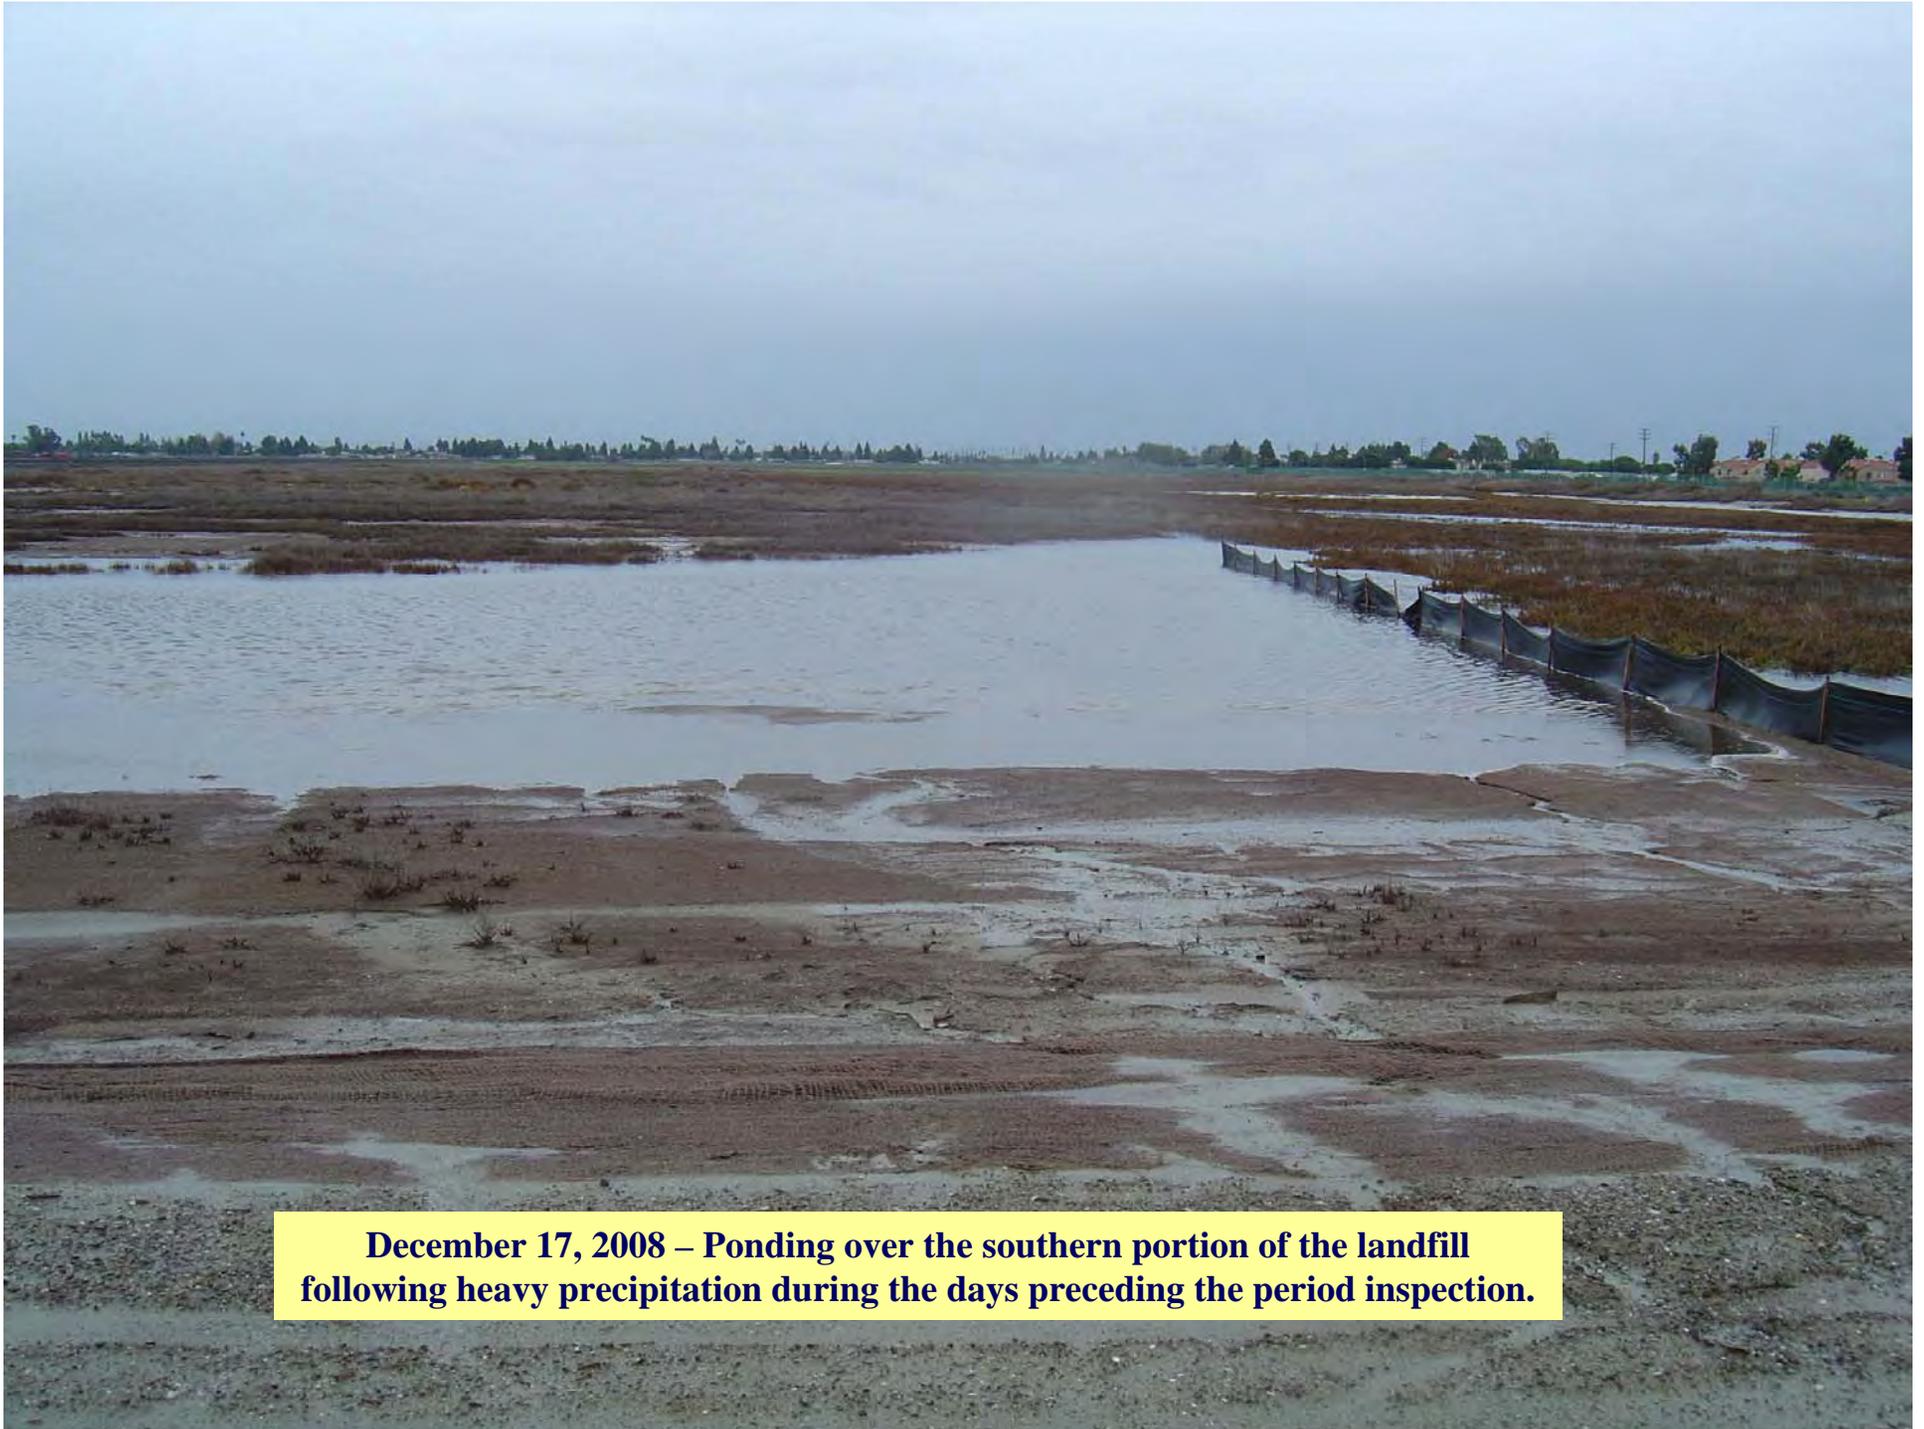
December 17, 2008 – Ponding over the southern portion of the landfill following heavy precipitation during the days preceding the period inspection.
