**DRAFT
WINTER 2008/2009 SEMIANNUAL POST-CLOSURE
INSPECTION AND MAINTENANCE REPORT
May 6, 2009**

**INSTALLATION RESTORATION PROGRAM SITE 7
(FORMER STATION LANDFILL)
NAVAL WEAPONS STATION SEAL BEACH
SEAL BEACH, CALIFORNIA**

DCN: ECSD-3211-0008-0004

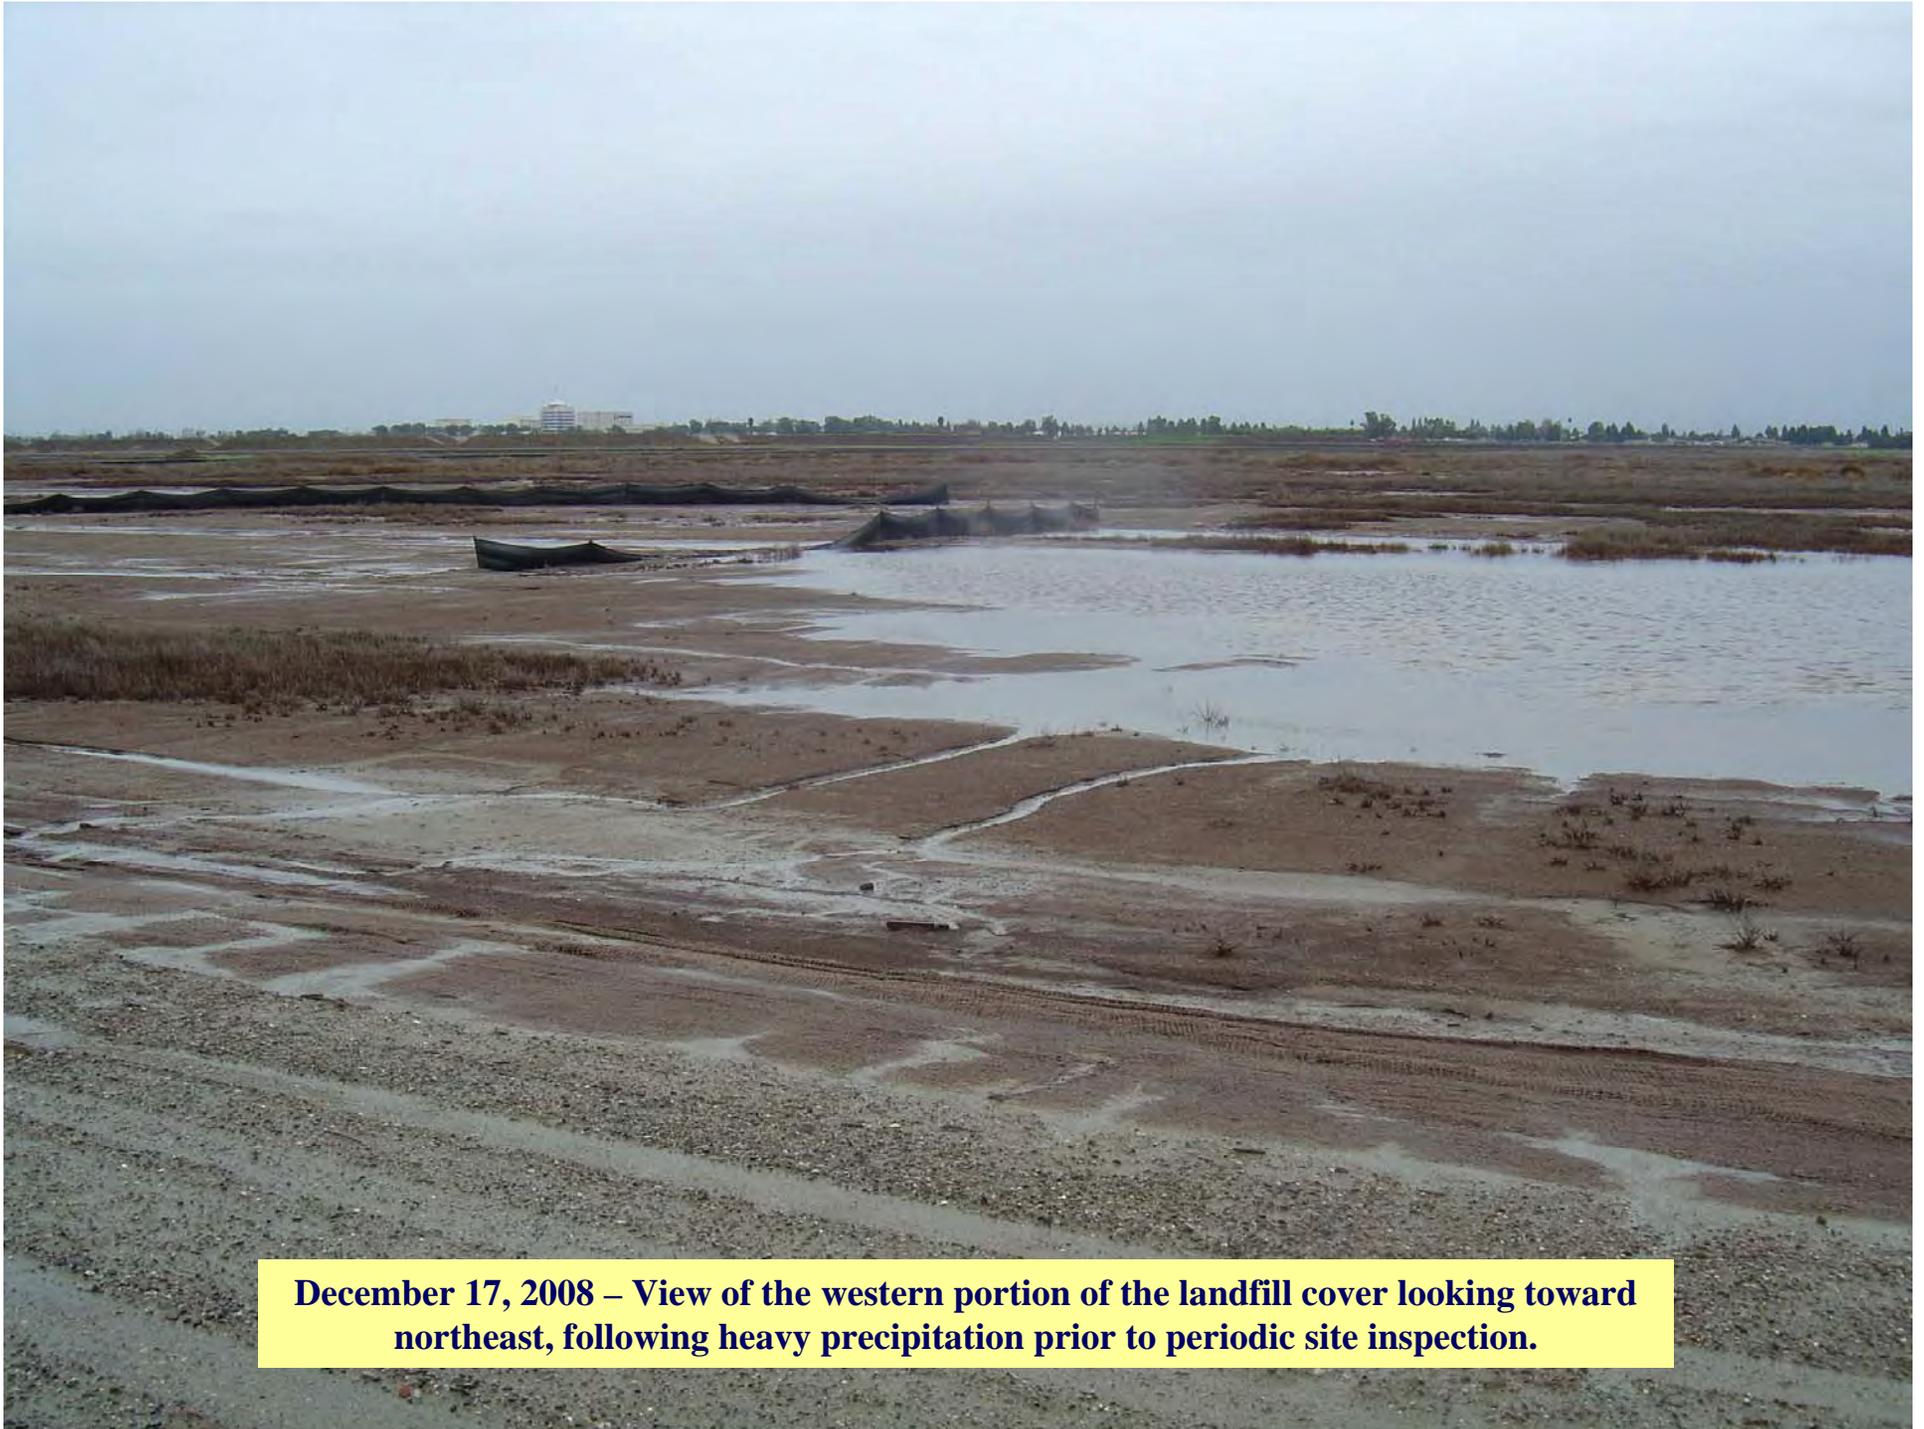
December 17, 2008 – View of the western portion of the landfill cover looking toward northeast, following heavy precipitation prior to periodic site inspection.

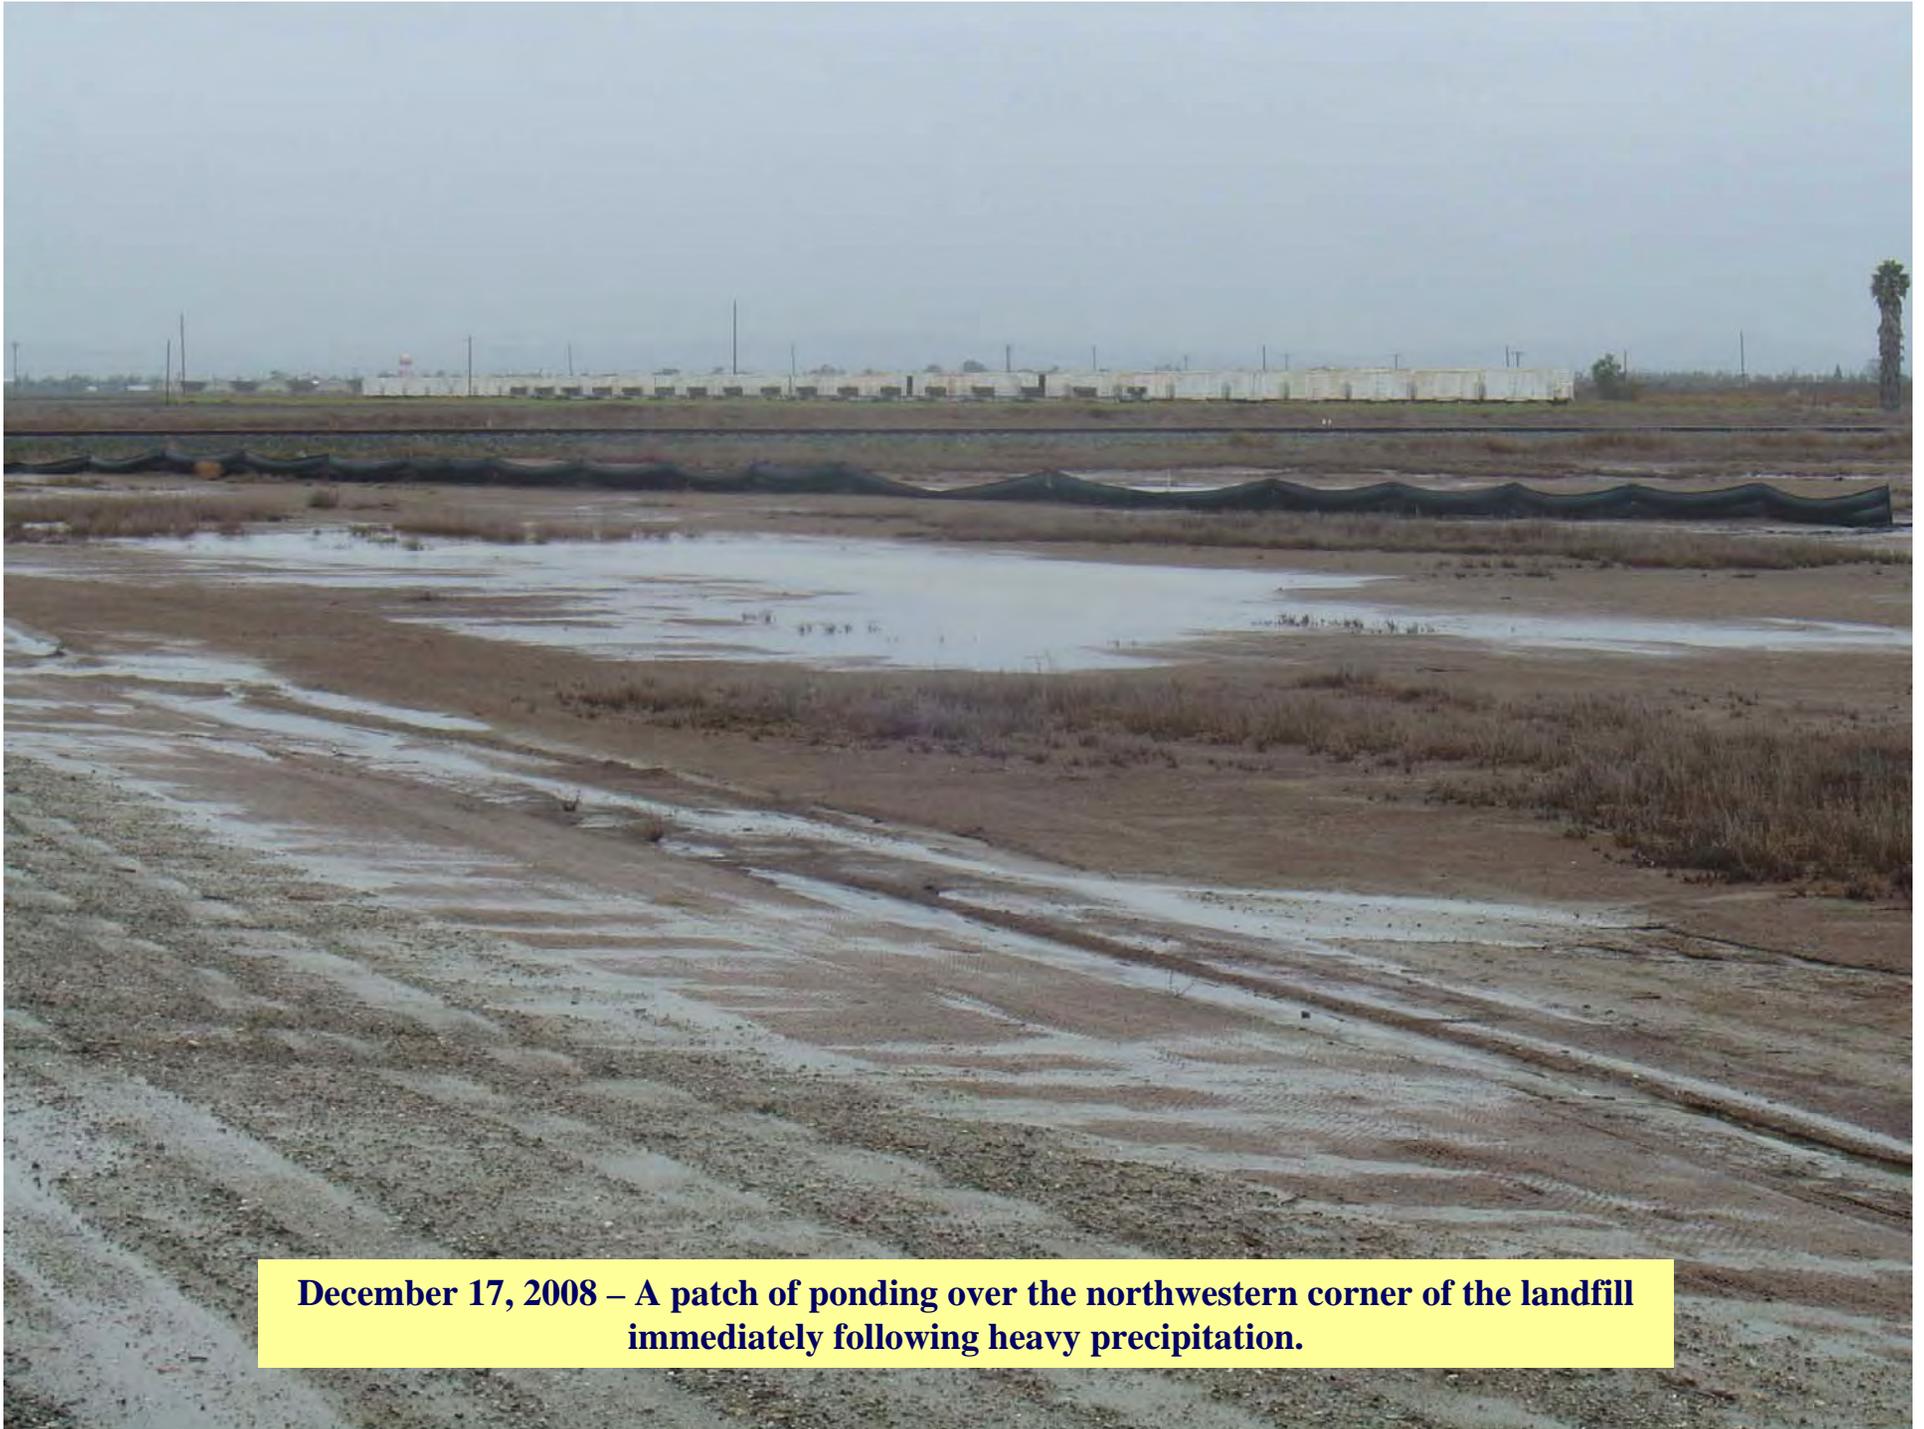
December 17, 2008 – A patch of ponding over the northwestern corner of the landfill immediately following heavy precipitation.

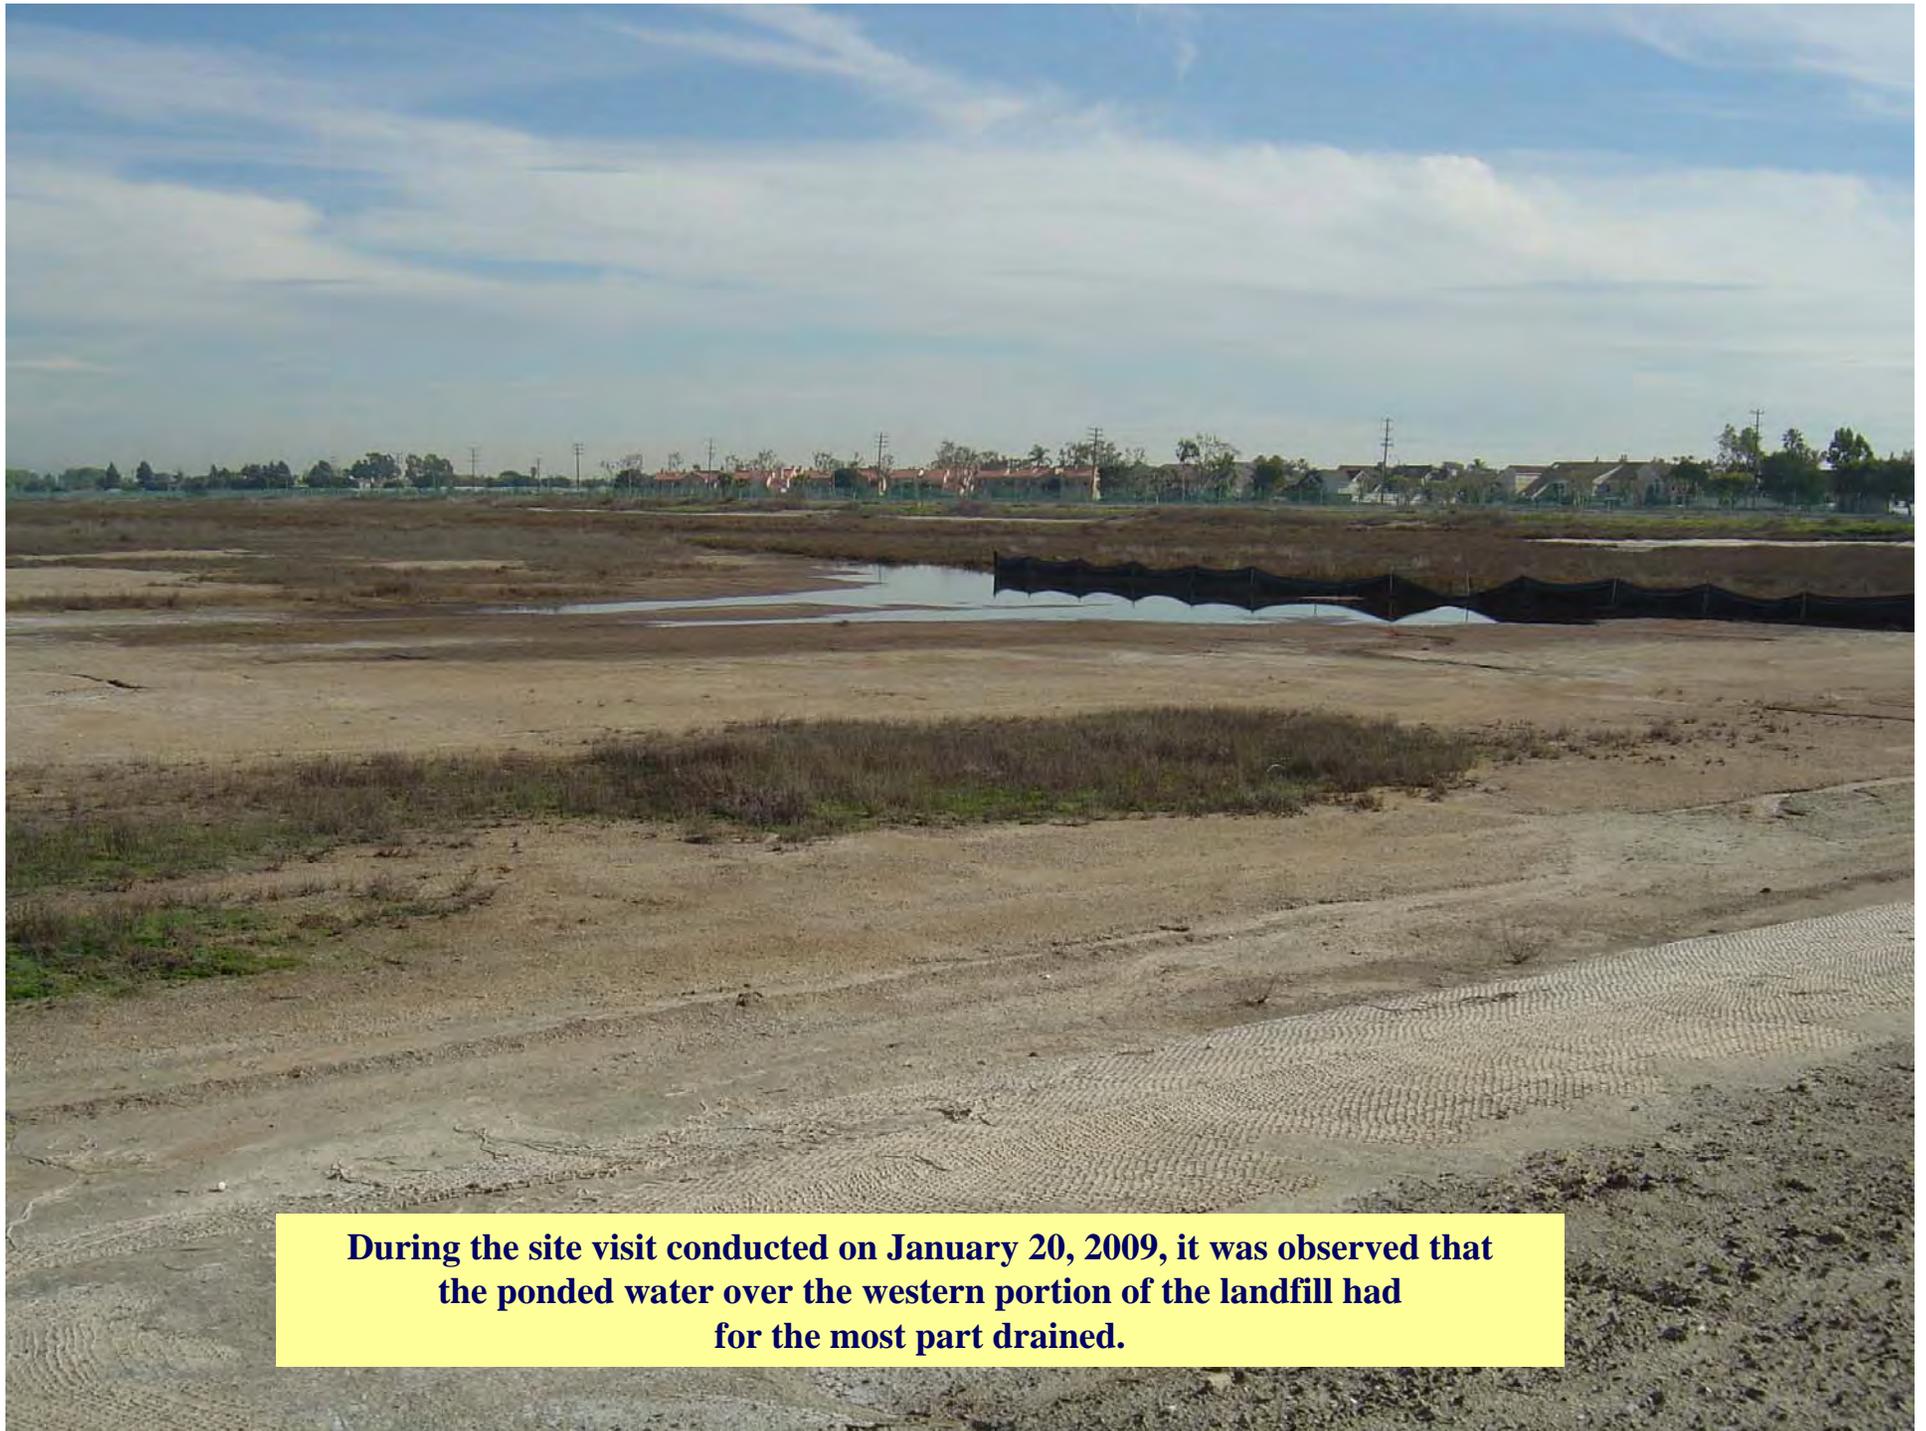
During the site visit conducted on January 20, 2009, it was observed that the ponded water over the western portion of the landfill had for the most part drained.

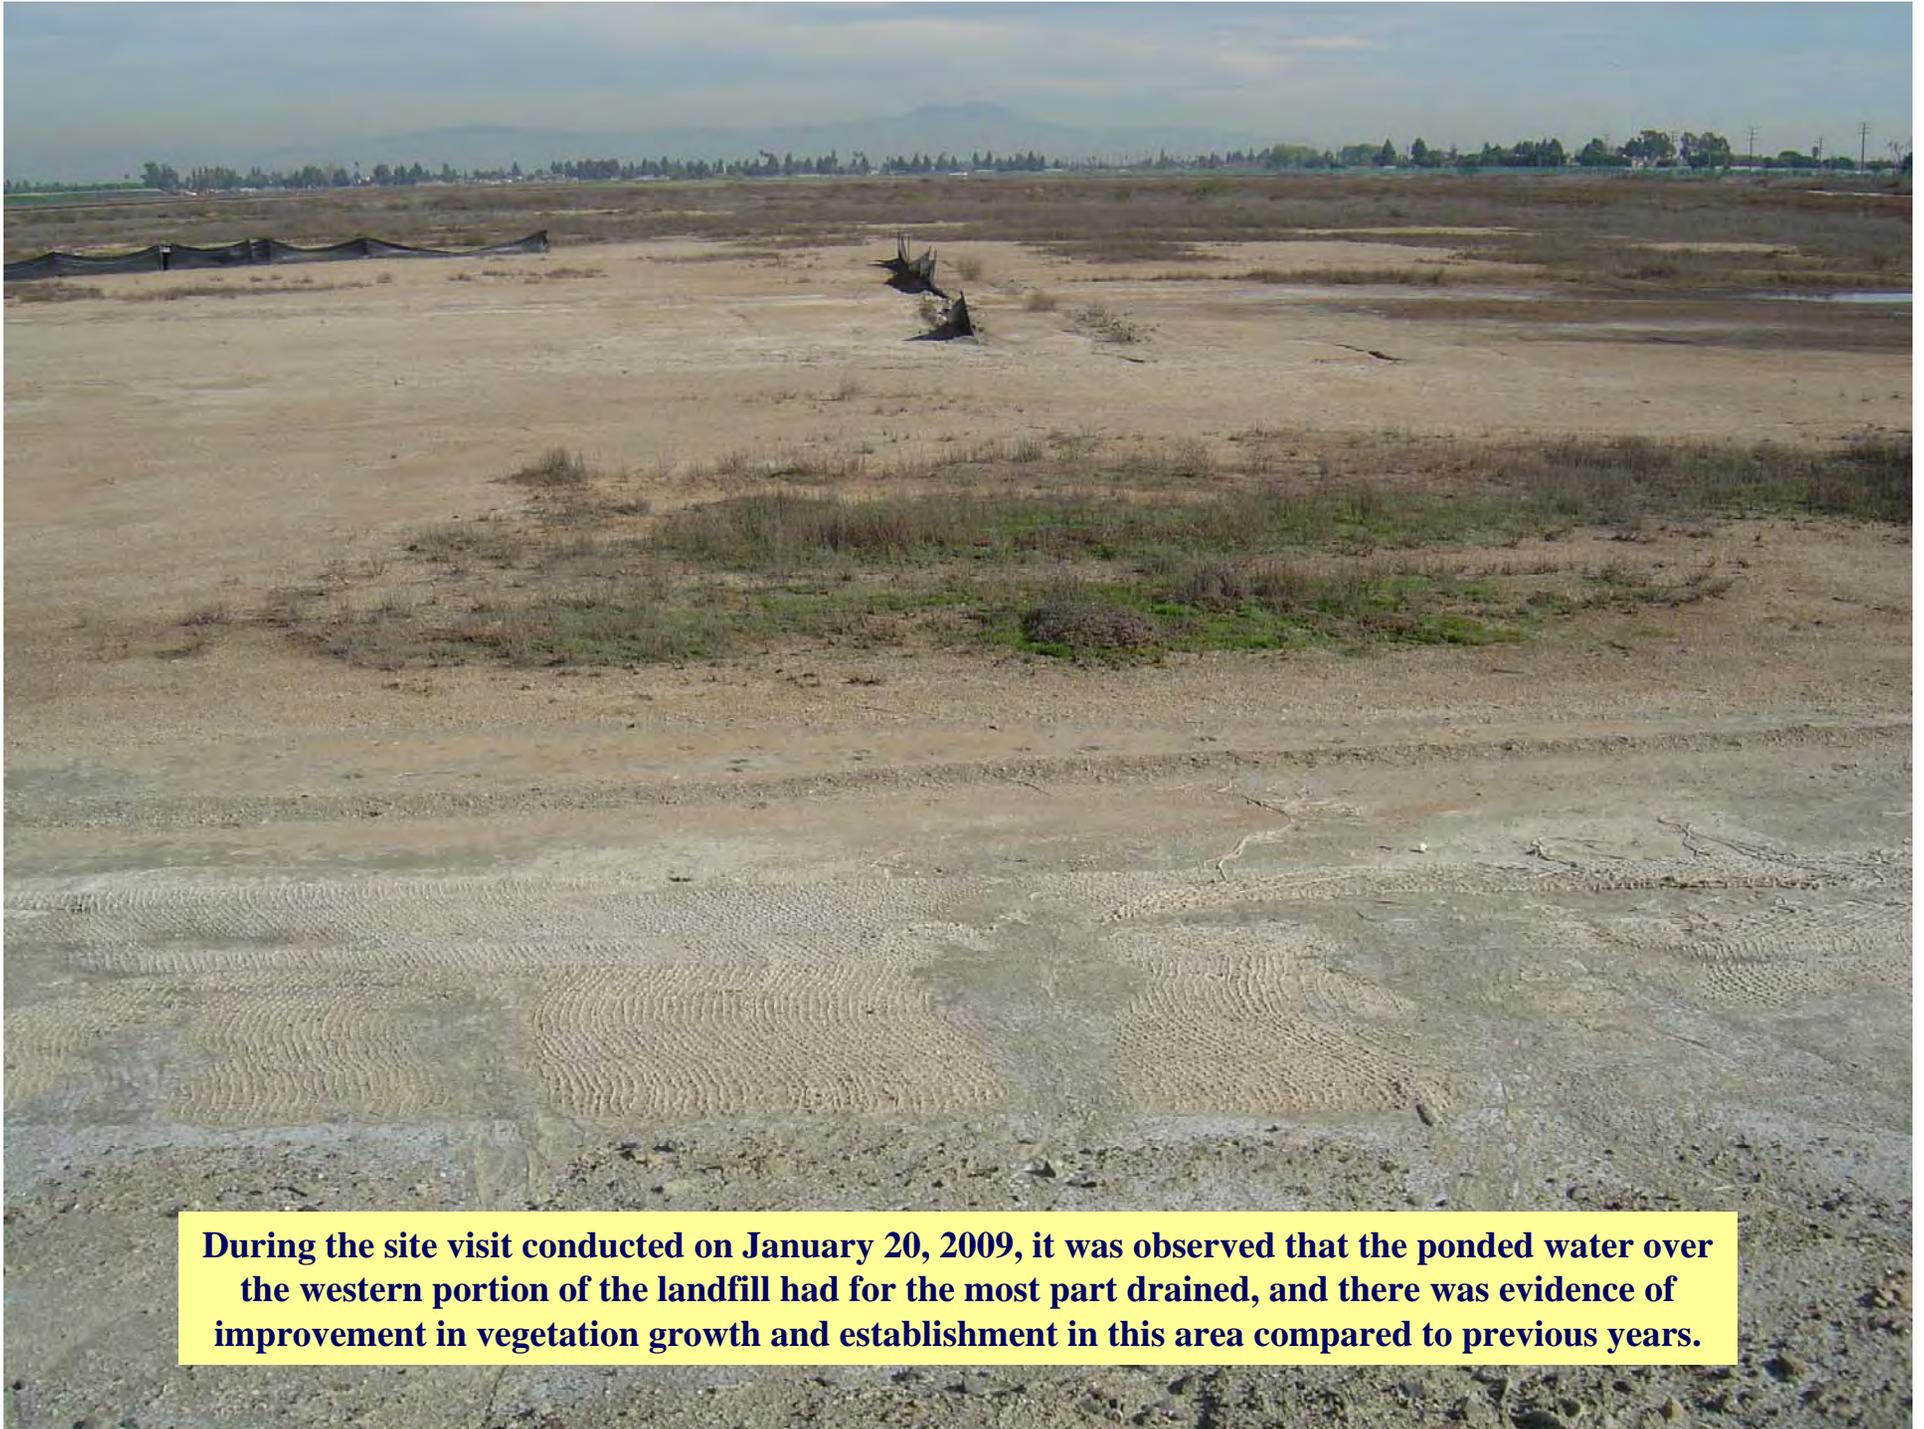
During the site visit conducted on January 20, 2009, it was observed that the ponded water over the western portion of the landfill had for the most part drained, and there was evidence of improvement in vegetation growth and establishment in this area compared to previous years.

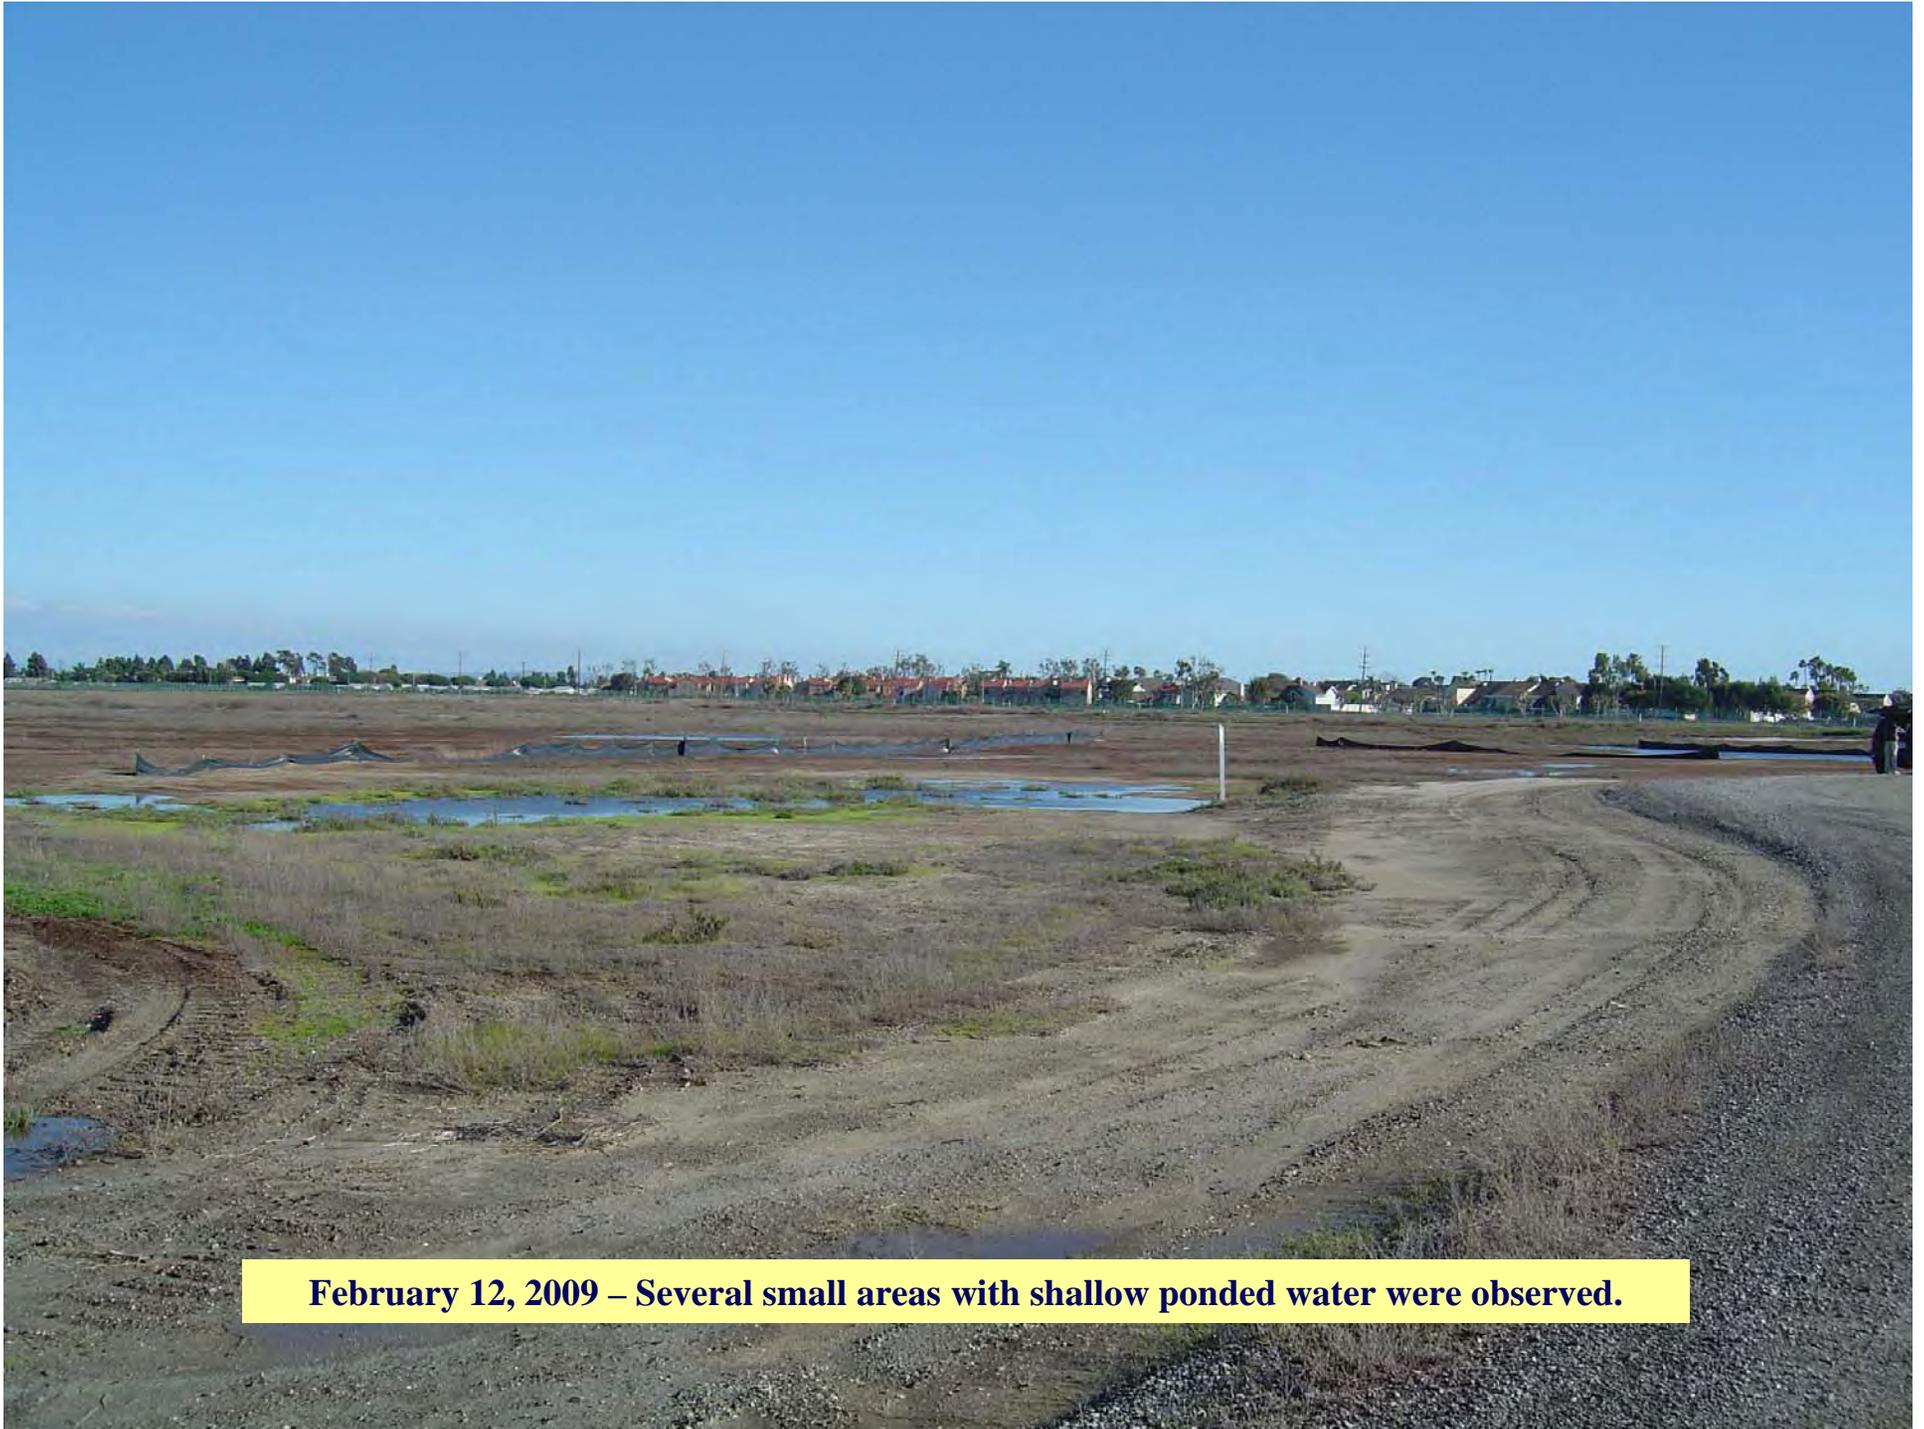
February 12, 2009 – Several small areas with shallow ponded water were observed.

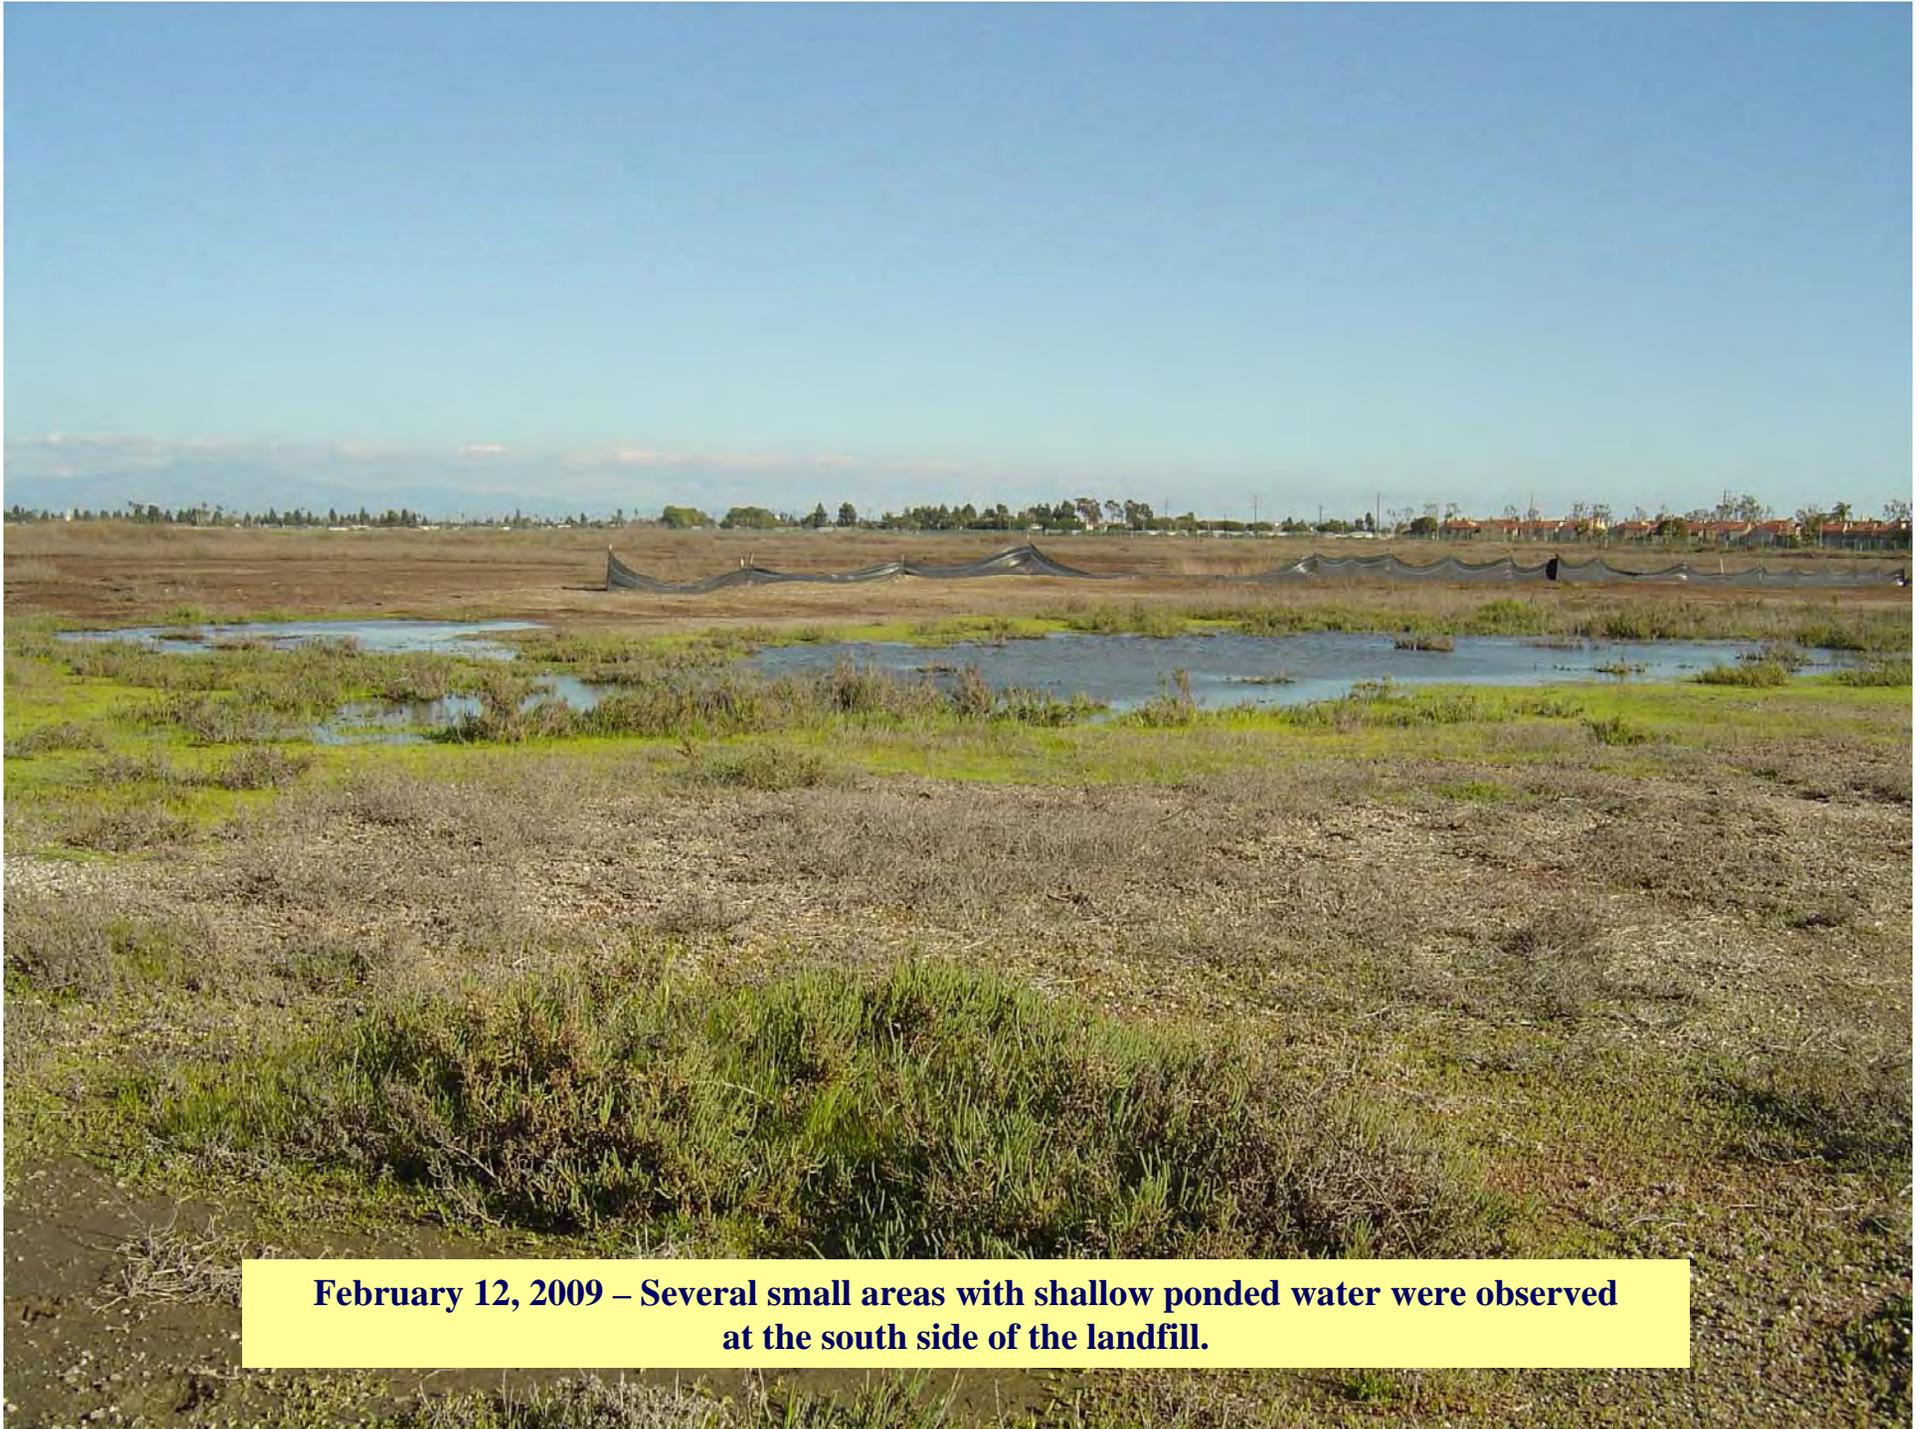
February 12, 2009 – Several small areas with shallow ponded water were observed at the south side of the landfill.

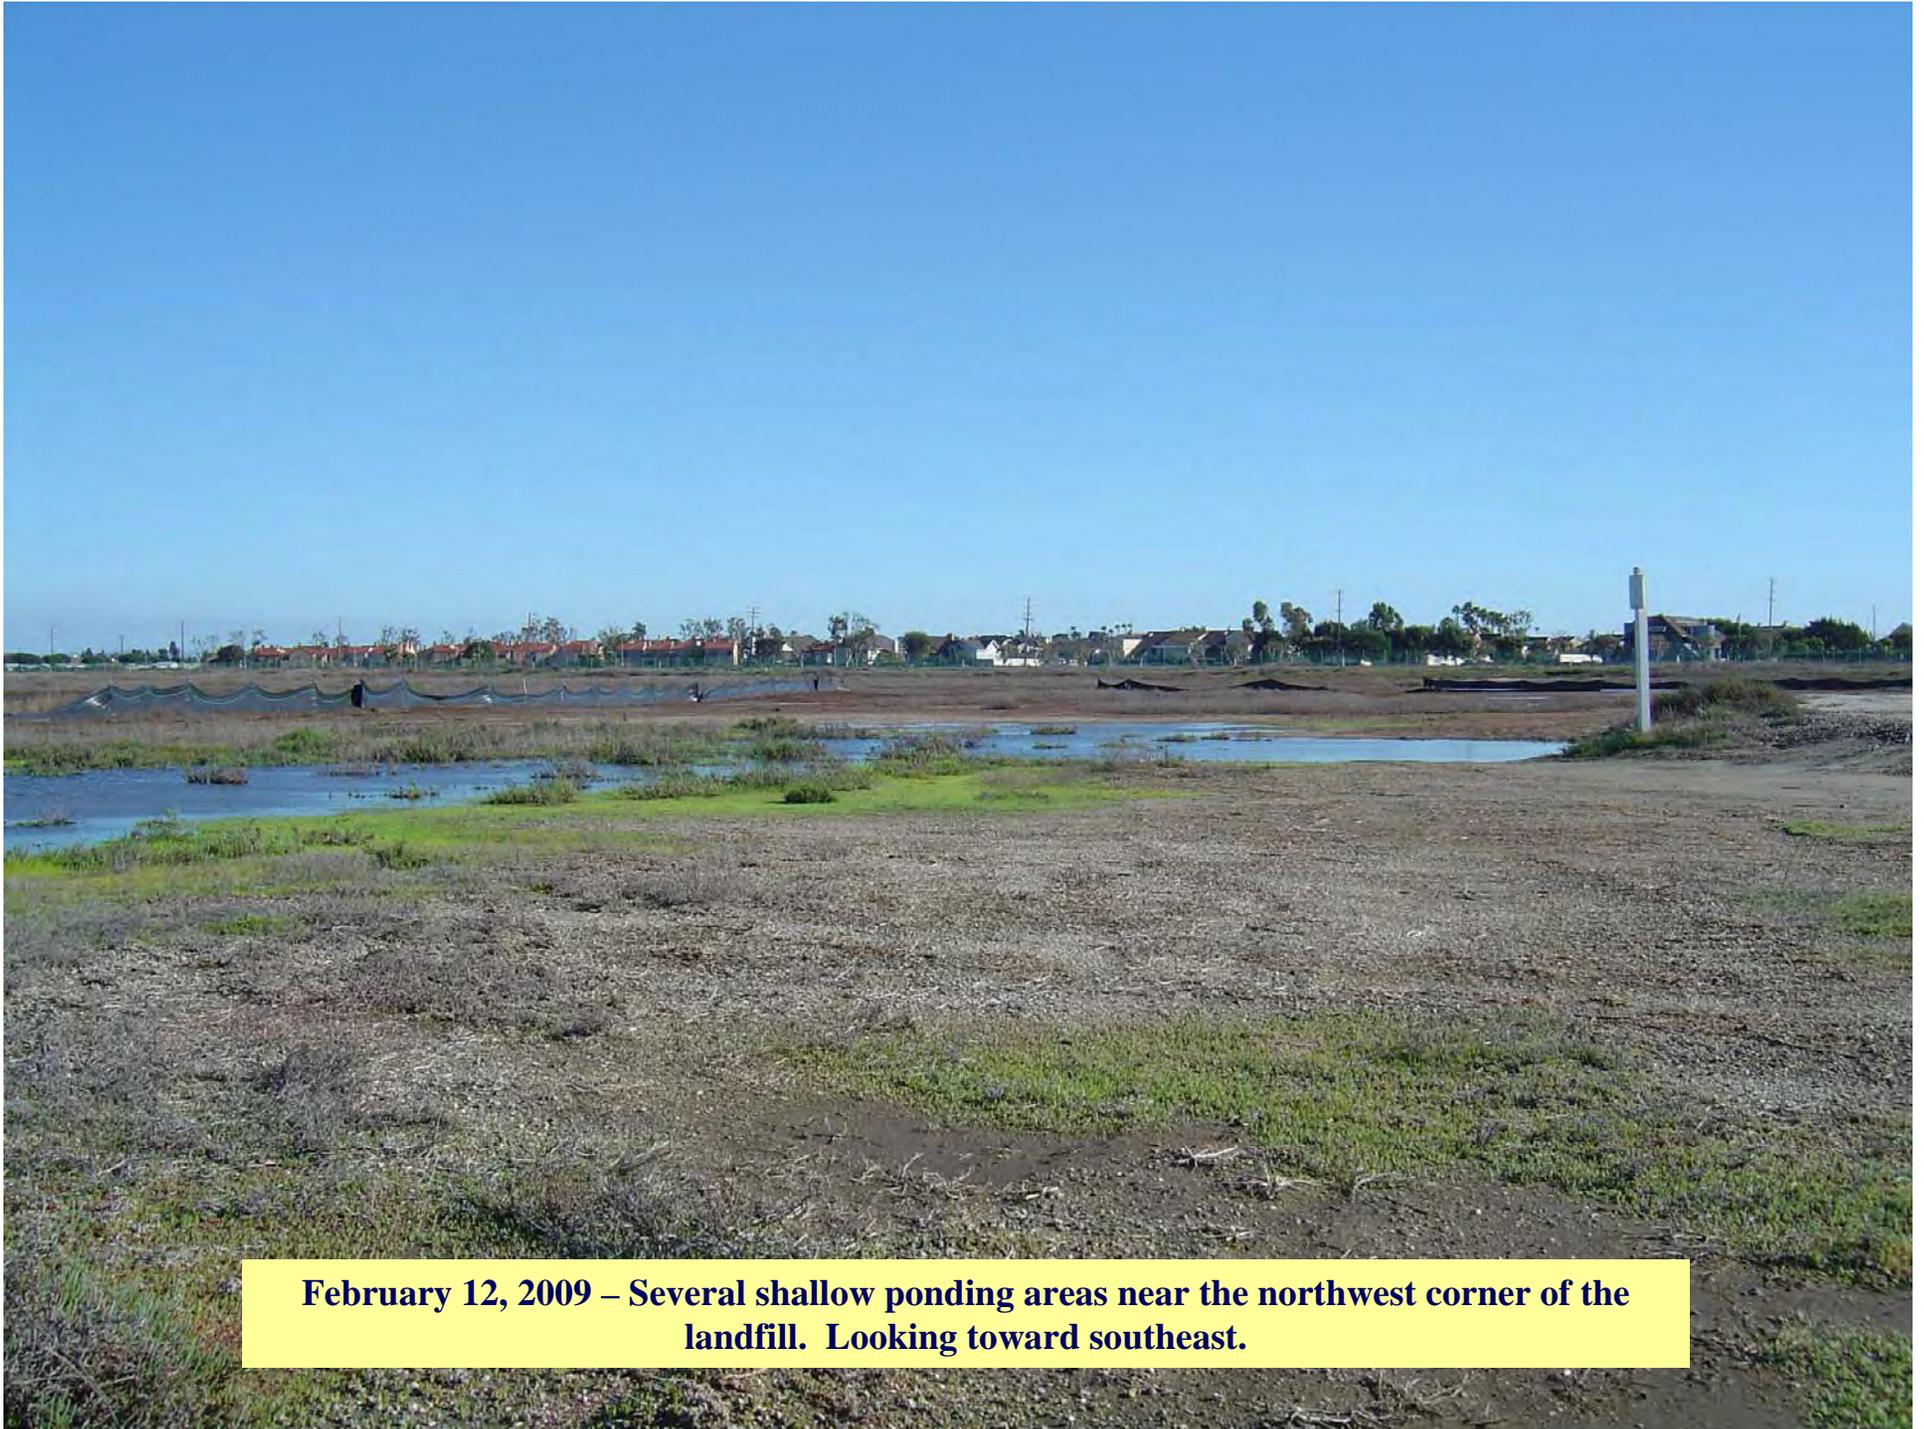
February 12, 2009 – Several shallow ponding areas near the northwest corner of the landfill. Looking toward southeast.

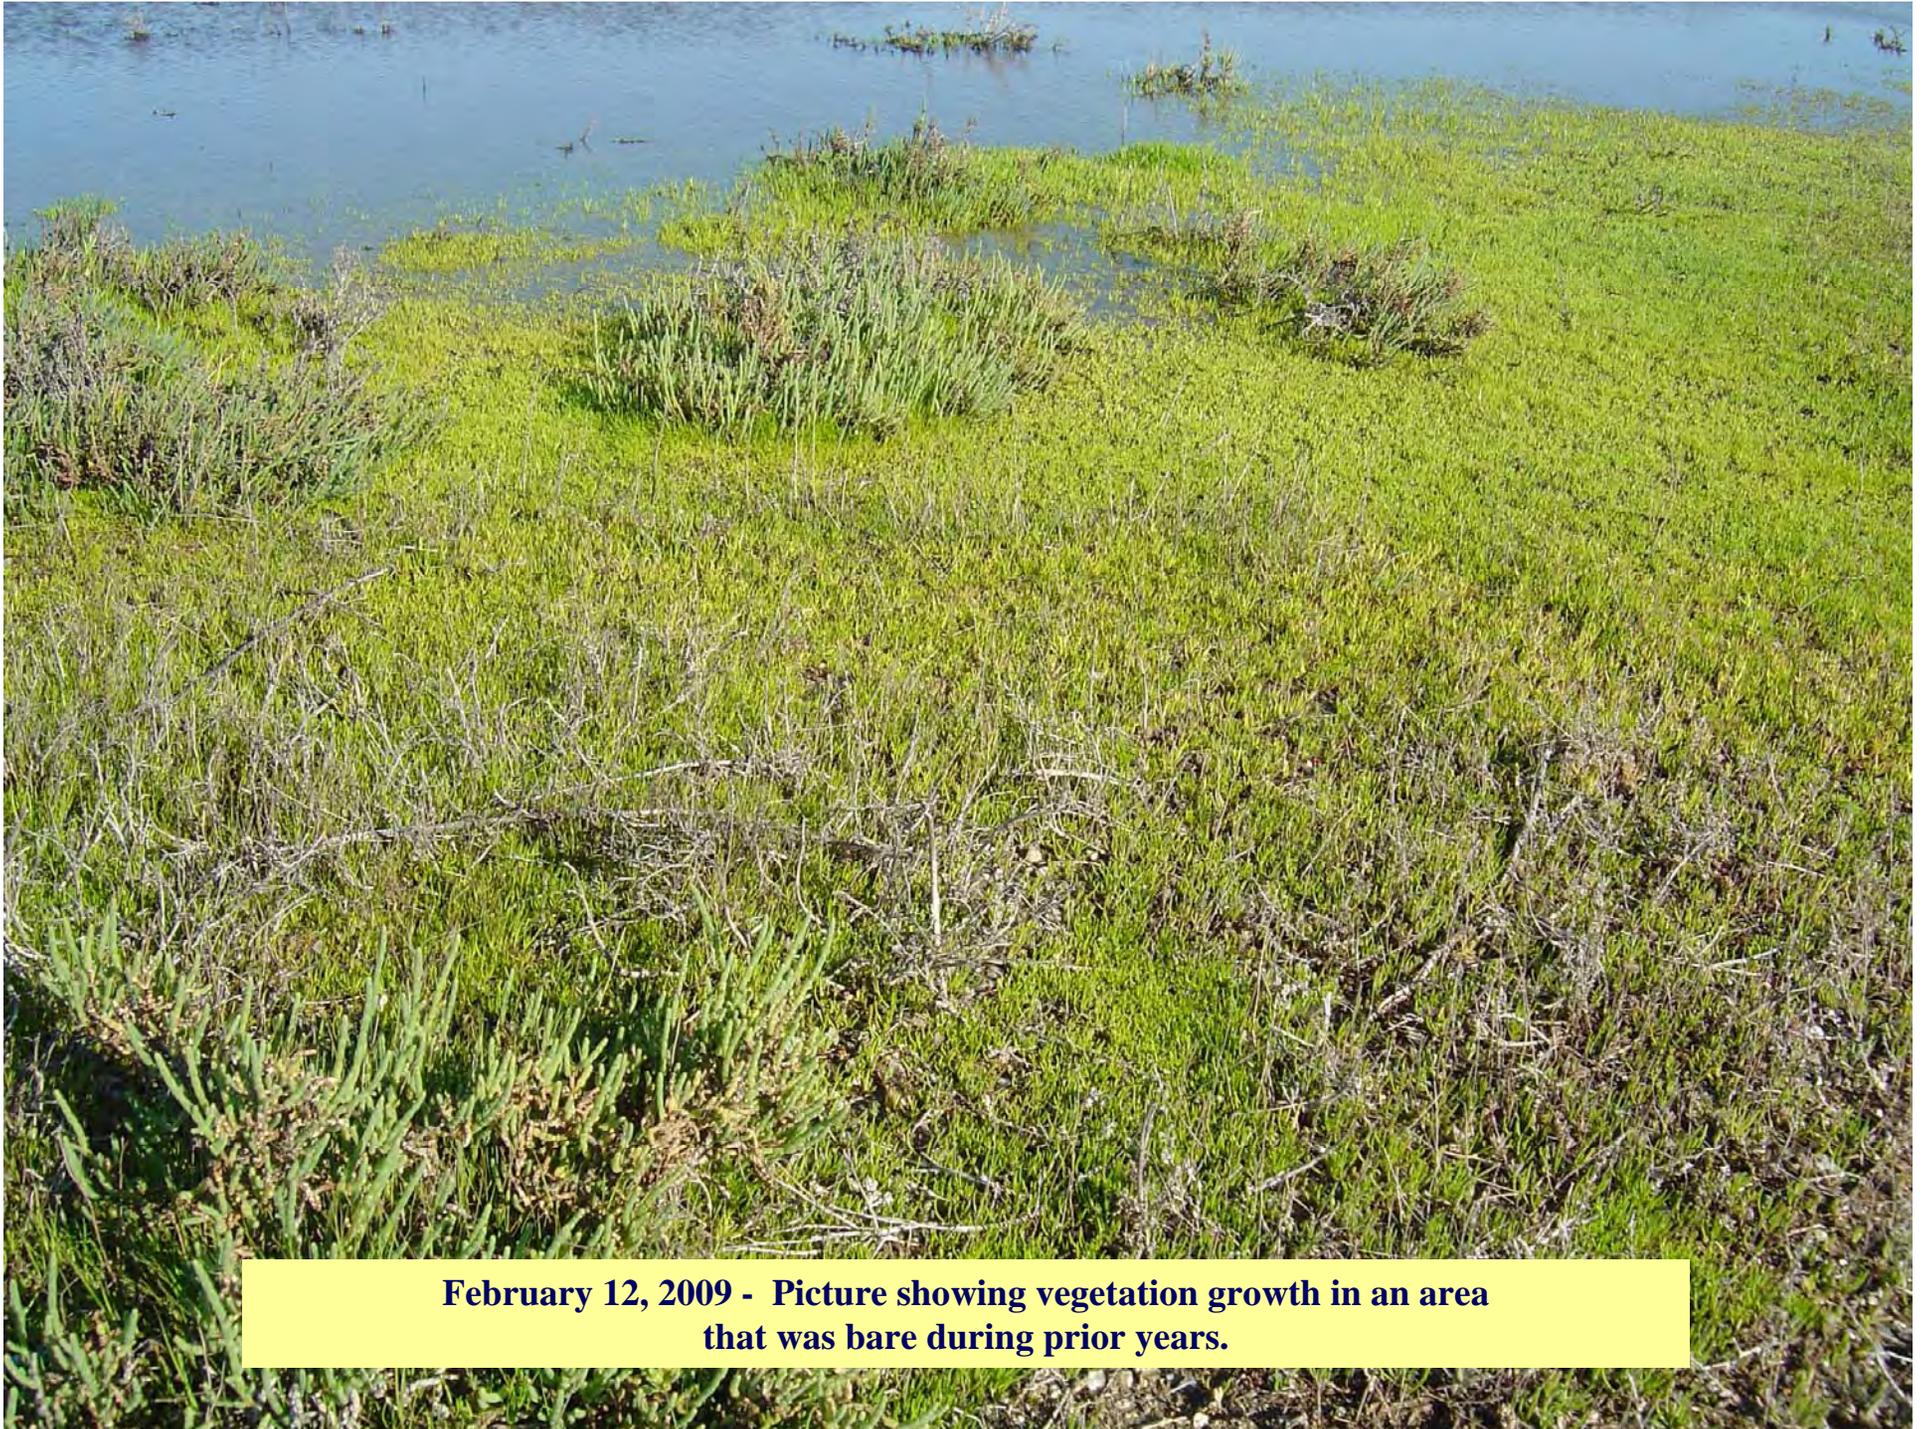
February 12, 2009 - Picture showing vegetation growth in an area that was bare during prior years.
