**DRAFT
WINTER 2008/2009 SEMIANNUAL POST-CLOSURE
INSPECTION AND MAINTENANCE REPORT
May 6, 2009**

**INSTALLATION RESTORATION PROGRAM SITE 7
(FORMER STATION LANDFILL)
NAVAL WEAPONS STATION SEAL BEACH
SEAL BEACH, CALIFORNIA**

DCN: ECSD-3211-0008-0004

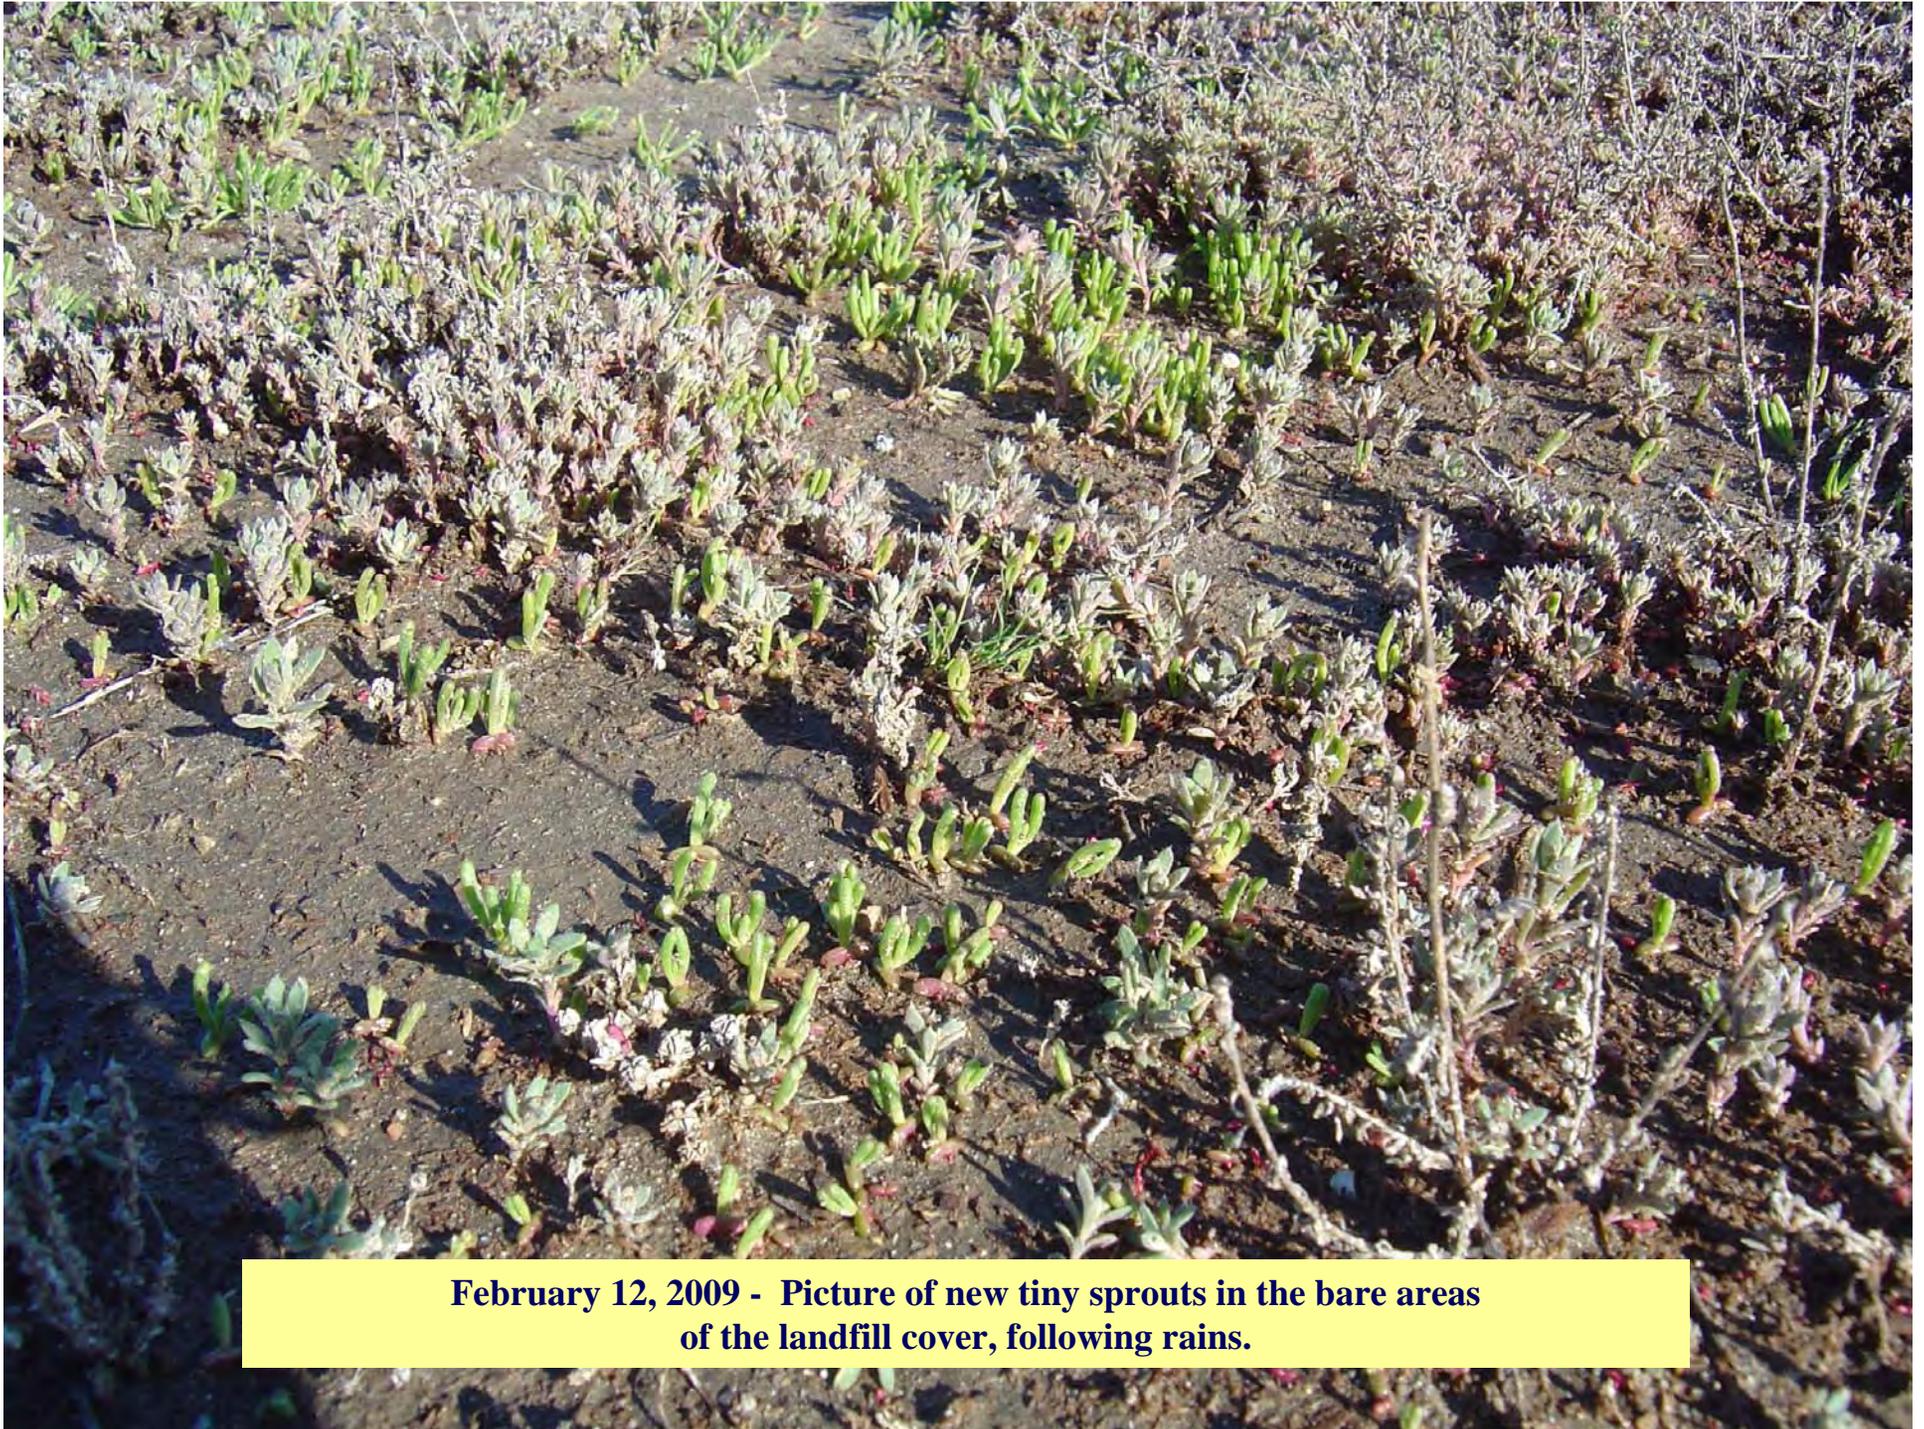
February 12, 2009 - Picture of new tiny sprouts in the bare areas of the landfill cover, following rains.

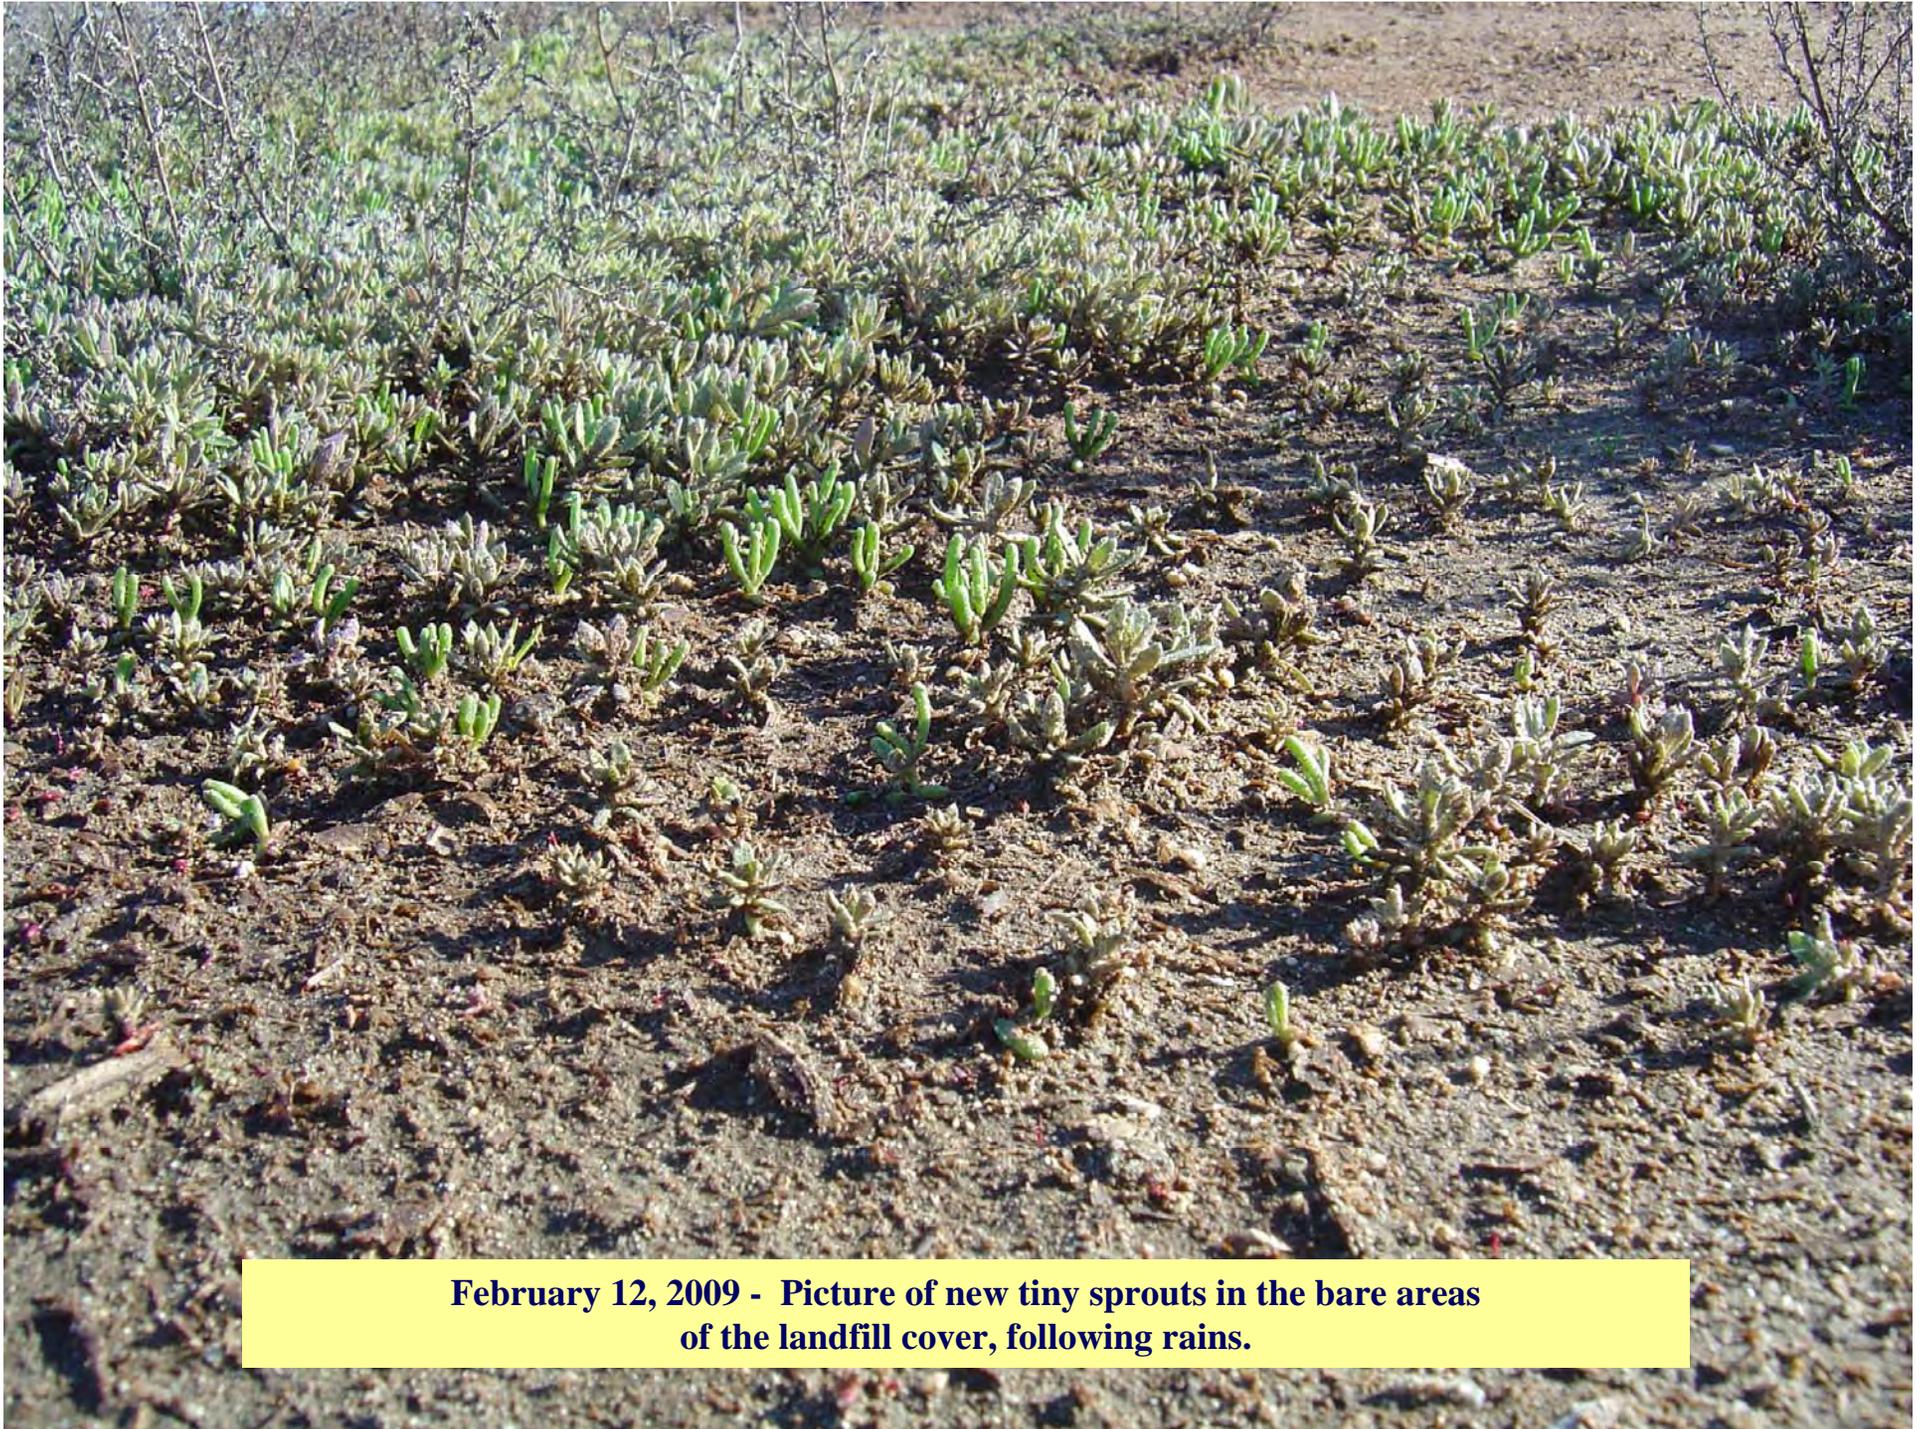
February 12, 2009 - Picture of new tiny sprouts in the bare areas of the landfill cover, following rains.

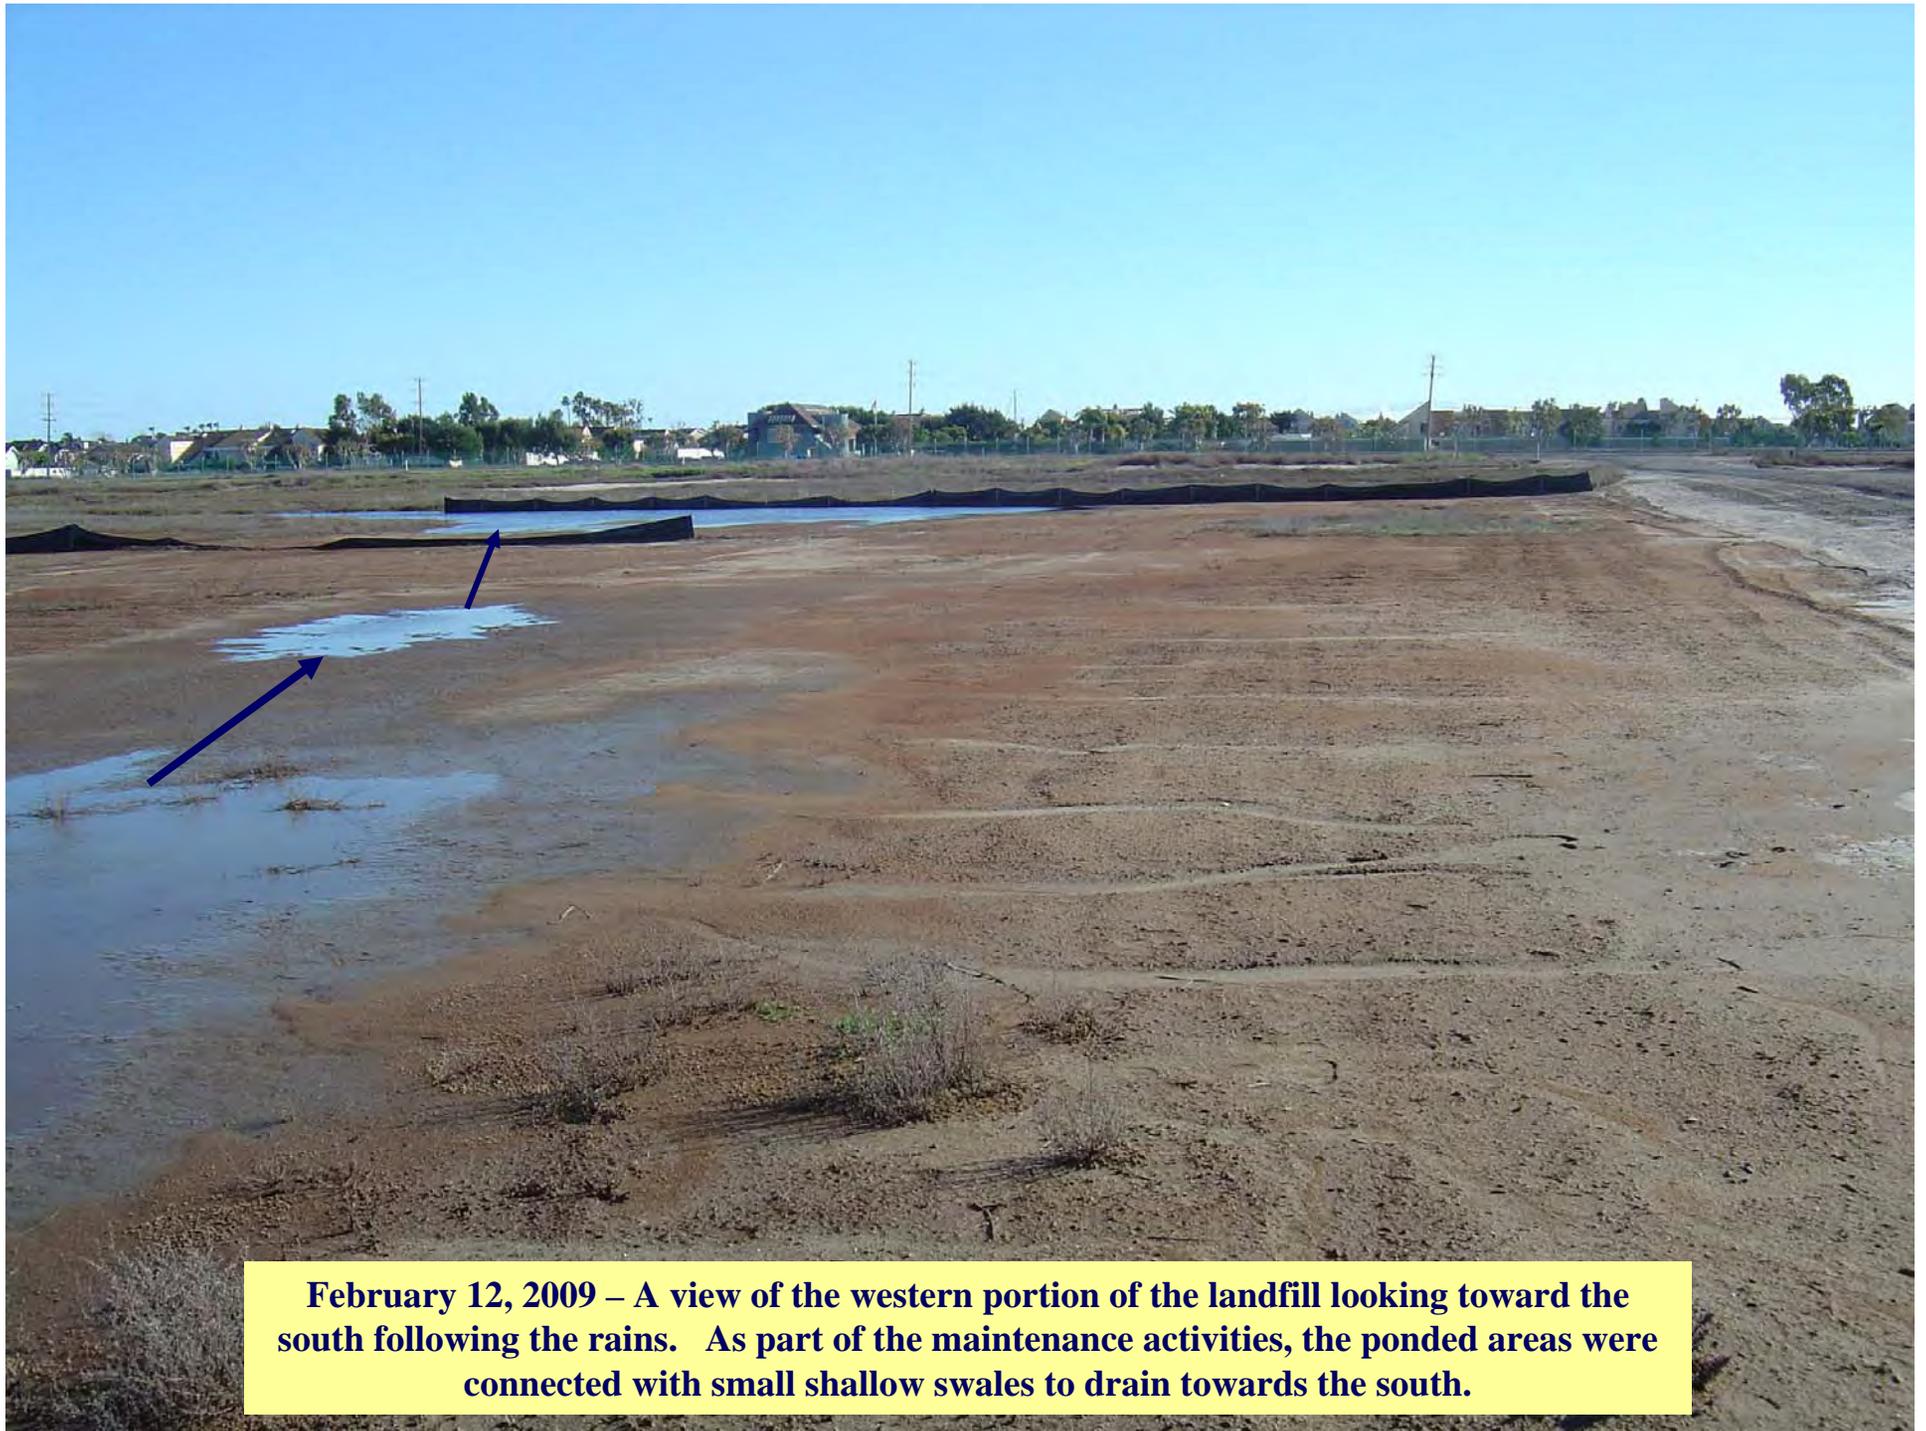
February 12, 2009 – A view of the western portion of the landfill looking toward the south following the rains. As part of the maintenance activities, the ponded areas were connected with small shallow swales to drain towards the south.

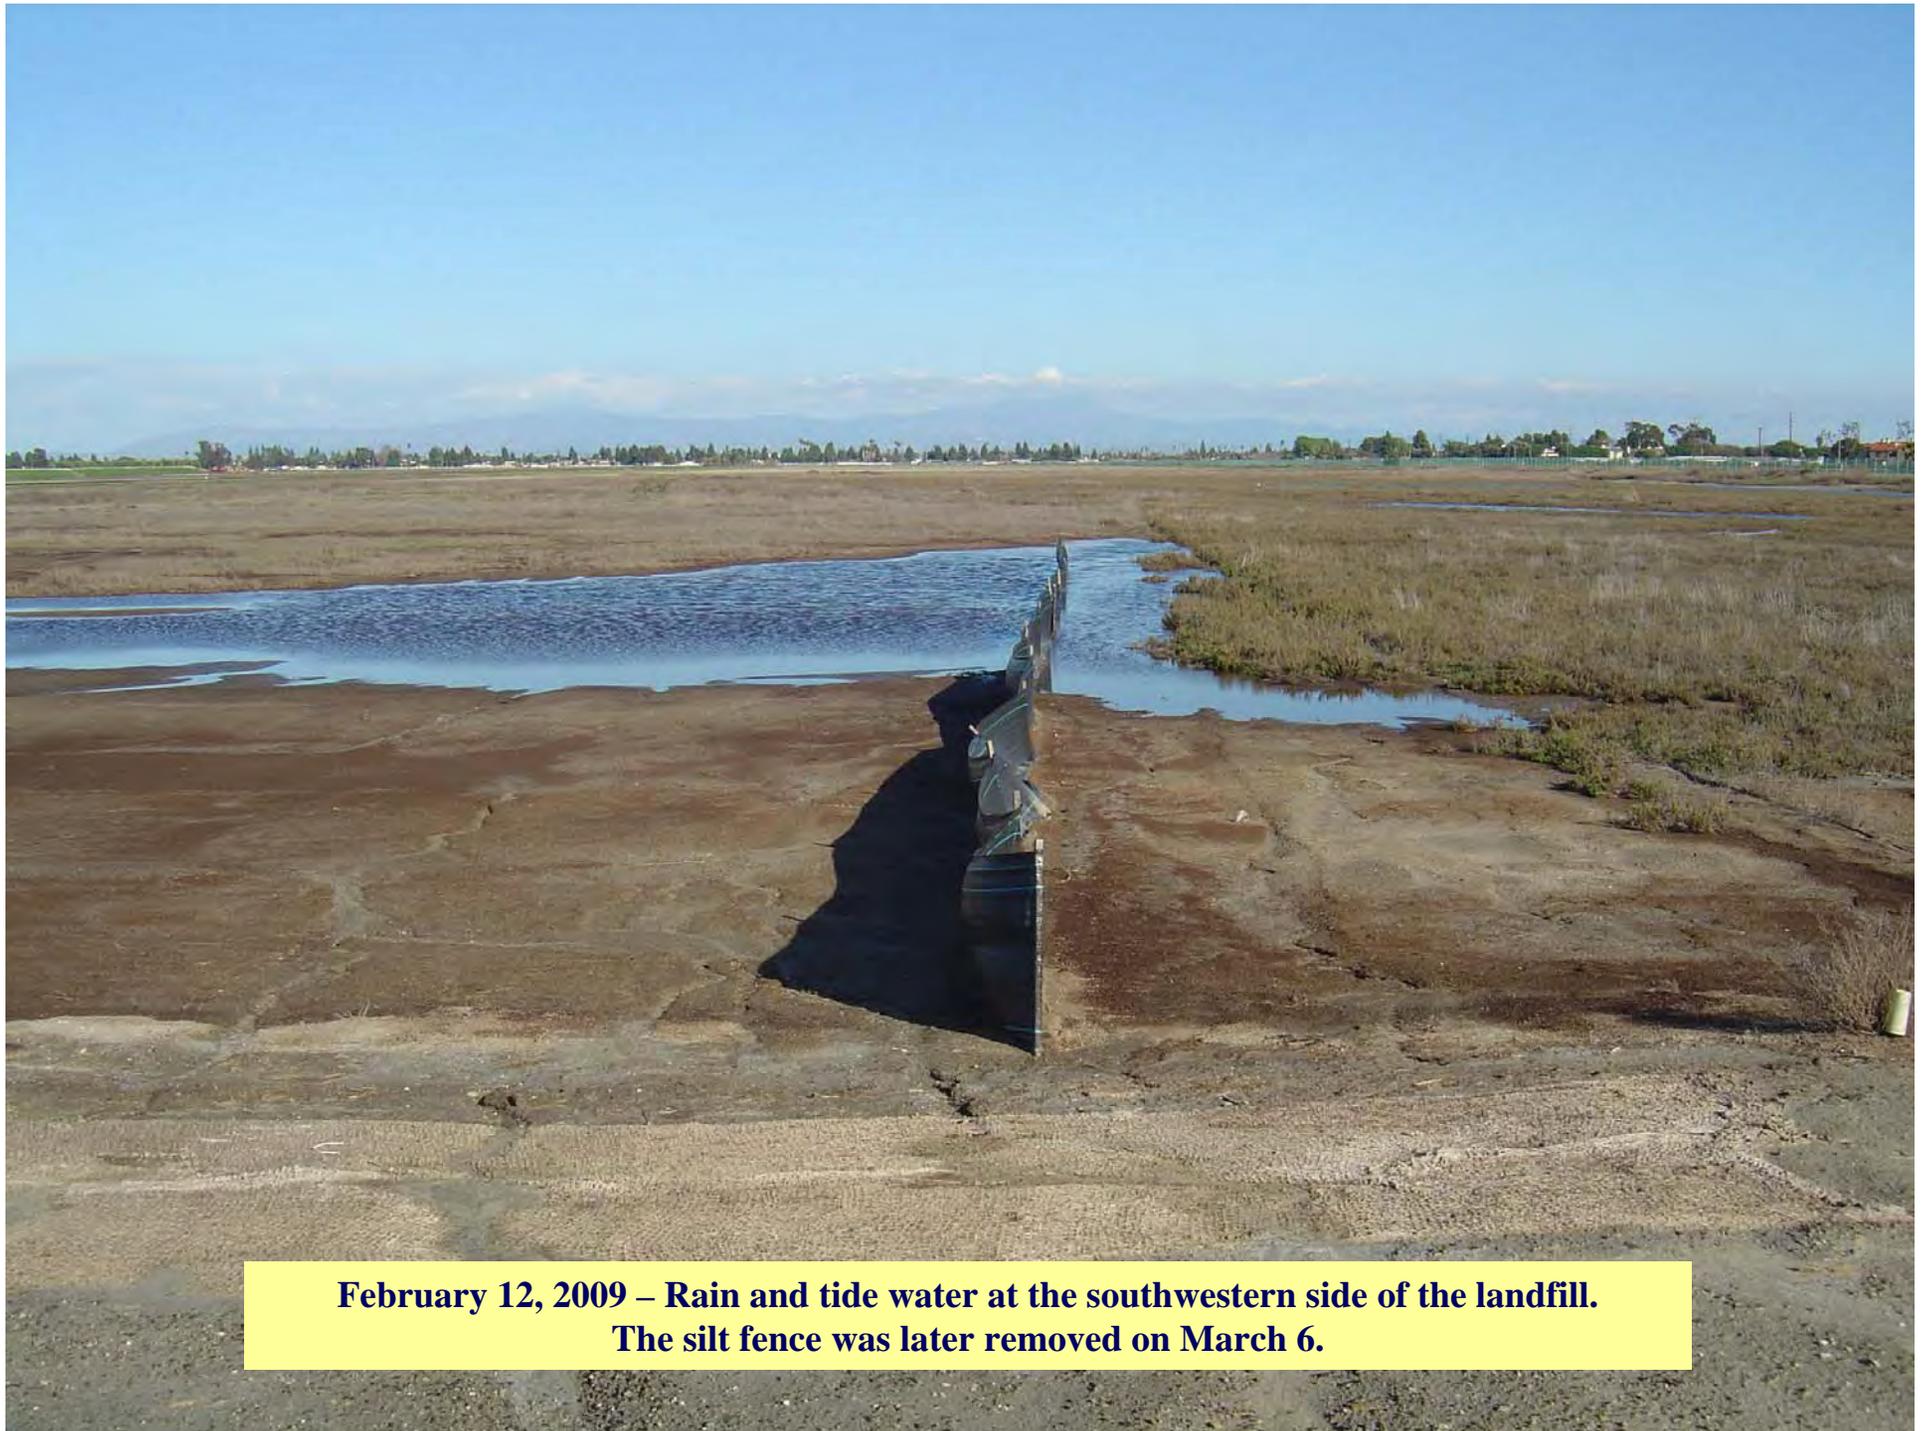
**February 12, 2009 – Rain and tide water at the southwestern side of the landfill.
The silt fence was later removed on March 6.**

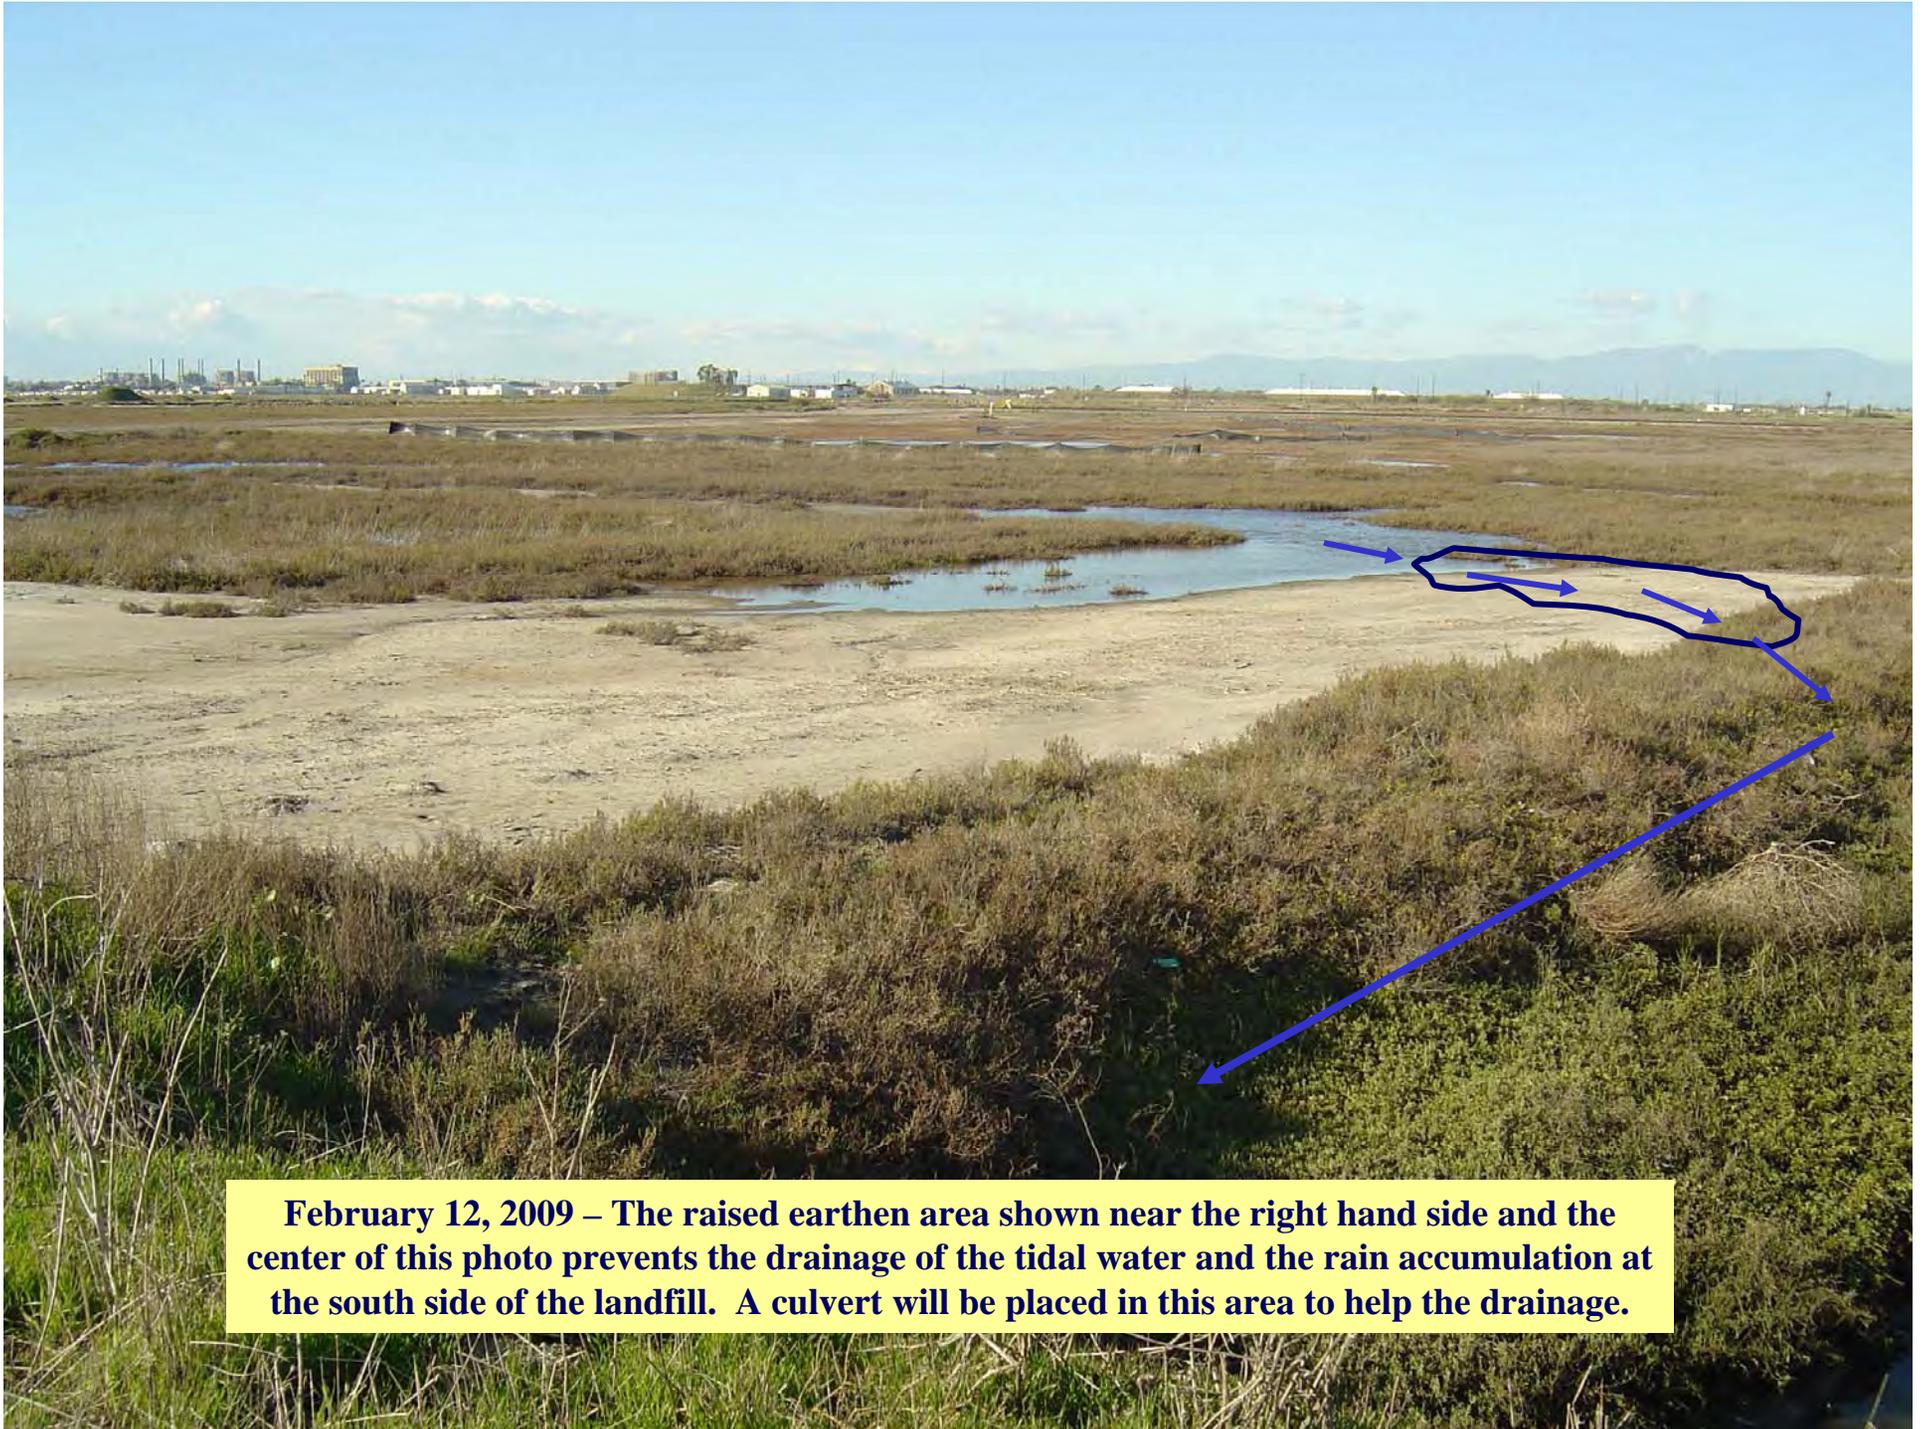
High salinity in soils is attributed primarily to interrupted drainage of tidal and precipitation waters that accumulate in the southwestern portion of the site, as discussed in Section 2.3. Water is lost through evapotranspiration in which water evaporates and salt remains and accumulates over time. The presence of saline water occurs regularly via surface tidal flooding and groundwater influx, but the removal of salts (through brief winter rains) is minimal. Due to the climatic conditions of the area, salt content is likely to increase in salt marsh wetlands between April and November when evapotranspiration is dominant, and decrease between December and late March if there is enough precipitation to flush the accumulated salt out (Zedler et al. 1992). Because of the lack of natural drainage at the site, however, salinity concentration will tend to increase as long as drainage remains interrupted.

February 12, 2009 – The raised earthen area shown near the right hand side and the center of this photo prevents the drainage of the tidal water and the rain accumulation at the south side of the landfill. A culvert will be placed in this area to help the drainage.

To improve the drainage in the southwestern portion of the landfill, two 12-inch-diameter pipes with flapper gates will be installed. The installed pipes will allow the tide waters to drain back into the drainage channel that leads to the Bolsa Chica Flood Control Channel. The proposed location of the drainage pipes is shown on Figure 2-1. The pipes will be inspected and maintained as part of the IRP Site 7 post-closure inspection and maintenance activities until the site is closed. It is recommended that these improvements be put into place prior to fall 2009.

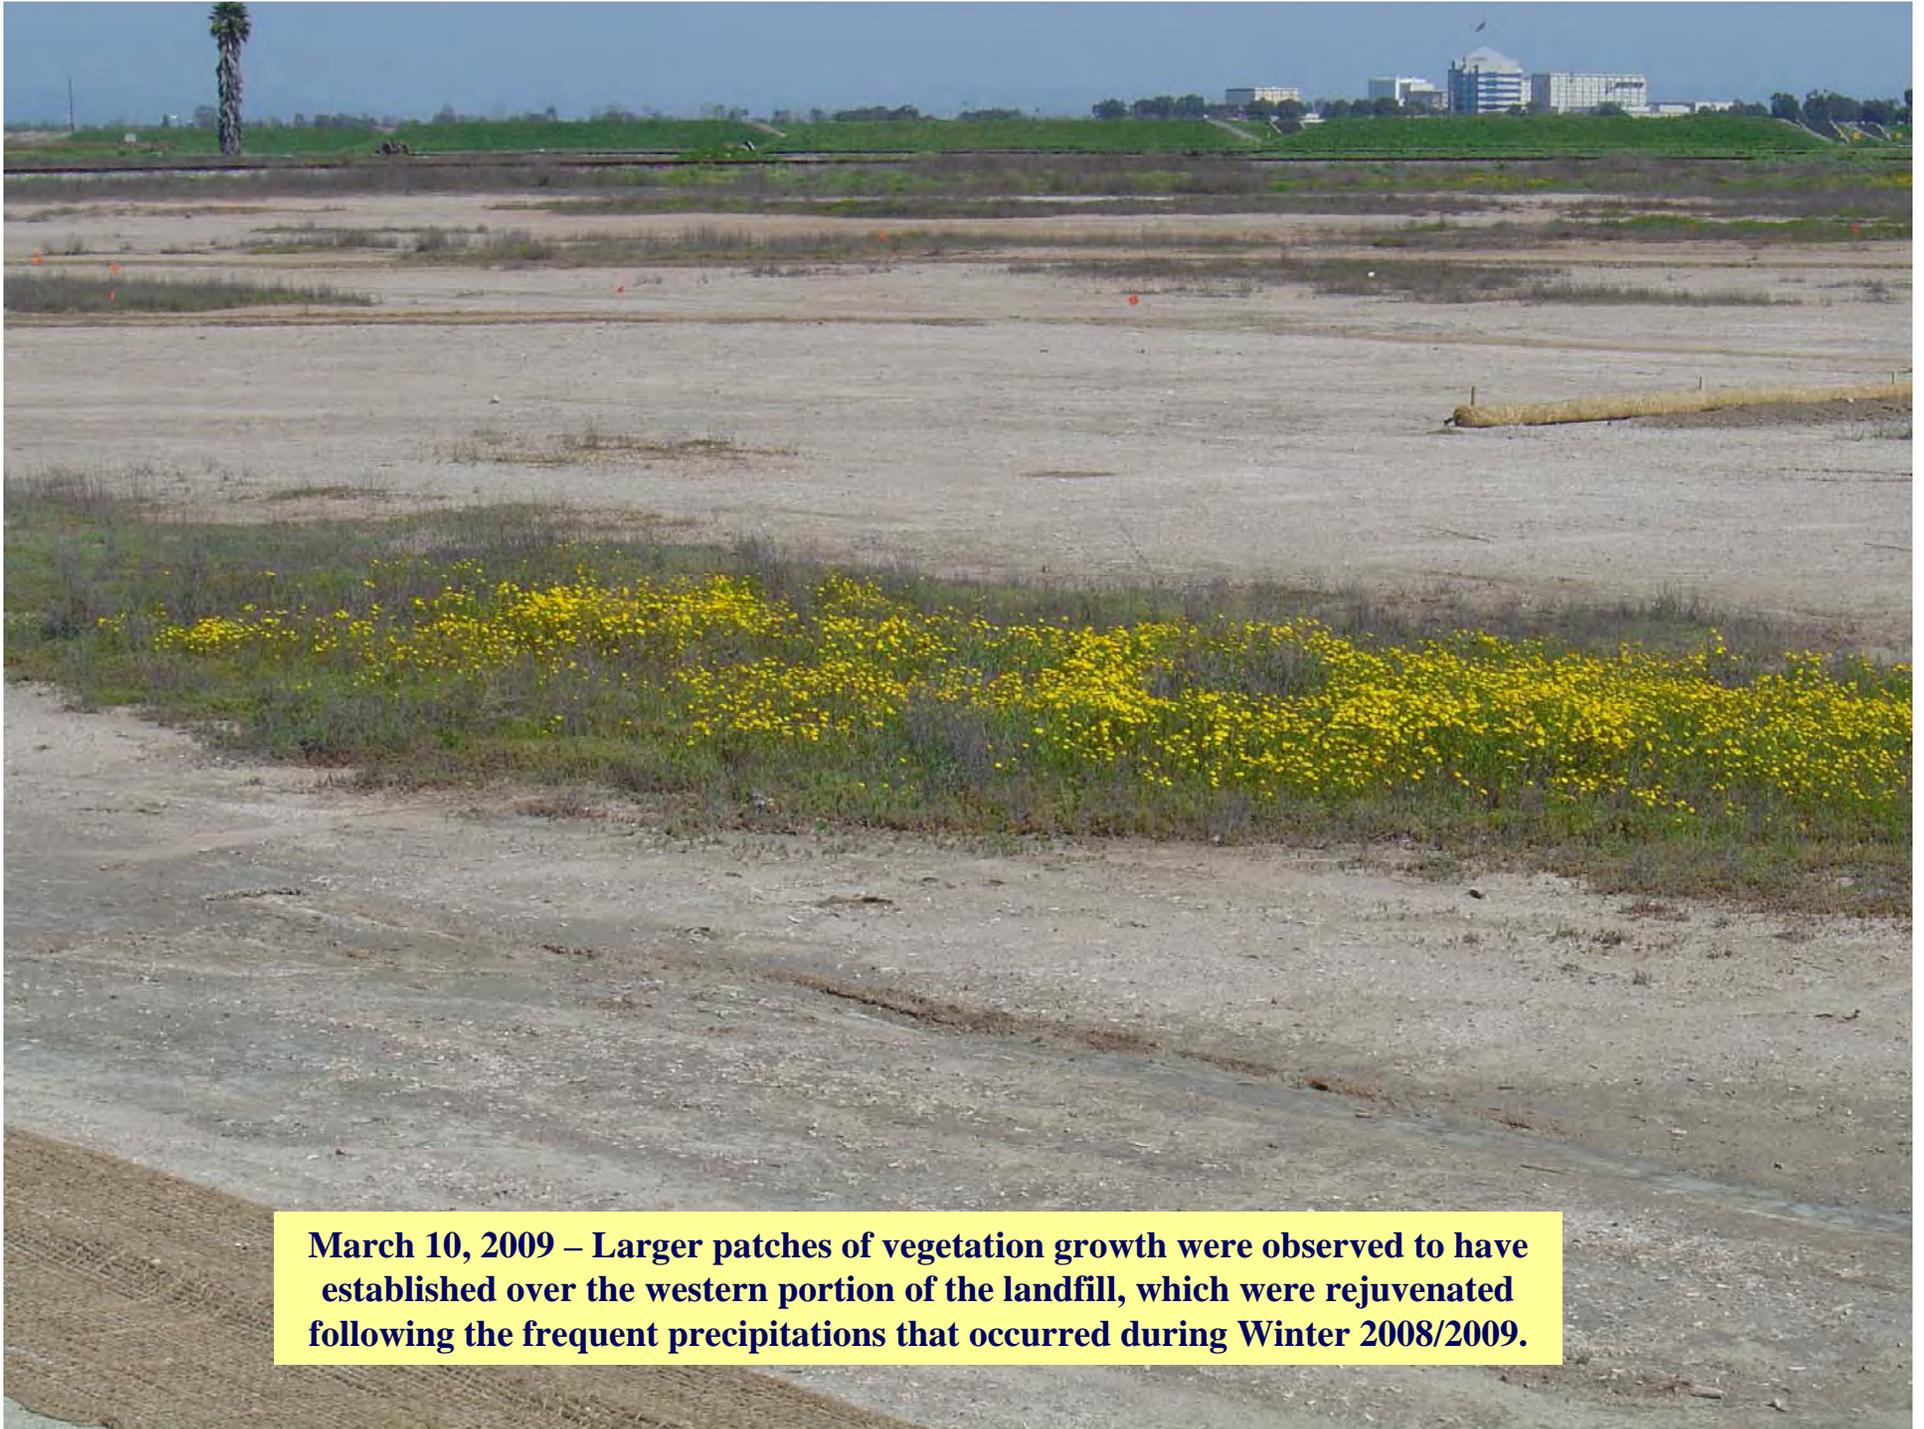
March 10, 2009 – Larger patches of vegetation growth were observed to have established over the western portion of the landfill, which were rejuvenated following the frequent precipitations that occurred during Winter 2008/2009.
