**FALL 2009 & WINTER 2010 ANNUAL POST-CLOSURE
INSPECTION AND MAINTENANCE REPORT**

May 21, 2010

**INSTALLATION RESTORATION PROGRAM SITE 7 AREA 1
(FORMER STATION LANDFILL)
NAVAL WEAPONS STATION SEAL BEACH
SEAL BEACH, CALIFORNIA**

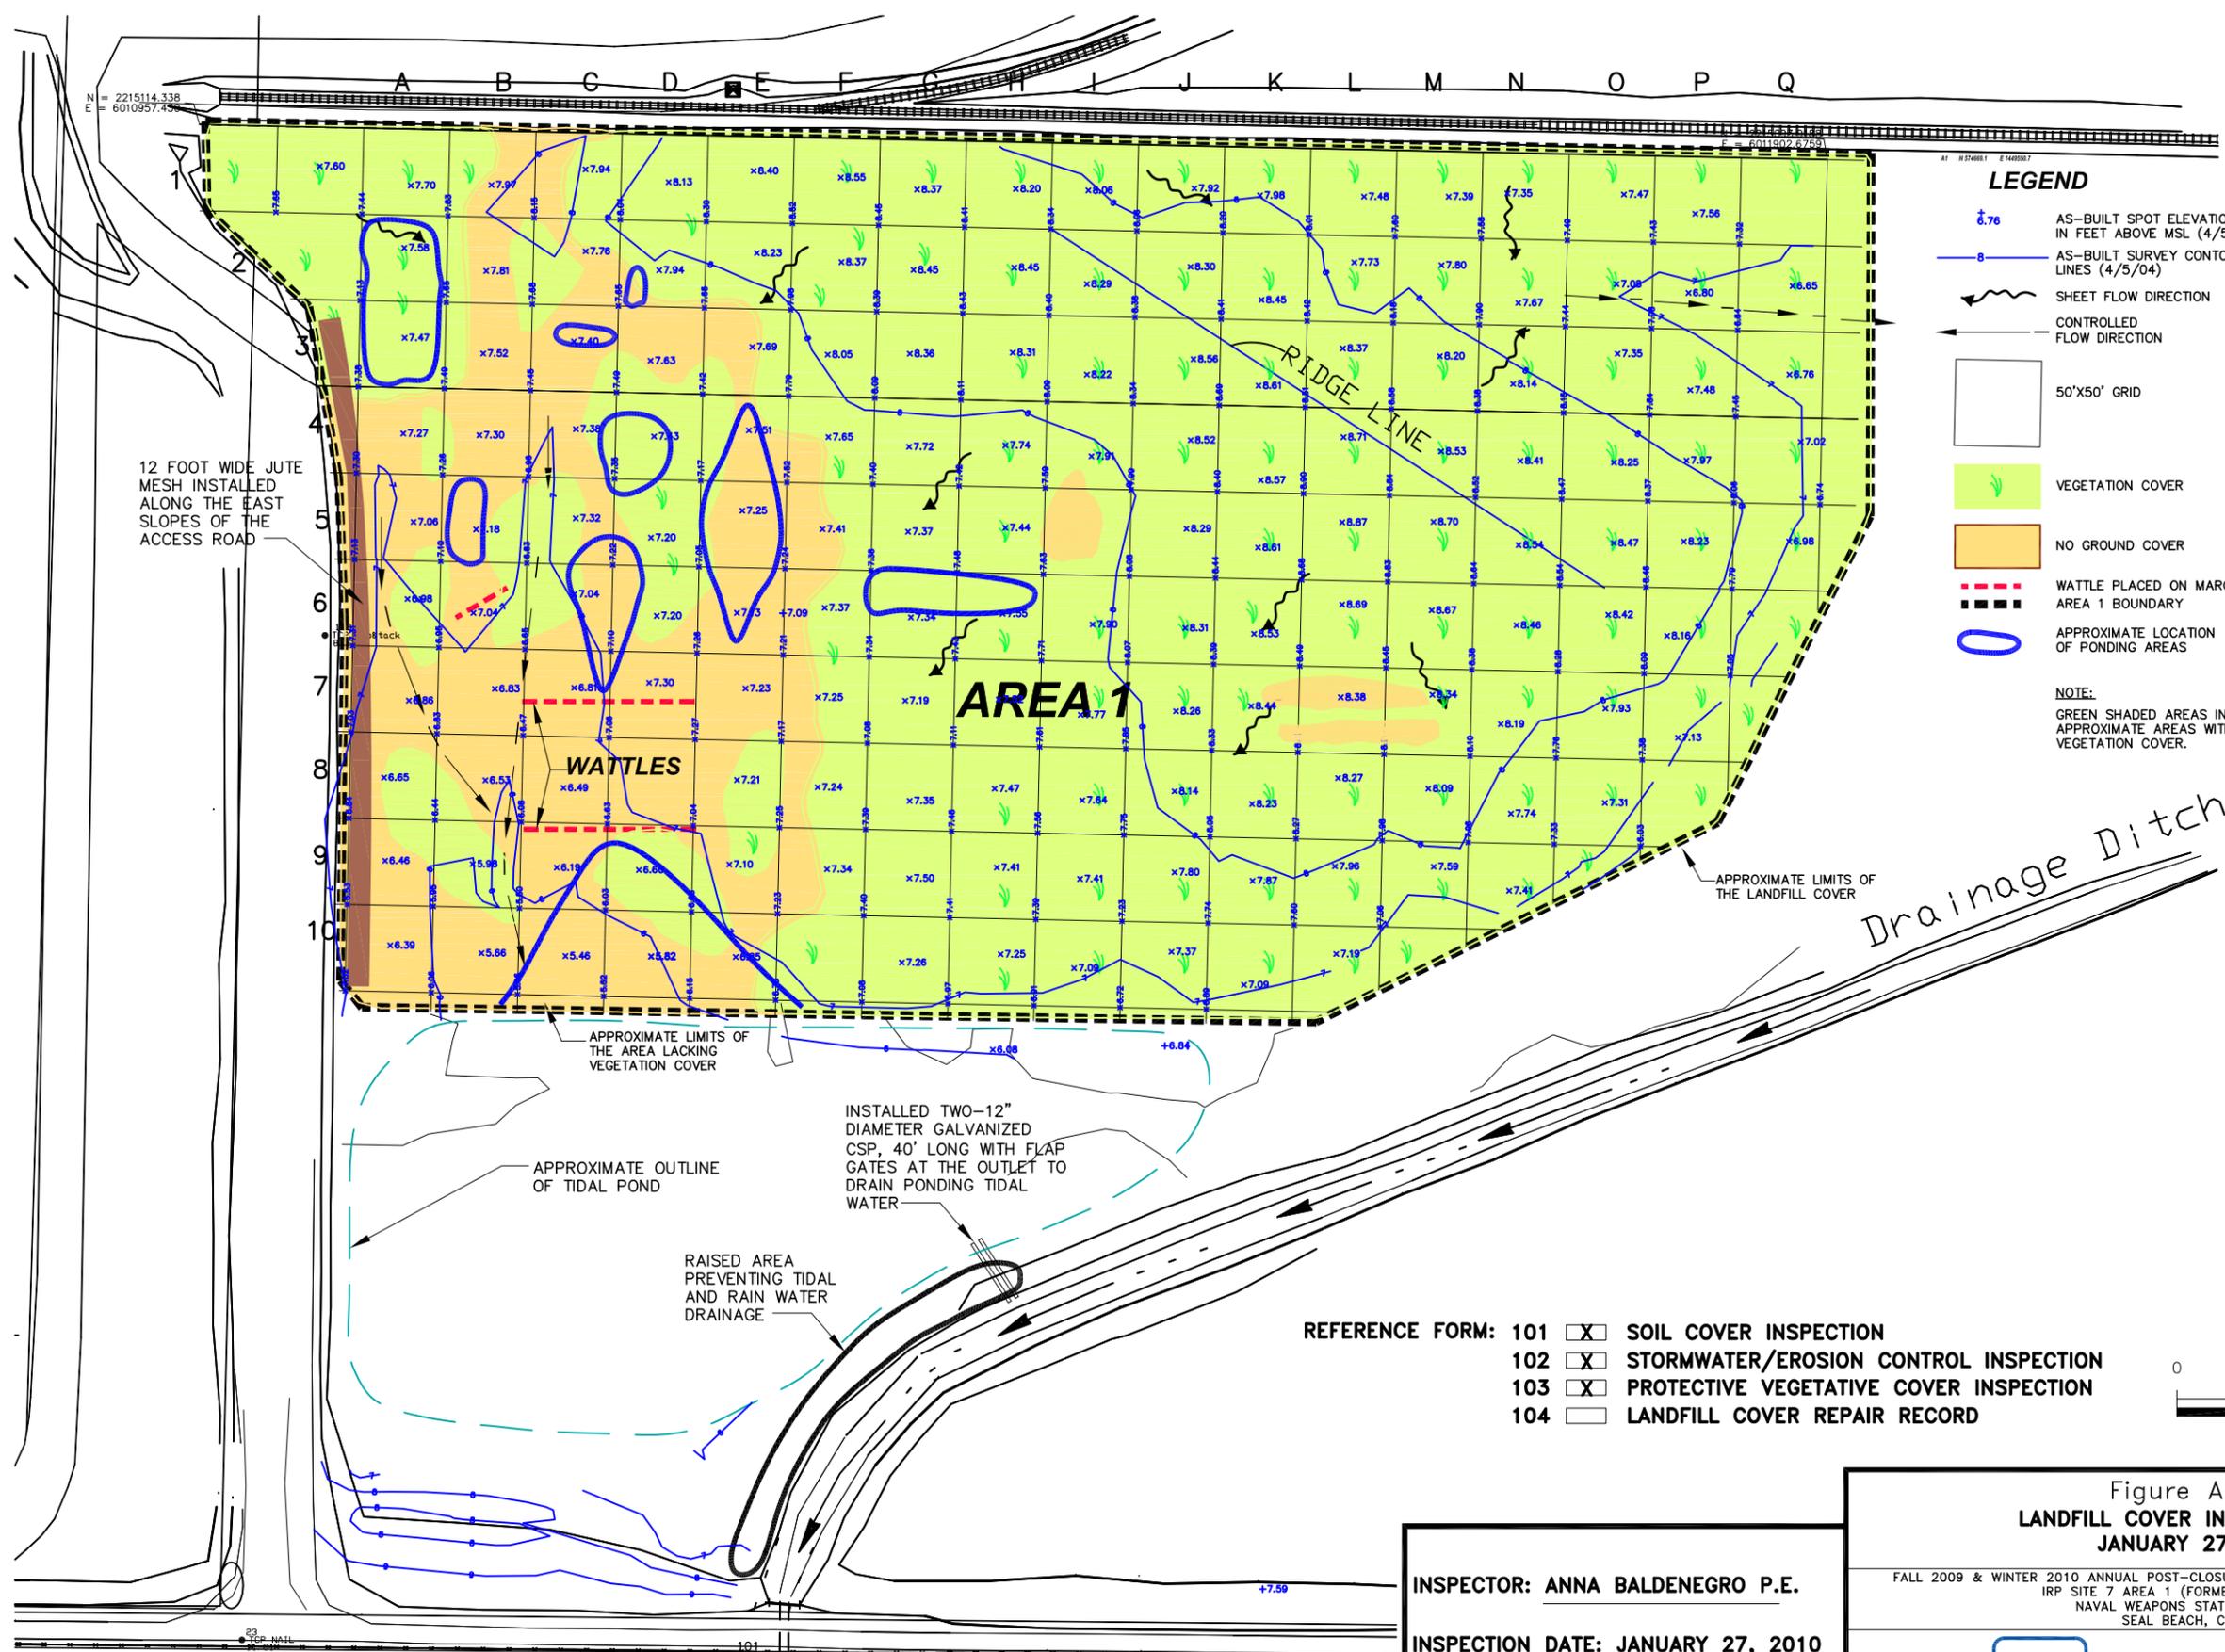
Figure A-1C
 LANDFILL COVER INSPECTION MAP
 JANUARY 27, 2010

There were no signs of erosion or cracks present. The soil cover in the 1/3 western portion of the landfill was wet due to the recent rain that occurred from January 18-22 and on January 26, 2010. Several areas with shallow ponding were observed. The ponding areas were similar to those observed during the prior inspection that was conducted on December 15, 2009.

TYPE OF DEFICIENCY: _____
Shallow ponding (less than 3-inches deep) was observed in several locations.

No deep ponding (greater than 6-inches deep) was observed. The shallow ponds are expected to evaporate – raking would be sufficient to help these areas drain properly.

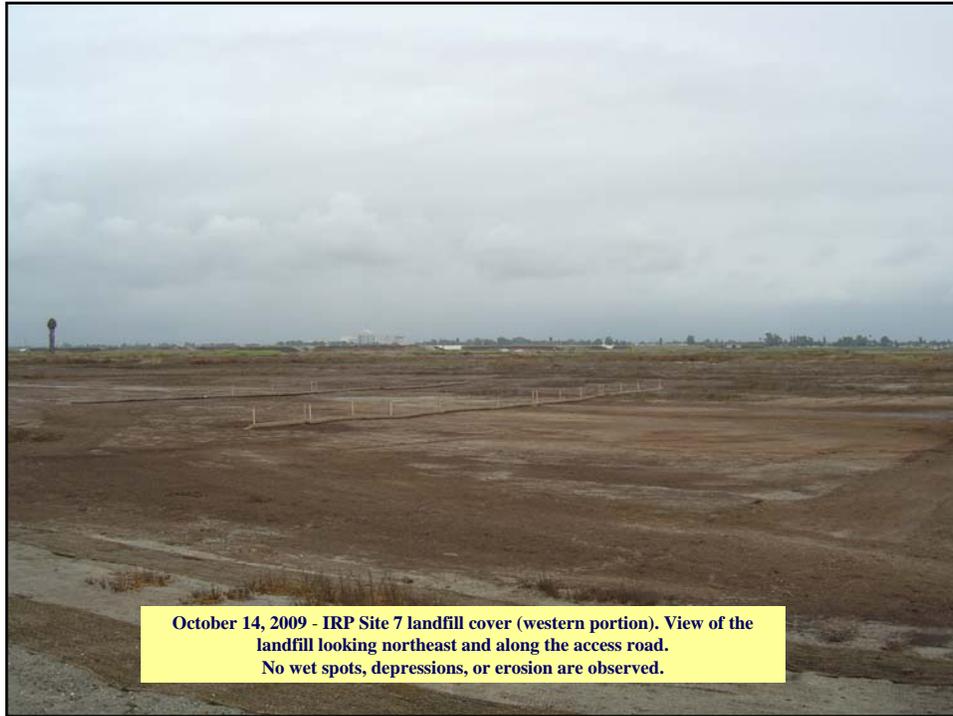
October 14, 2009 - IRP Site 7 landfill cover (western portion). View of the landfill looking northeast and along the access road. No wet spots, depressions, or erosion are observed.

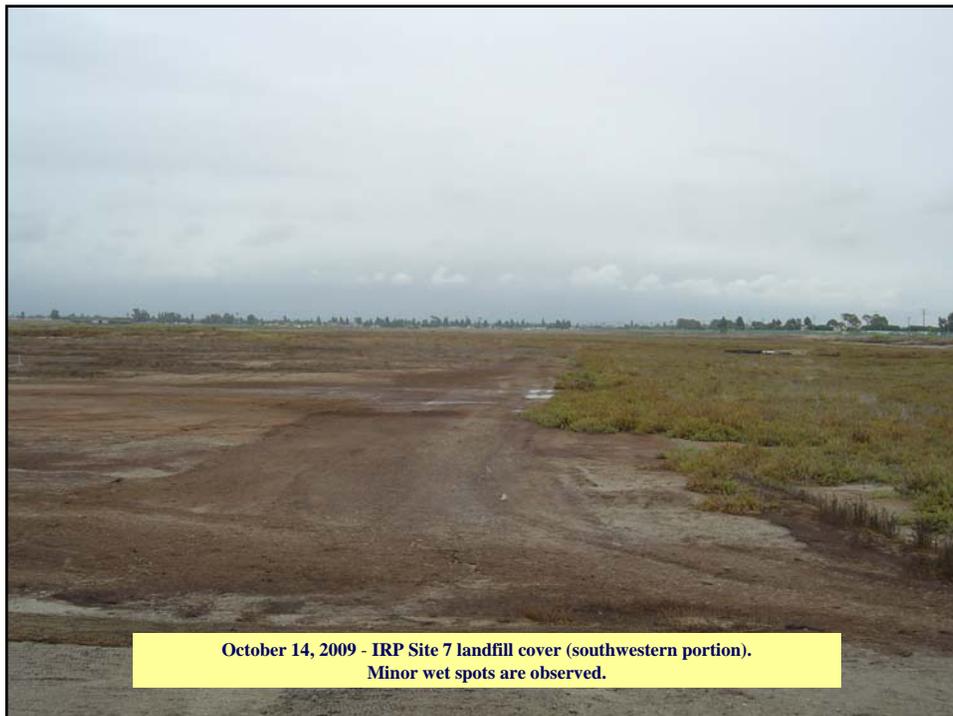
October 14, 2009 - IRP Site 7 landfill cover (southwestern portion). Minor wet spots are observed.

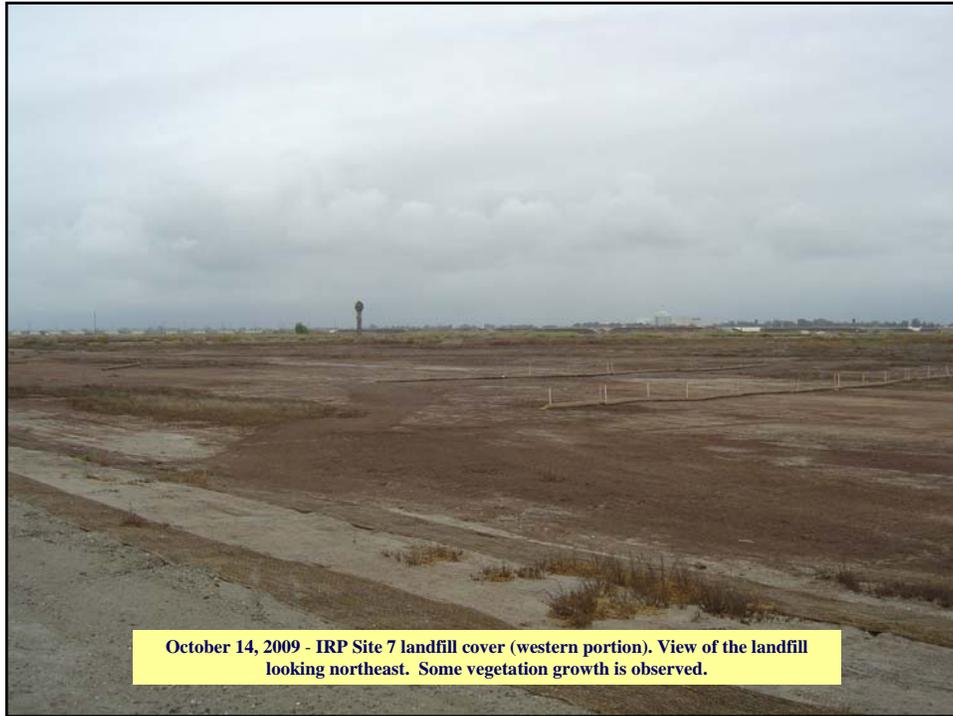
October 14, 2009 - IRP Site 7 landfill cover (western portion). View of the landfill looking northeast. Some vegetation growth is observed.

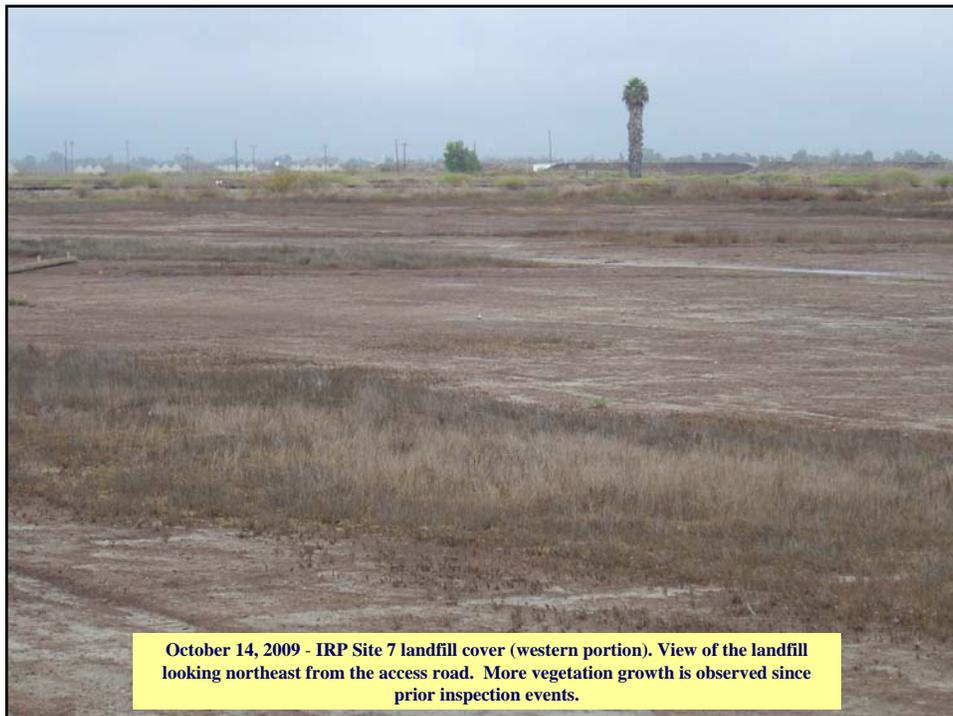
October 14, 2009 - IRP Site 7 landfill cover (western portion). View of the landfill looking northeast from the access road. More vegetation growth is observed since prior inspection events.

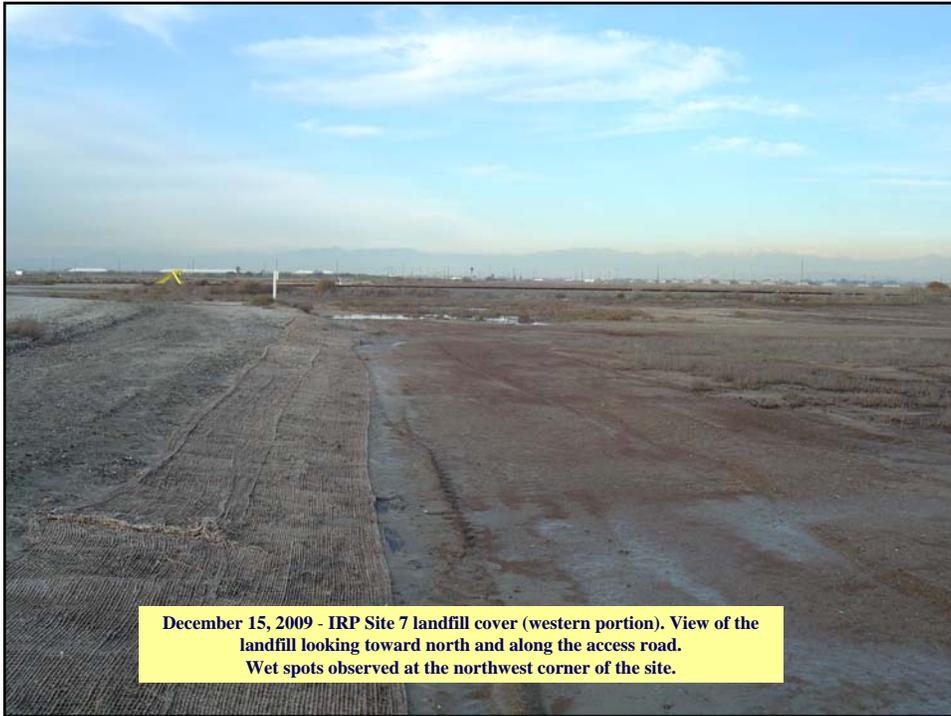
December 15, 2009 - IRP Site 7 landfill cover (western portion). View of the landfill looking toward north and along the access road. Wet spots observed at the northwest corner of the site.

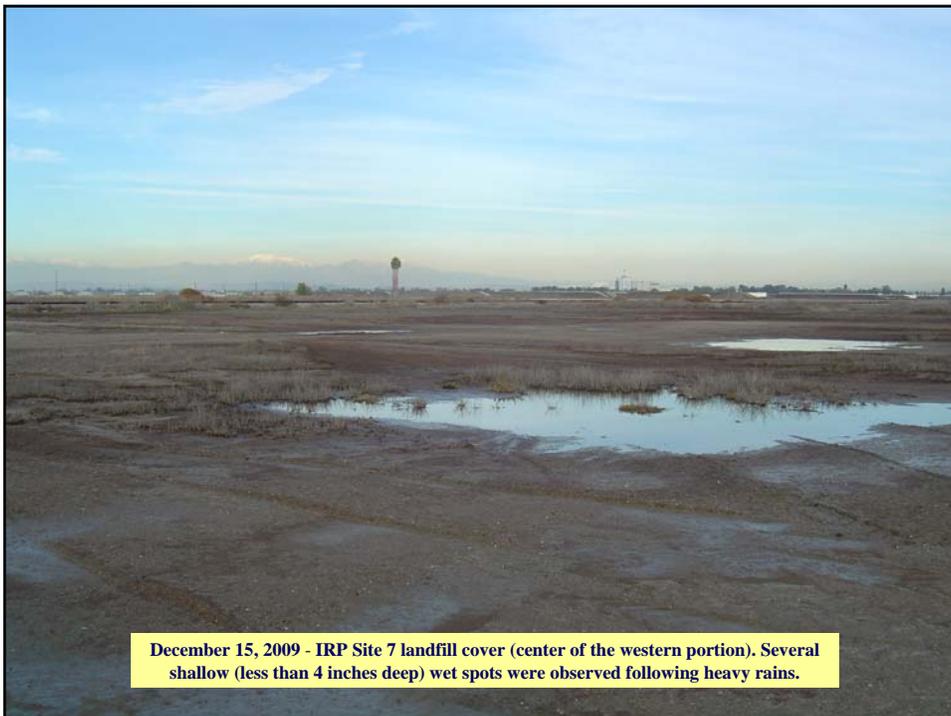
December 15, 2009 - IRP Site 7 landfill cover (center of the western portion). Several shallow (less than 4 inches deep) wet spots were observed following heavy rains.

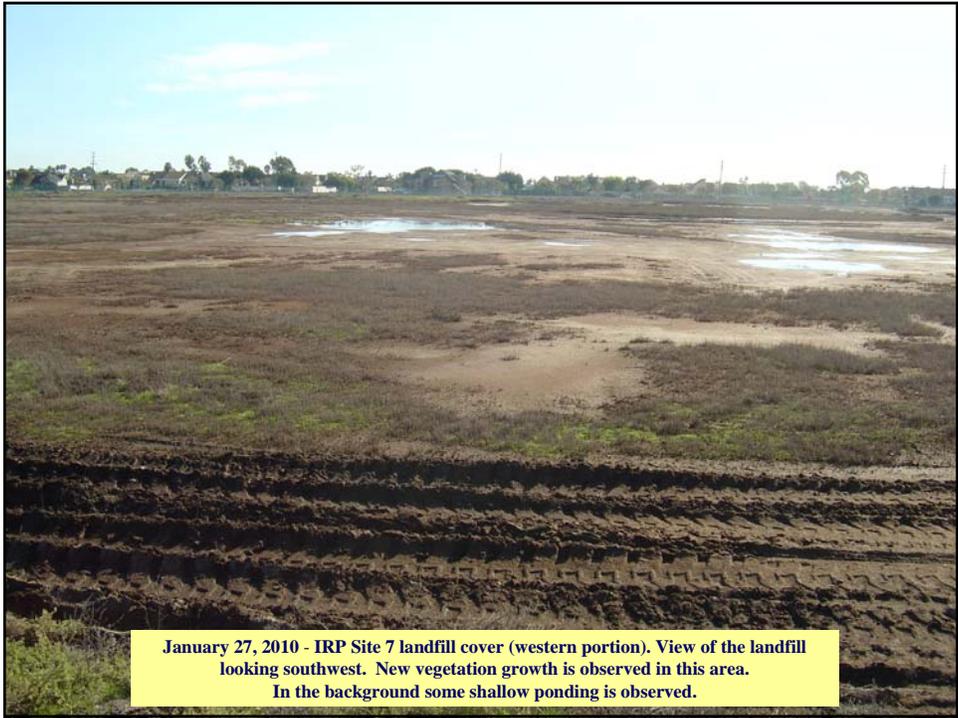
January 27, 2010 - IRP Site 7 landfill cover (western portion). View of the landfill looking southwest. New vegetation growth is observed in this area. In the background some shallow ponding is observed.

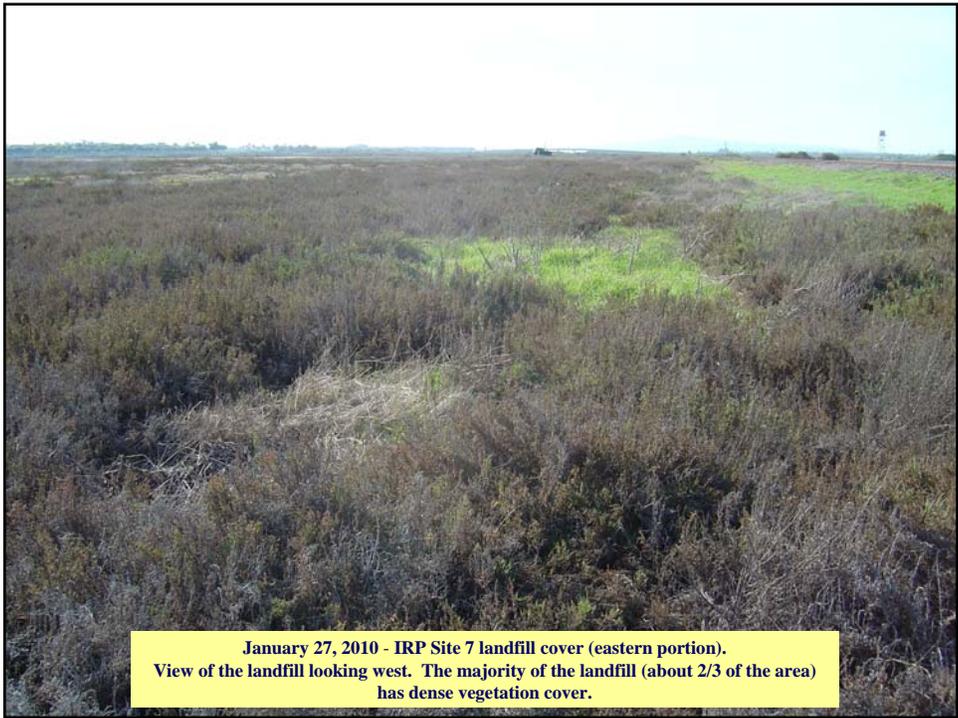
January 27, 2010 - IRP Site 7 landfill cover (eastern portion). View of the landfill looking west. The majority of the landfill (about 2/3 of the area) has dense vegetation cover.

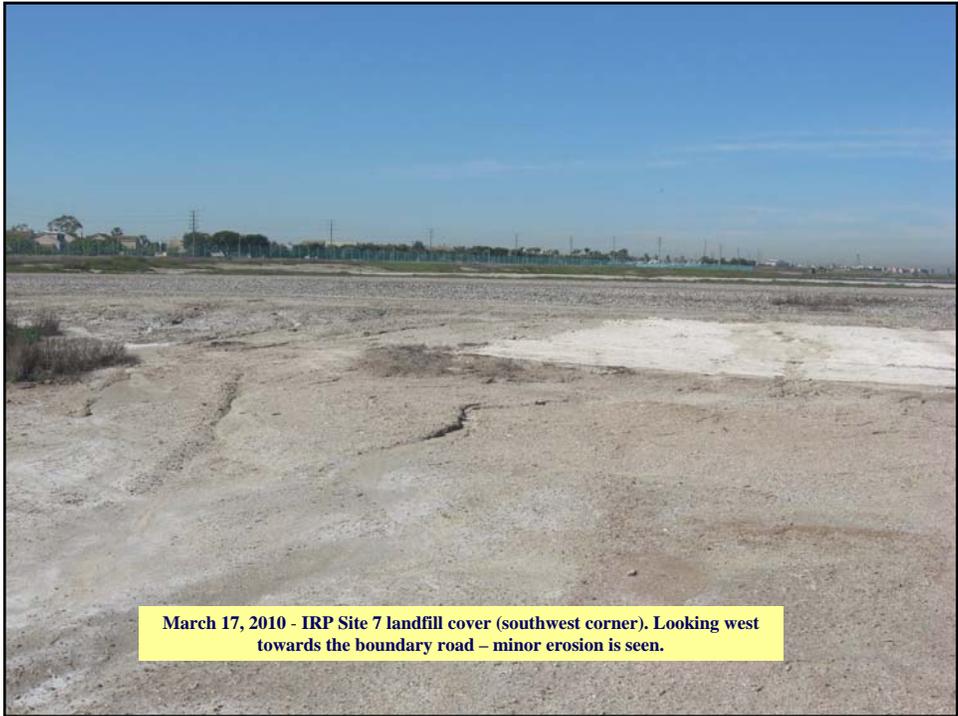
March 17, 2010 - IRP Site 7 landfill cover (southwest corner). Looking west towards the boundary road – minor erosion is seen.

In addition, it is recommended that the minor erosion areas, shallow depressions, and swale flowlines be regraded to facilitate positive drainage towards the southern boundary of the landfill.

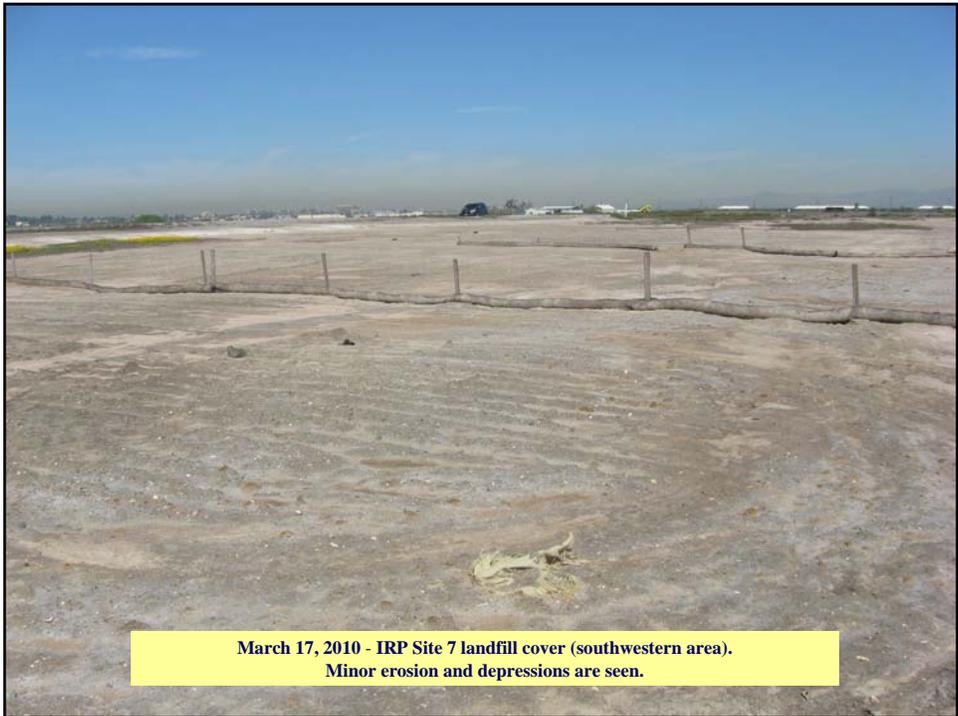
March 17, 2010 - IRP Site 7 landfill cover (southwestern area). Minor erosion and depressions are seen.

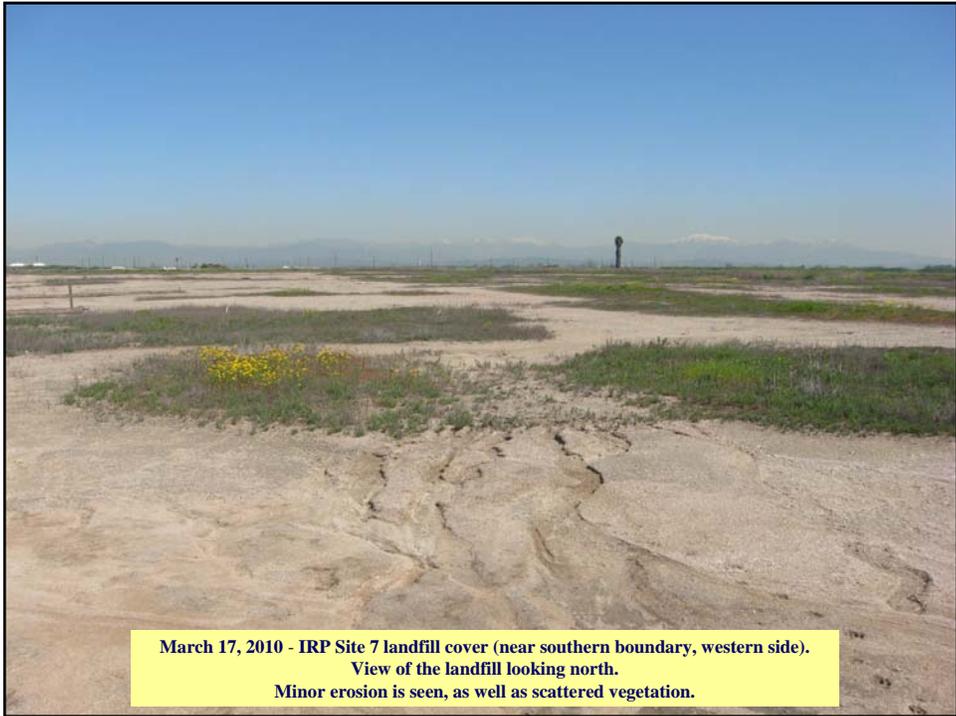
March 17, 2010 - IRP Site 7 landfill cover (near southern boundary, western side).
View of the landfill looking north.
Minor erosion is seen, as well as scattered vegetation.

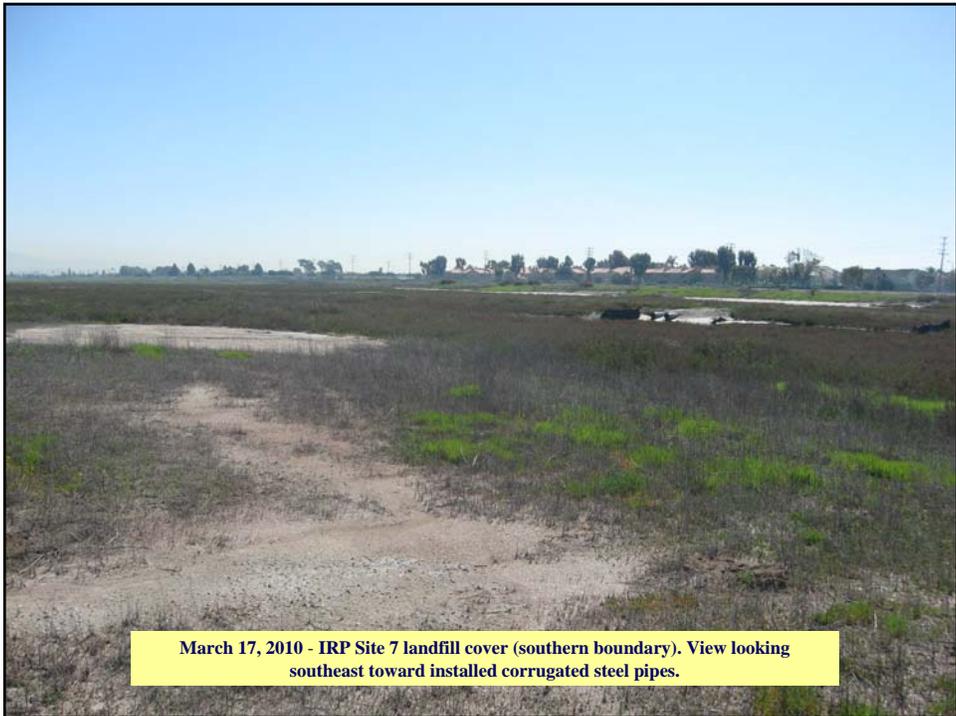
March 17, 2010 - IRP Site 7 landfill cover (southern boundary). View looking
southeast toward installed corrugated steel pipes.

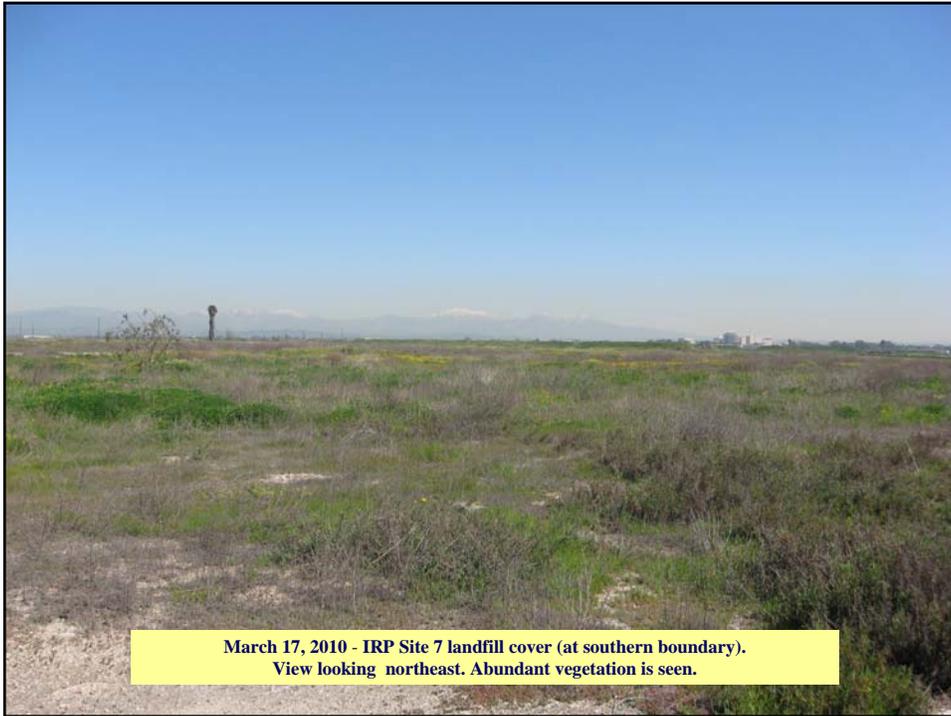
**March 17, 2010 - IRP Site 7 landfill cover (at southern boundary).
View looking northeast. Abundant vegetation is seen.**

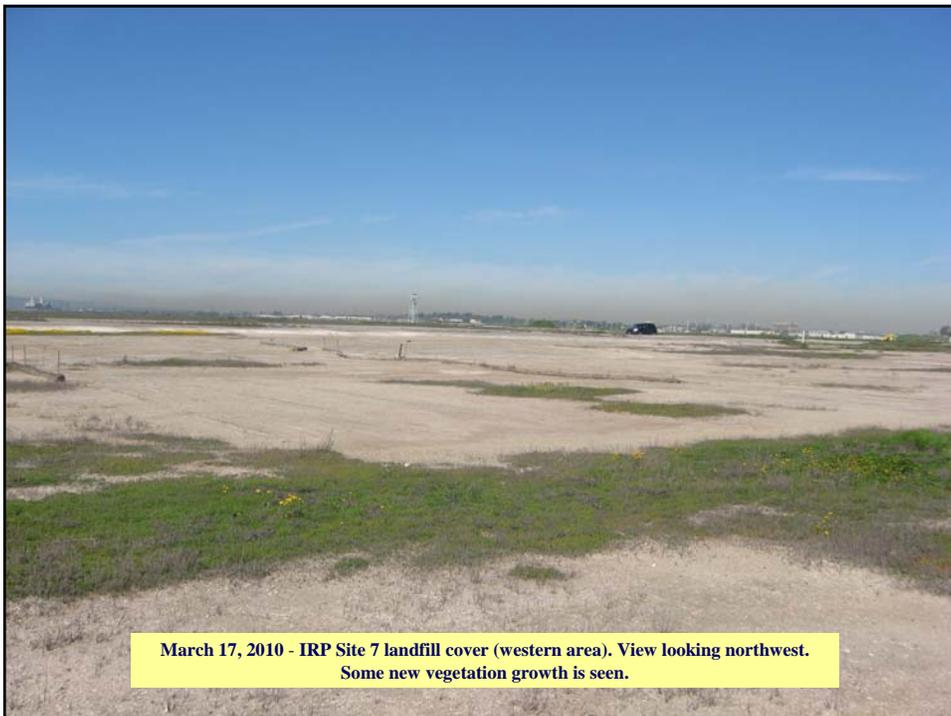
**March 17, 2010 - IRP Site 7 landfill cover (western area). View looking northwest.
Some new vegetation growth is seen.**

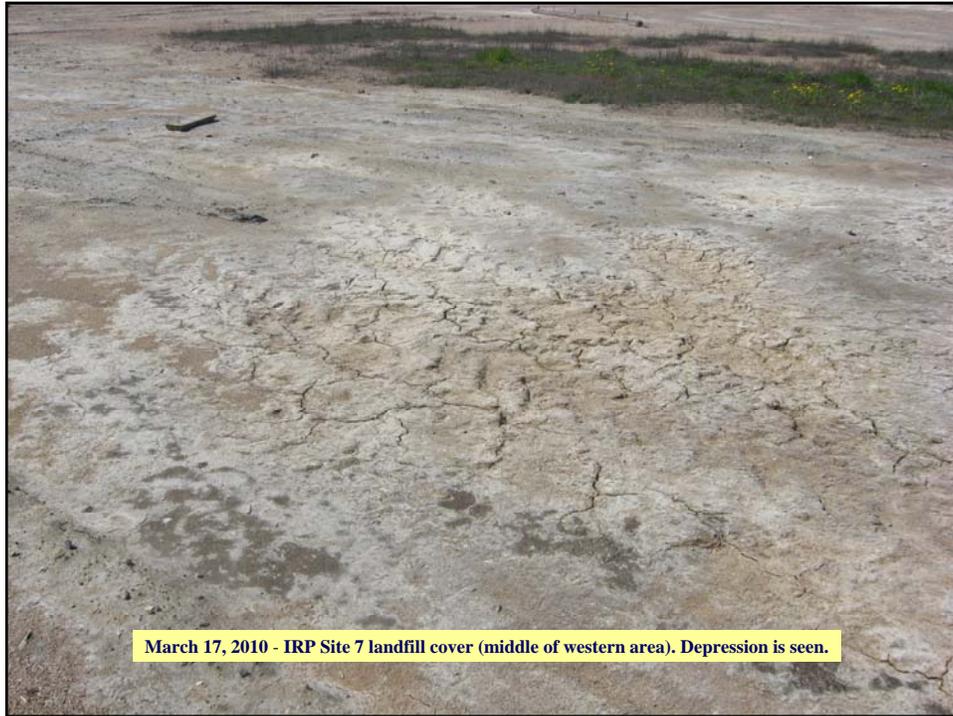
March 17, 2010 - IRP Site 7 landfill cover (middle of western area). Depression is seen.

It is recommended that the minor shallow depressions be regraded or small drainage swale flowlines be formed to facilitate positive drainage towards the southern boundary of the landfill. These areas are indicated on Figure A-1D in Appendix A.

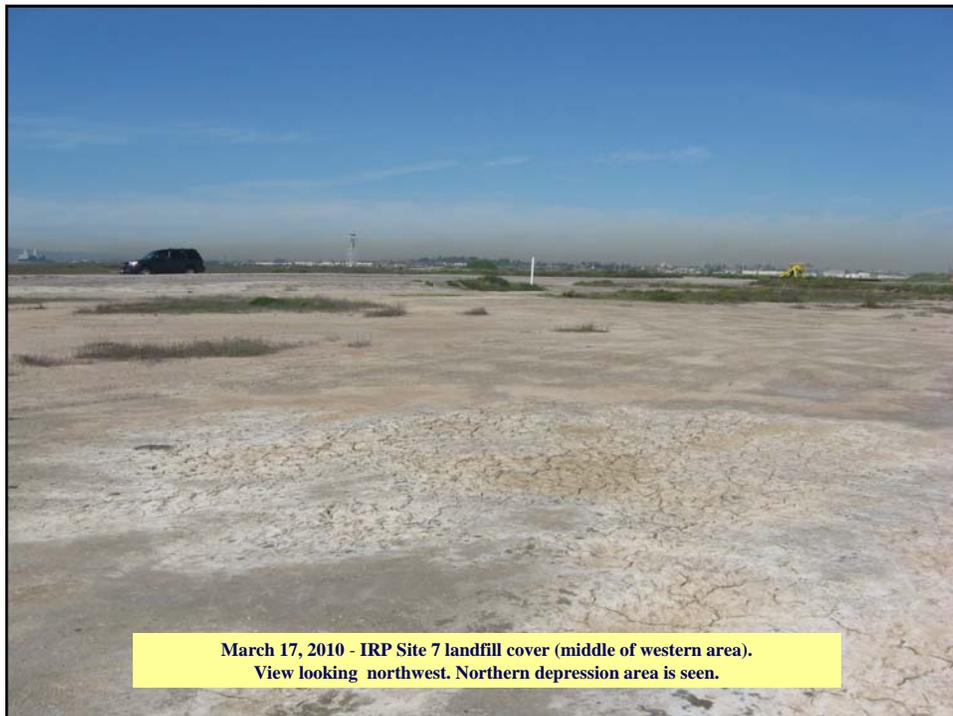
March 17, 2010 - IRP Site 7 landfill cover (middle of western area).
View looking northwest. Northern depression area is seen.
