RIPDES SMALL MS4 ANNUAL REPORT GENERAL INFORMATION PAGE

RIPDES PERMIT #RIR040004

REPORTING PERIOD: **X** YEAR 4
Jan 07-Dec 07

Name: Naval Station Newport			
Mailing Address: 1 Simonpietri Drive			
City: Newport	State: RI	Zip: 02841	Phone: (401) 841-1790
Contact Person: Deborah Moore		Title: Environmental Engineer	
Legal status (circle one):			
PRI - Private	PUB - Public	BPP - Public/Private	STA - State FED - Federal
Other (please specify):

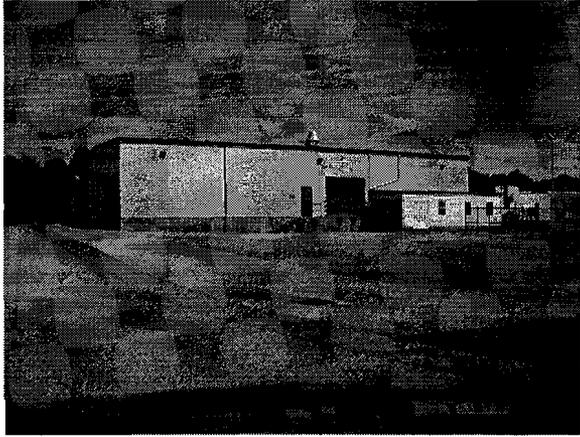
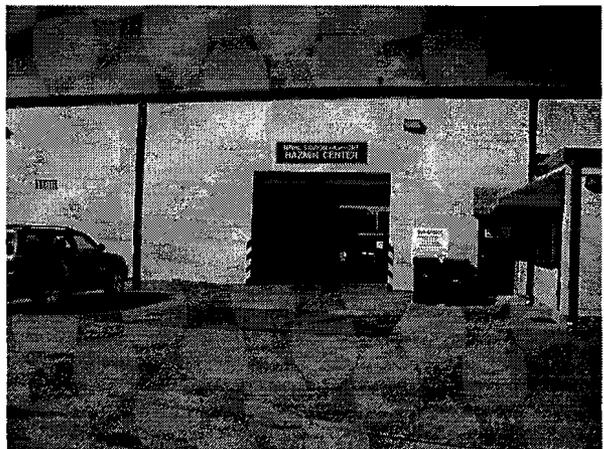
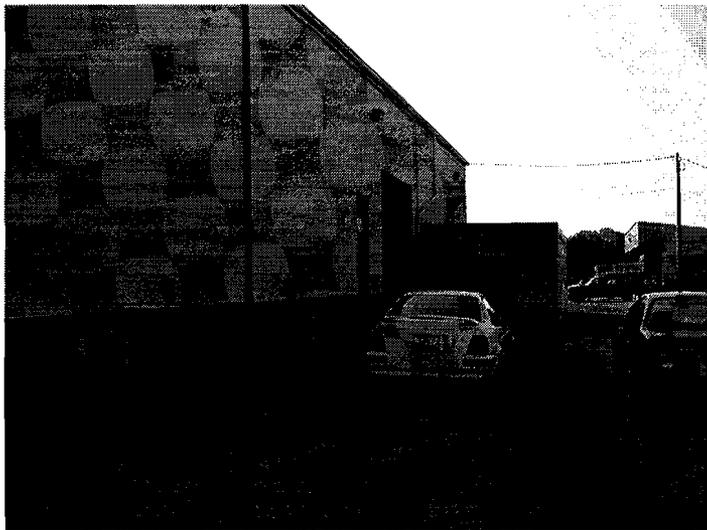
Location: 1166CC, Hazardous Material Warehouse

Storm drain catch basins near the building appear fairly clean. There is some sand on various paved surfaces which should be swept up.

Recommendations: Parking area should be swept up of all sand and debris.

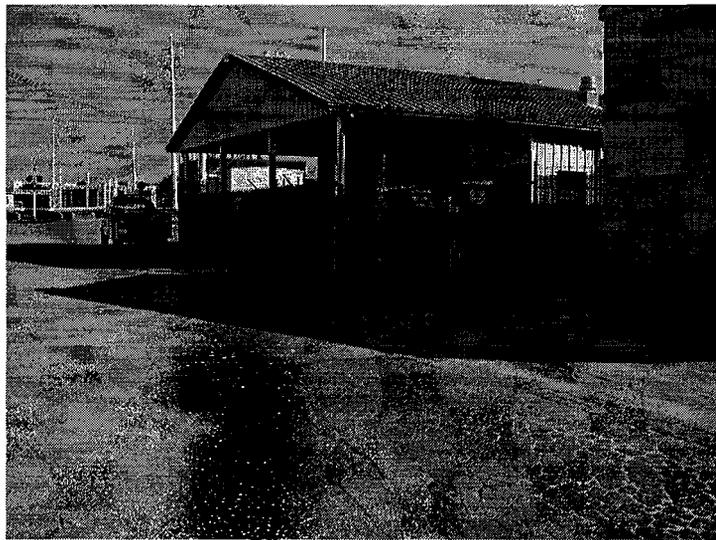
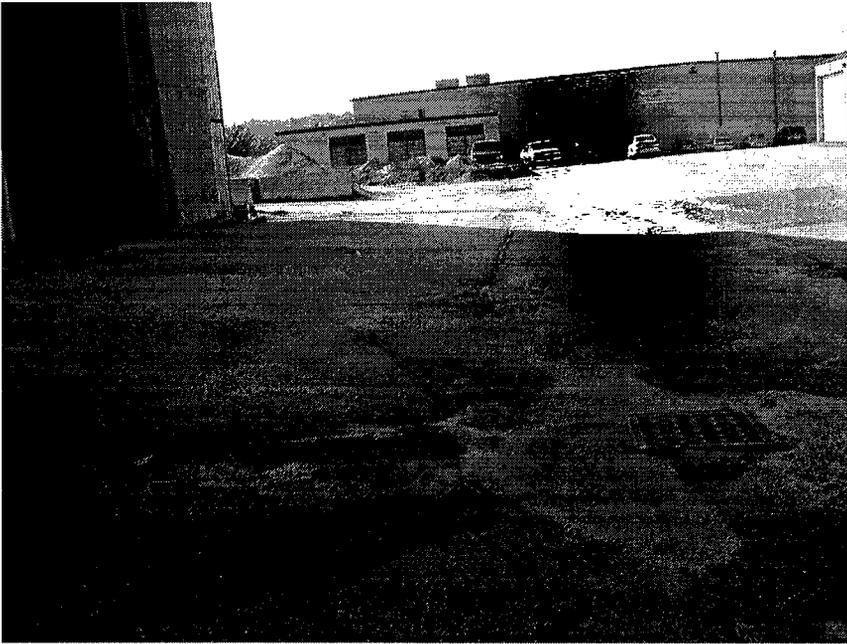
Refer to Figure BLDG 1276, which indicates the direction of possible spill routes and storm water runoff. If spilled outside, the spill would flow right into the catch basin outside the shed as the grade is sloped toward the basin. Any hazardous material spill inside the building would be soaked up by the sand and salt mixture and would not flow outside the building.

In addition, transformers have been stored across from this building with residual oil still inside. The transformers must be stored inside the building to prevent oil from leaking onto the ground and getting into the storm drain system.

Clean up of area outside salt and sand shed along with cleaning of the catch basin adjacent to the building is required. Also, the piles of sand collected from sand sweeping must be recycled and cleaned up (see pictures).

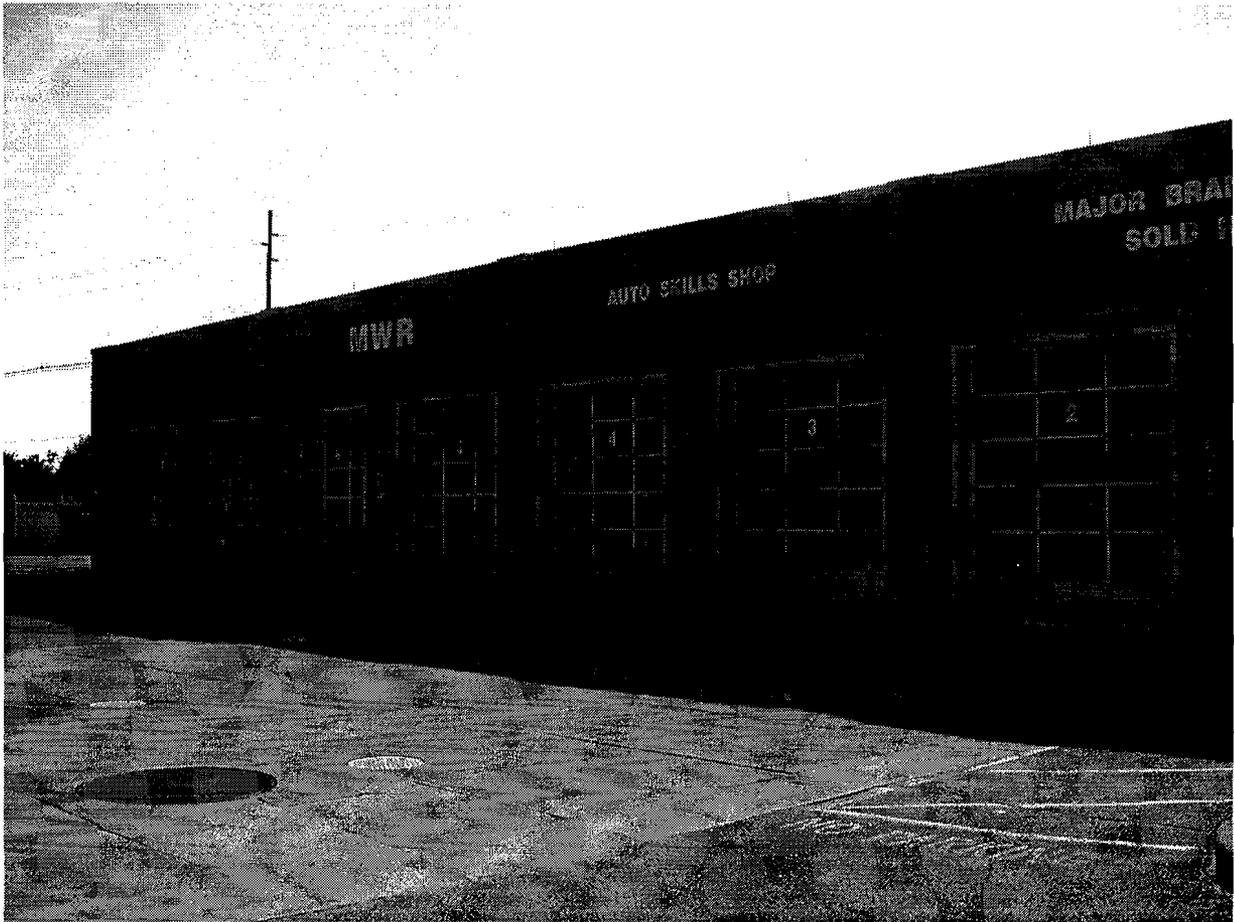
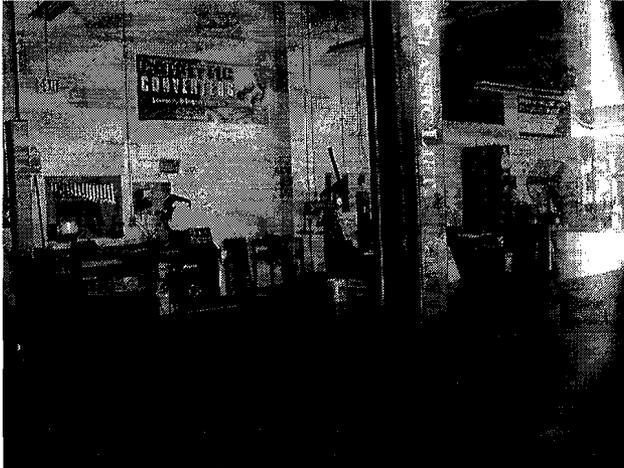
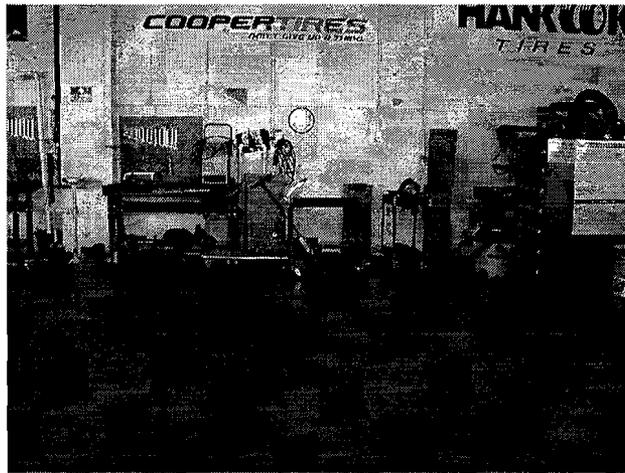
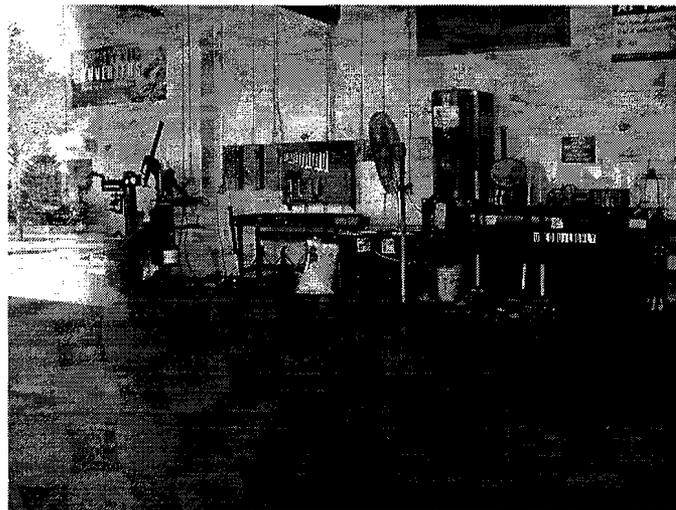
No recommendation is given to the area where the materials are loaded. The quantities delivered to this building are small. A rupture of a 55 gallon drum during loading would puddle at one of the many low points in the roadway, thus allowing cleanup with spill control equipment

Excellent housekeeping is evident inside the shop area.

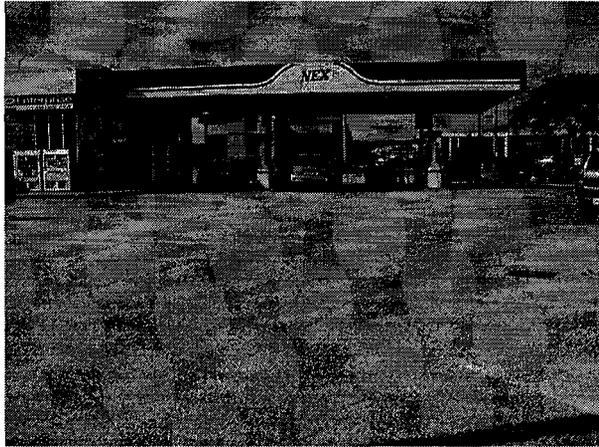
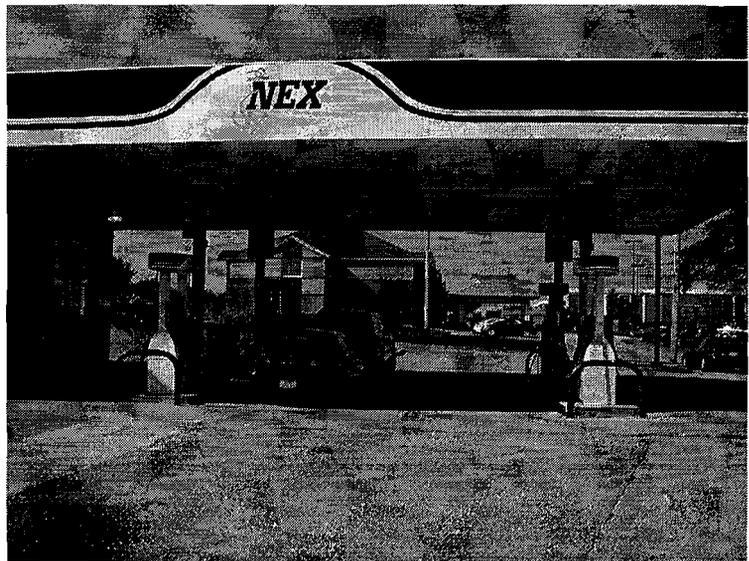
Storm drains clear of Debris: (list any storm drain catch basins that need cleaning): All catch basins were clean at the time of the inspection.

Recommendations: Keep absorbent in the catch basin in the middle of the island to catch small amounts of spilled fuel.

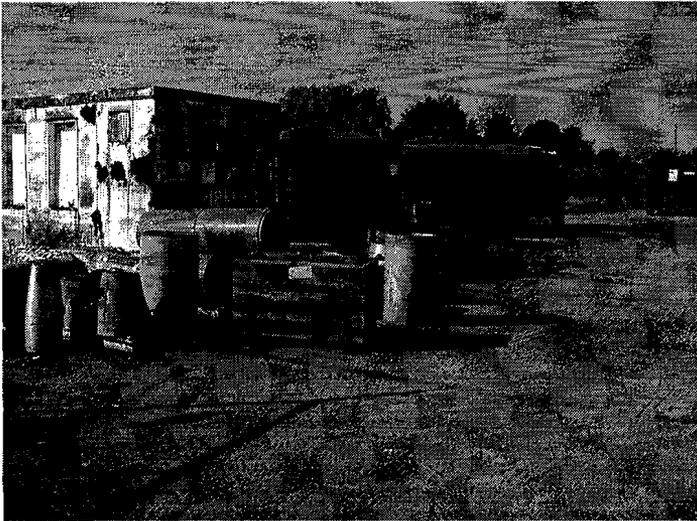
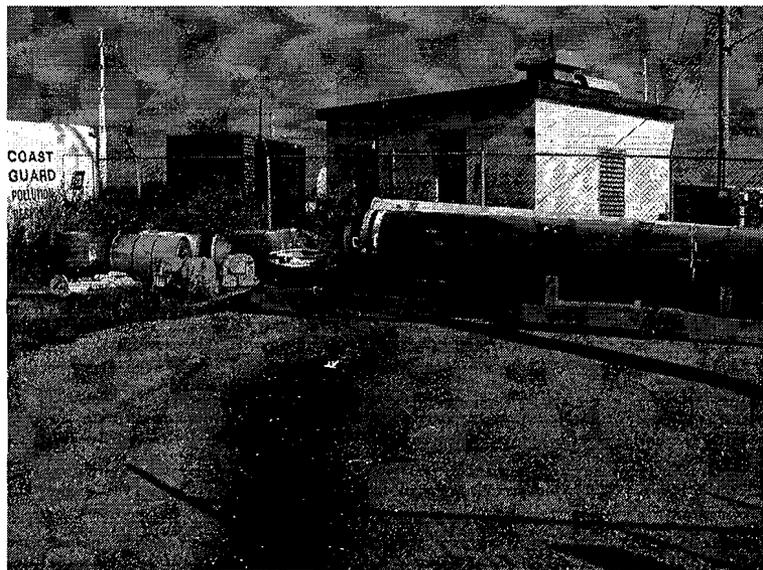
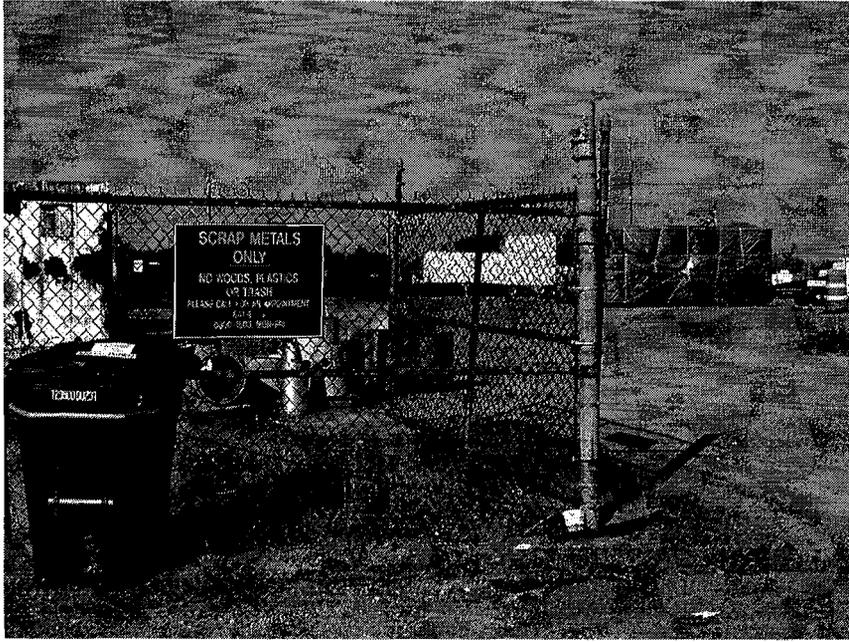
Storm drains in the area have been stenciled to indicate that runoff from this area is discharged to Narragansett Bay.

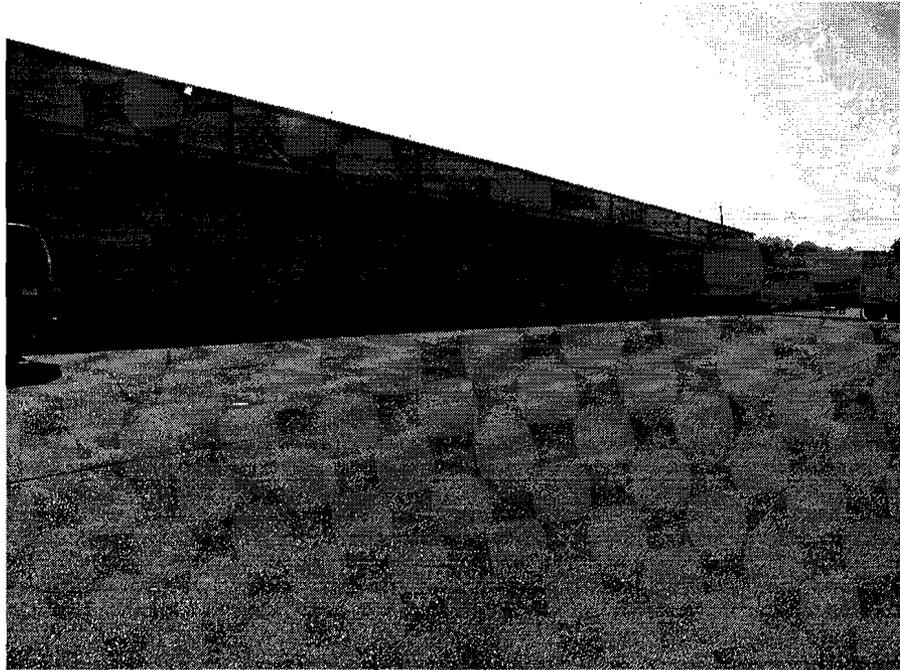
Storm drains have been stenciled in parking areas

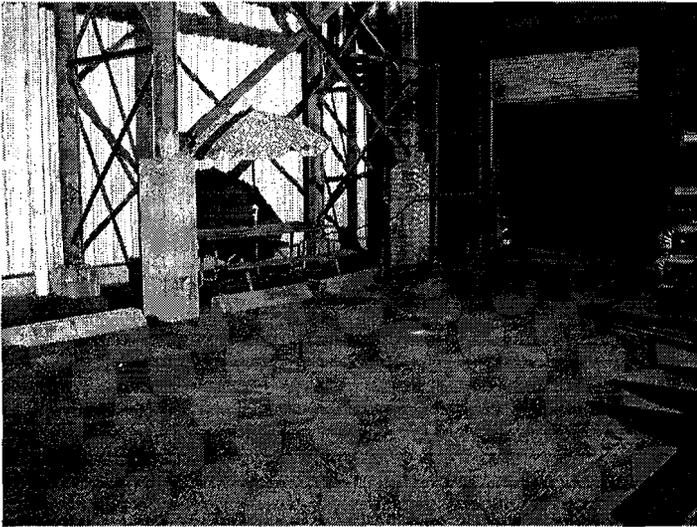
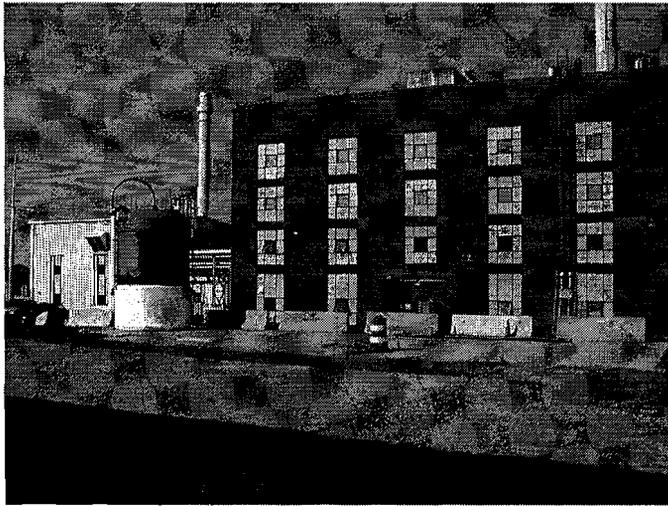
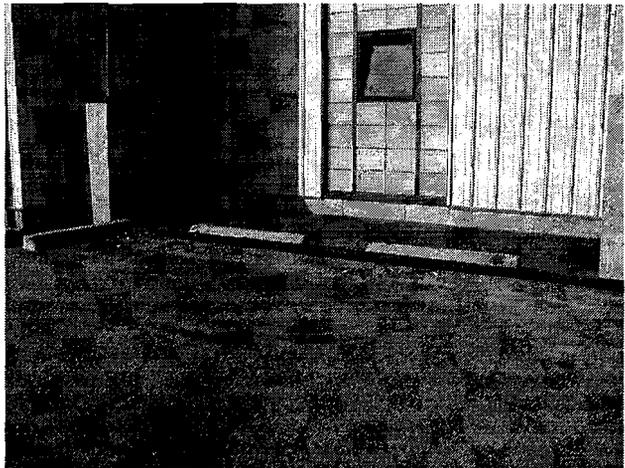
The entire building has a secondary containment area designed to collect condensate, oils and other fluids that may leak or be blown off by the plant. The water/fluids are collected in the bilge area, tested monthly and discharged to the sanitary sewer.

Recommendations: Some sweeping required outside plant doors in smoking areas.

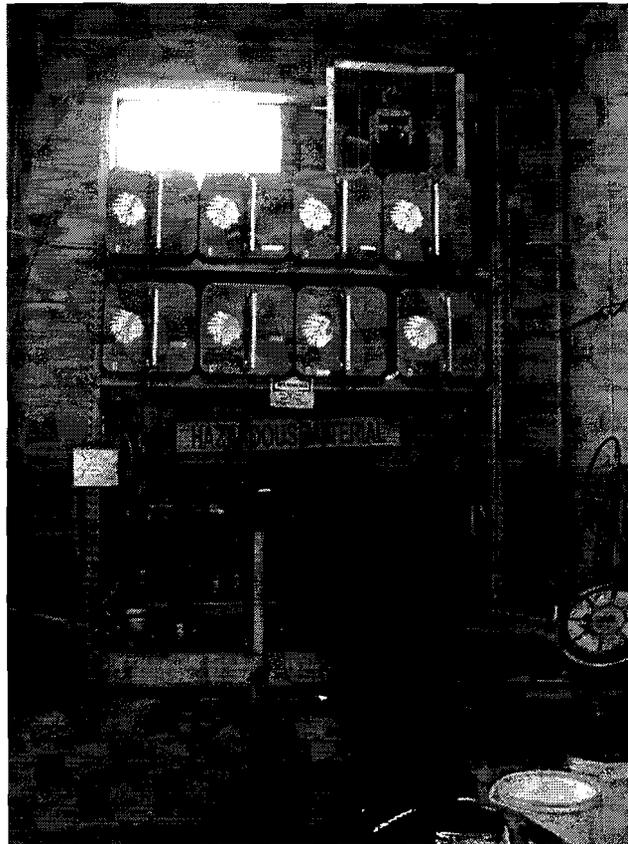
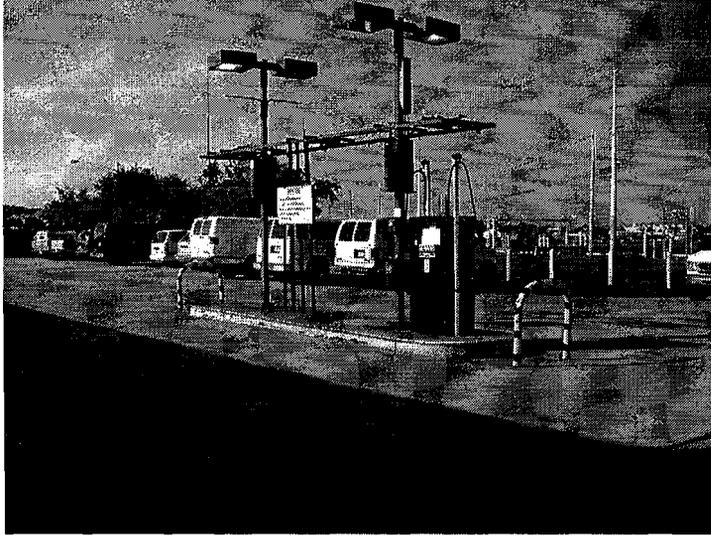
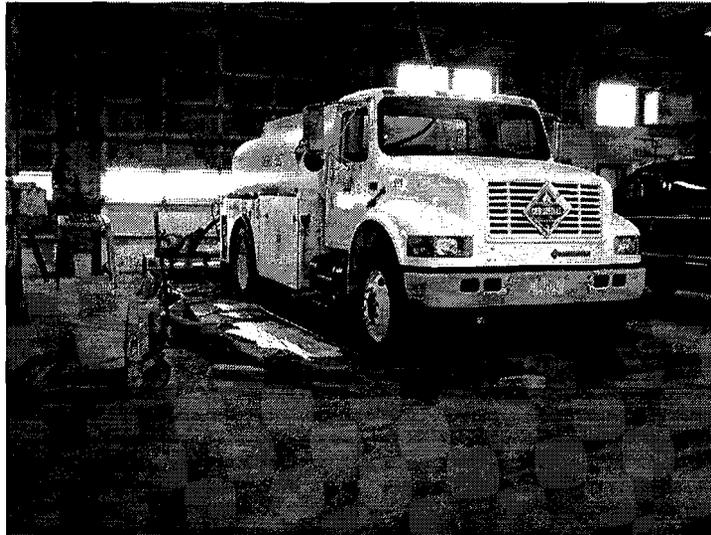
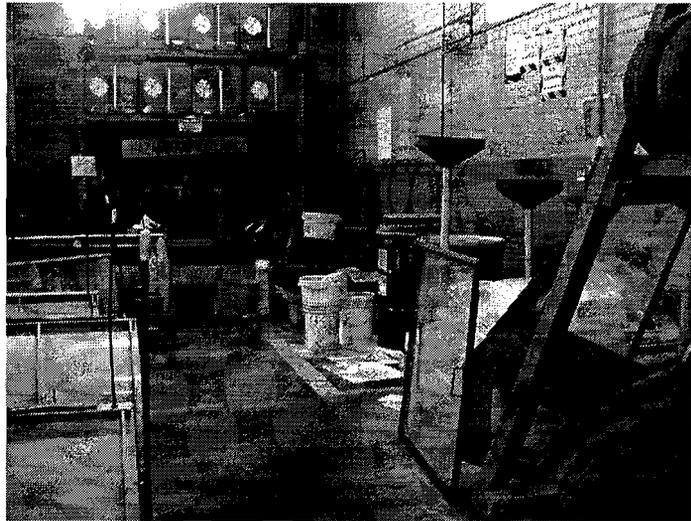
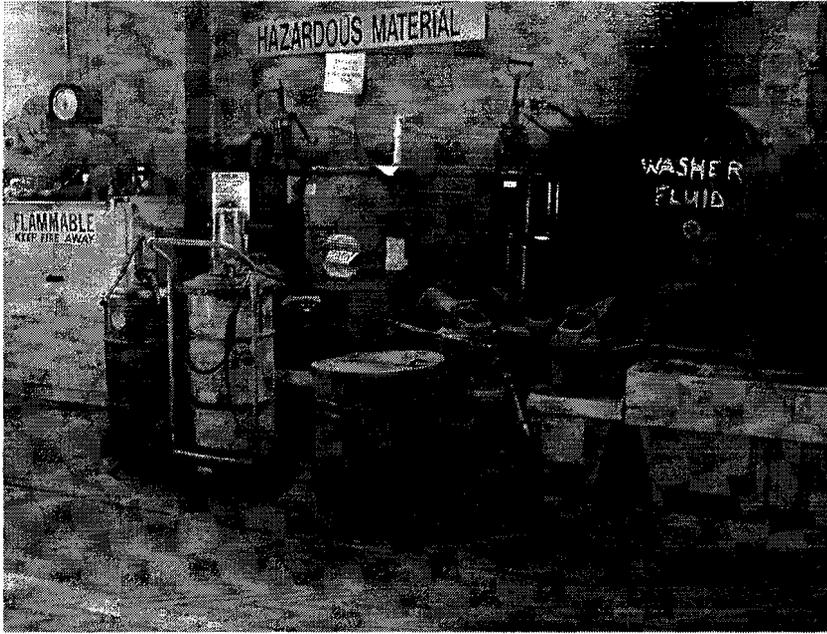
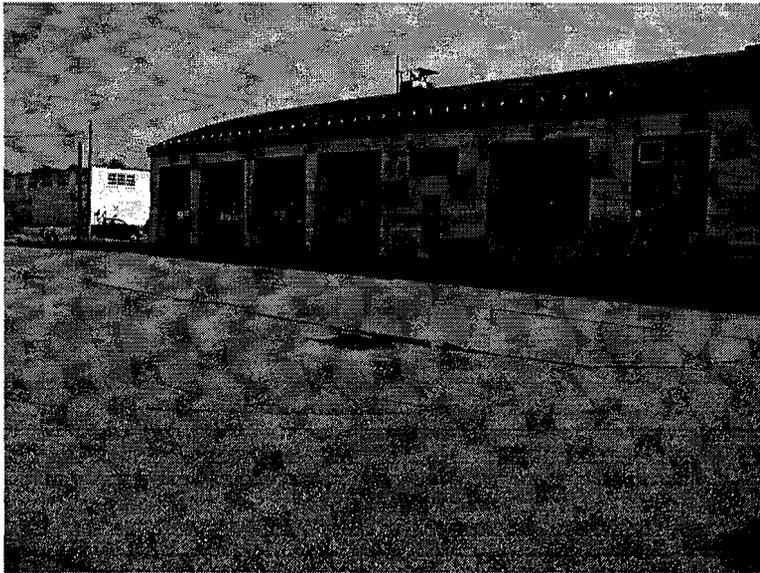
1. One (1) - 4,000 gal double wall fiberglass UST containing diesel fuel with fuel pump
2. Miscellaneous small quantity containers of hazardous materials for the use of automobile maintenance, such as oils, antifreeze, batteries, windshield cleaner, used parts, and lubricants.
3. One (1) - 55-gallon drum used to store used motor oil.
4. One (1) - 55 gallon drum used to store oil debris and rags.
5. One (1) - 5-gallon drum used to store oil filters.

Improve general housekeeping procedures inside building A9. Do not pour liquid waste down floor drains, sinks, or outdoor storm drain inlets. Park vehicles and equipment indoors whenever possible. Dispose of greasy rags, oil filters, air filters, batteries, spent coolant, and degreasers properly. Use speedy dry for spills, no hosing allowed. Maintain inventory of materials used in the maintenance shop. Stencil storm drains in parking areas.
