FINAL
2005 SECOND SEMIANNUAL POST-CLOSURE
INSPECTION AND MAINTENANCE REPORT
Revision 1

April 17, 2006

INSTALLATION RESTORATION PROGRAM SITE 7
(FORMER STATION LANDFILL)
NAVAL WEAPONS STATION SEAL BEACH
SEAL BEACH, CALIFORNIA

DCN: FWSD-RAC-06-0341

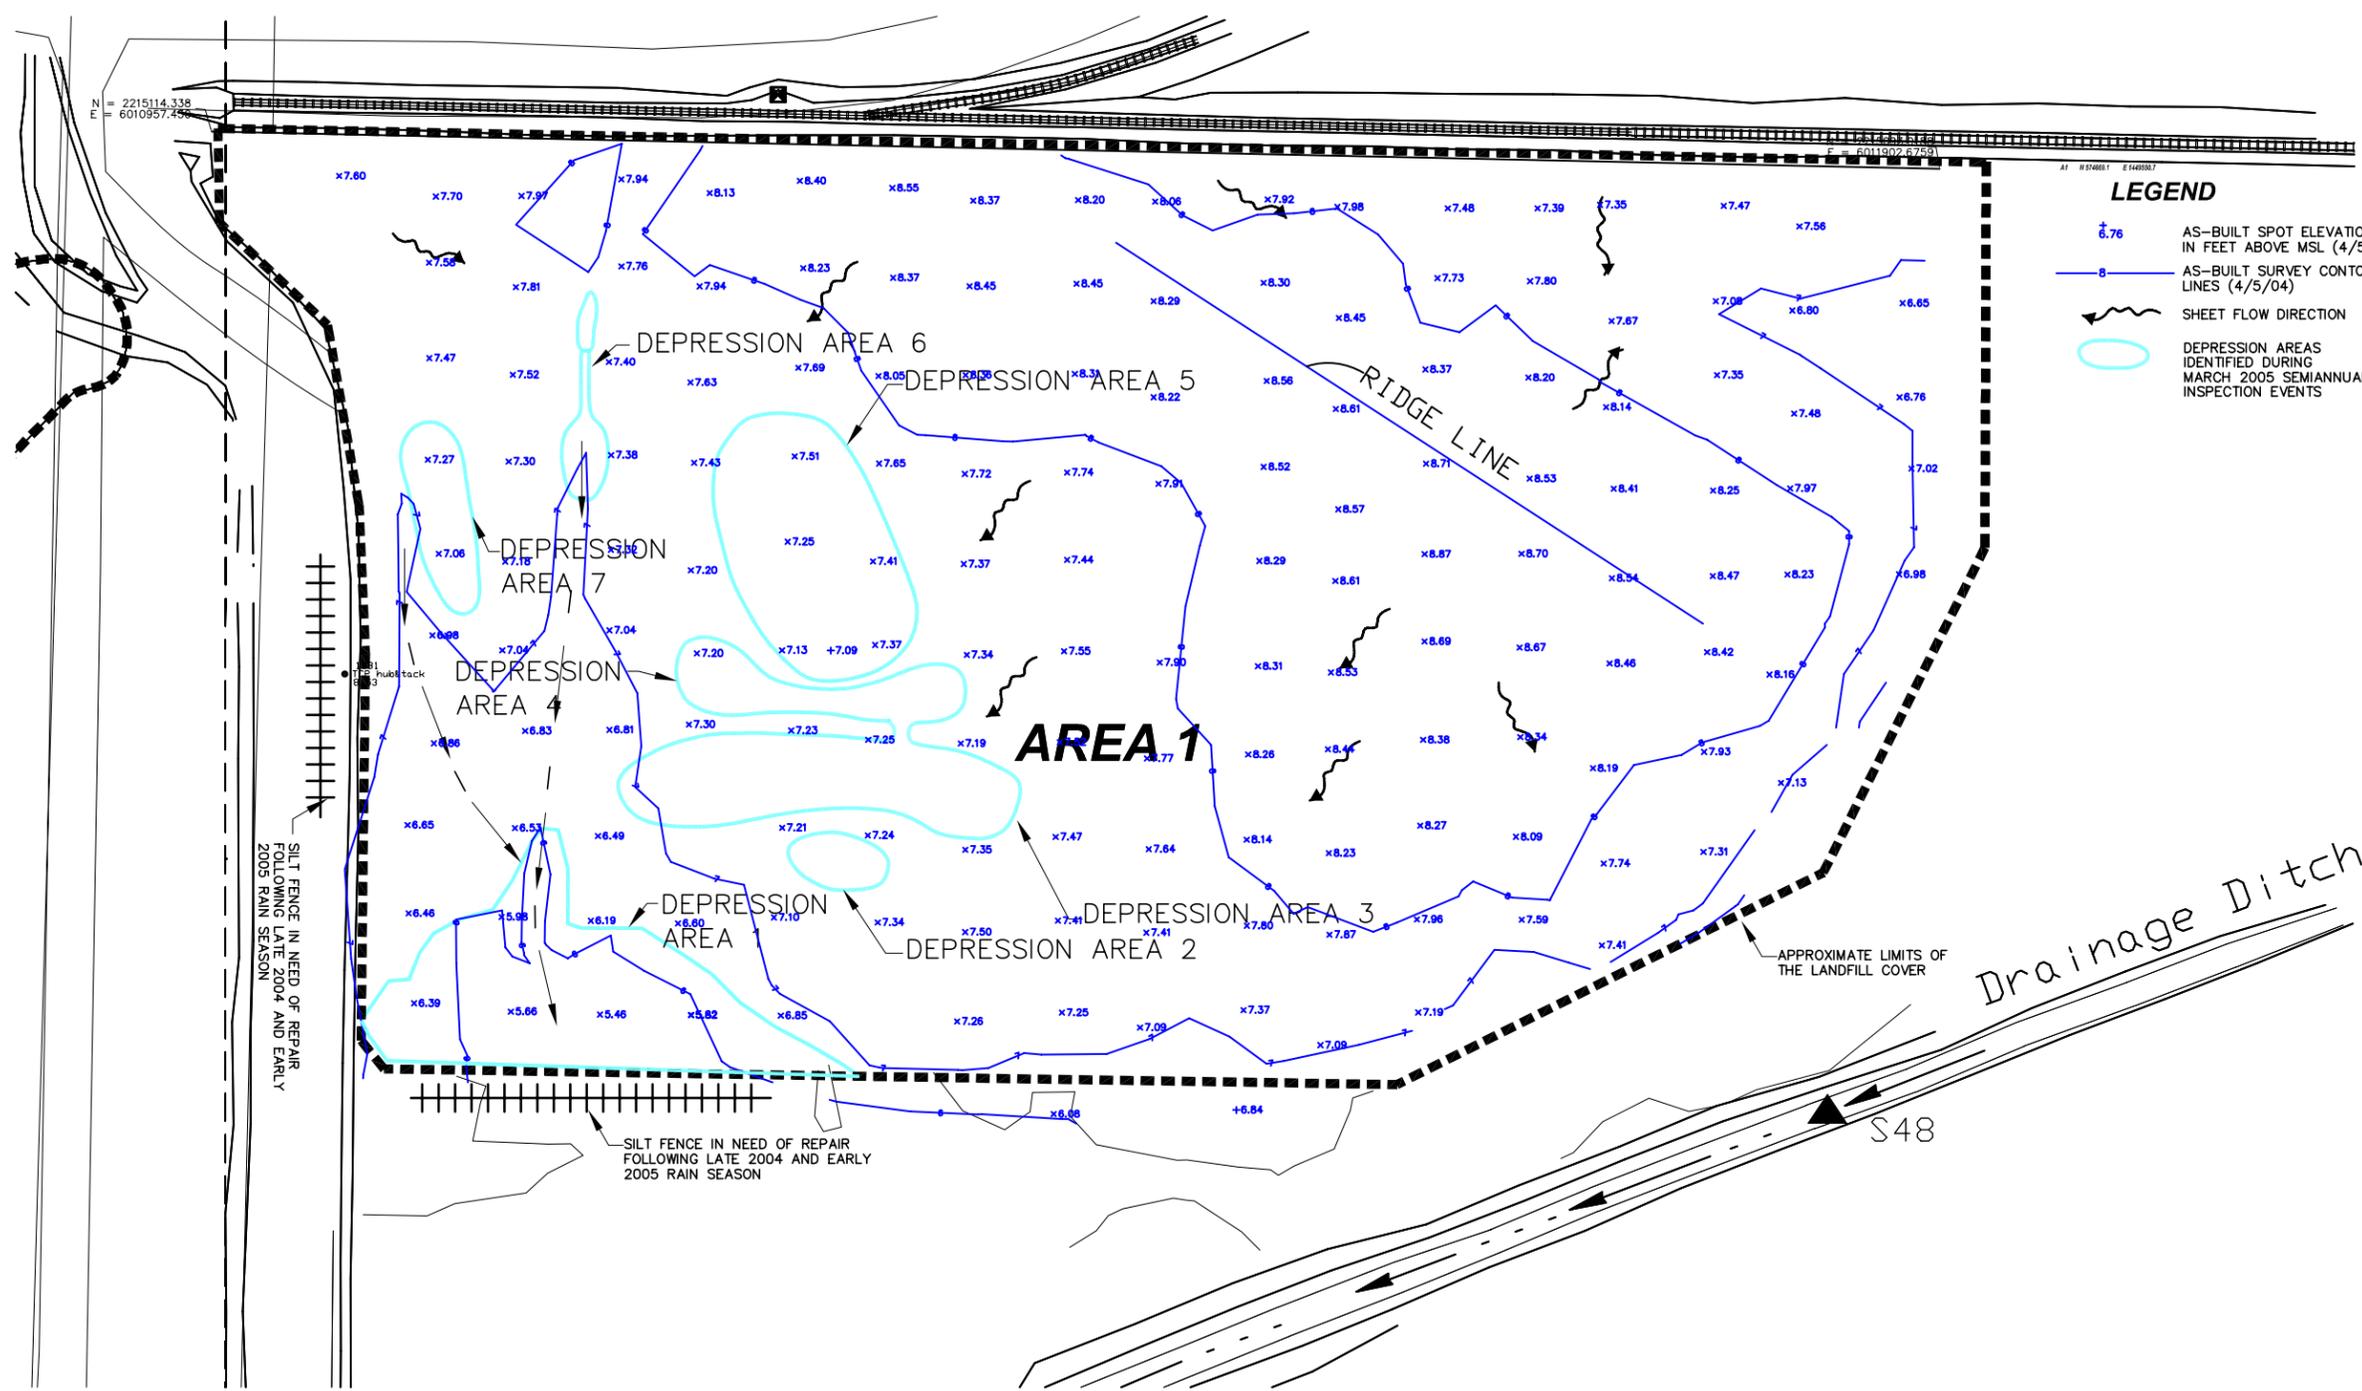
Figure 2-1
 DEPRESSION AND REPAIR AREAS IDENTIFIED DURING
 MARCH 2005 INSPECTIONS

As indicated in the *Final 2005 First Semiannual Post-Closure Inspection and Maintenance Report* (TtEC, 2005), there were seven depressions within the western portion of the landfill, which required backfilling and grading to alleviate future ponding and promote sheet flow. The size of the depressions were approximately 17 feet wide by 32 feet long, 30 feet wide by 90 feet long, 15 feet wide by 65 feet long, 35 feet wide by 95 feet long, 10 feet wide by 42 feet long, and 20 feet wide by 70 feet long. A triangular-shaped area located at the south side of the landfill, with a base length of approximately 275 feet and distance of approximately 125 feet, had water ponding and also required re-grading (see Figure 2-1). Corrective actions taken were intended to minimize future pondings in these areas. In addition, the western half of the landfill cover required reseeding and revegetation in order to adequately protect the cover soil from erosion.

Prior to mobilization, Coast Survey, Inc., a subcontractor to TtEC conducted a survey of the western portion of the landfill on August 30, 2005. The surveying subcontractor also provided grade stakes for backfill placement. Figure 2-1 provides the as-built survey contours conducted on April 5, 2004, at the completion of the landfill cover repair, conducted as part of the NTCRA at IRP Site 7 in early 2004. The August 30, 2005, survey (shown on Figure 2-2) was conducted to determine the locations of the depressions and ponding areas and to determine the thickness and amount of fill needed to raise the elevation of the depressions and re-grade the landfill cover to the design elevations. The design grades were compared with the August 30, 2005, survey elevations to determine the amount of fill needed.

These areas were recommended to be backfilled to the surrounding grade to promote sheet flow drainage. Sediment soil that accumulated along the southern perimeter silt fence was removed and mixed with imported clean soil obtained from an off-site source and reused to backfill and grade the depressions at the site. Additional imported topsoil material was also obtained from off-site borrow sources for backfilling and grading the depressions. The repairs were conducted in accordance with the PCIMP procedures and requirements. Topsoil was obtained from Redwood Products of Chino, Inc., located in Chino, California. Soil samples were collected for agronomic analysis to properly identify the soil amendments necessary for vegetation growth and sustenance. Agronomic analysis was conducted by Wallace Laboratories of El Segundo, California. Agronomic analysis included fertility testing and testing for pH, cations, anions, metals, phosphate, salinity, organic matter content, and relative infiltration rate. Test results indicated that the soil was suitable as topsoil and sustenance of vegetation at the site. In addition, a soil sample was collected and sent to Applied P and CH Laboratories located in Chino, California, for chemical analysis, prior to delivery of the topsoil to the site. The soil sample was tested for semivolatile organic compounds [U.S. Environmental Protection Agency (EPA) test Method 8270C], polynuclear aromatic hydrocarbons [EPA test Method 8270C-Selective Ion Monitoring (SIM)], metals (EPA test Method 60101B), pesticides (EPA test Method 8081A), and polychlorinated biphenyls (EPA test Method 8082) to ensure that the imported soil was free of contamination prior to hauling it to the site.

The seven areas of settlement and depression that were identified during the March 2005 inspections were all regraded and repaired by placing additional fill in order to maintain adequate sheet flow drainage and to minimize future ponding.

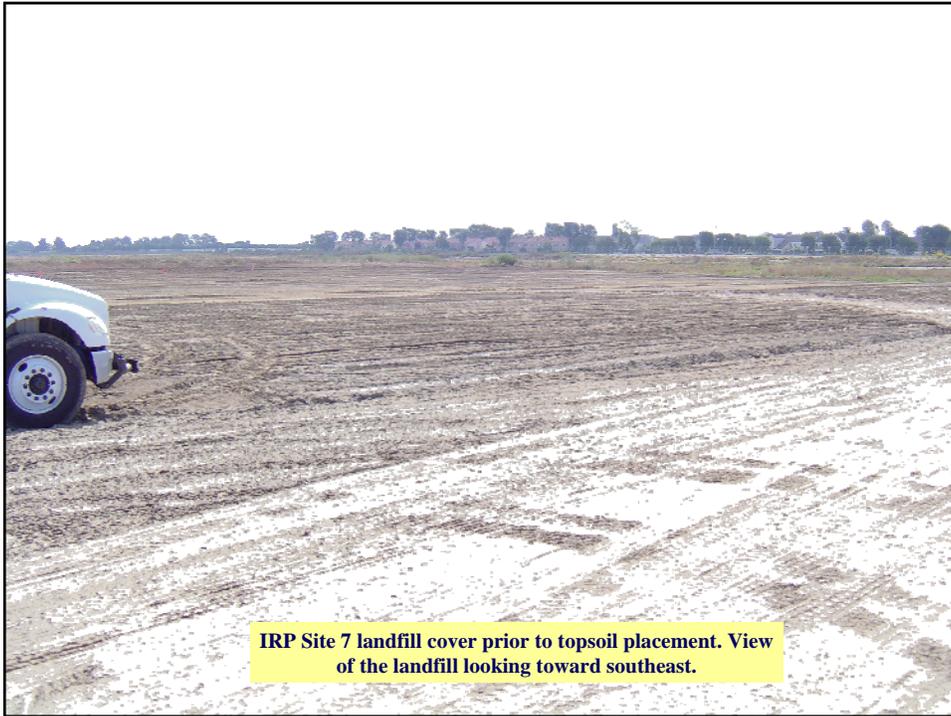
IRP Site 7 landfill cover prior to topsoil placement. View of the landfill looking toward southeast.

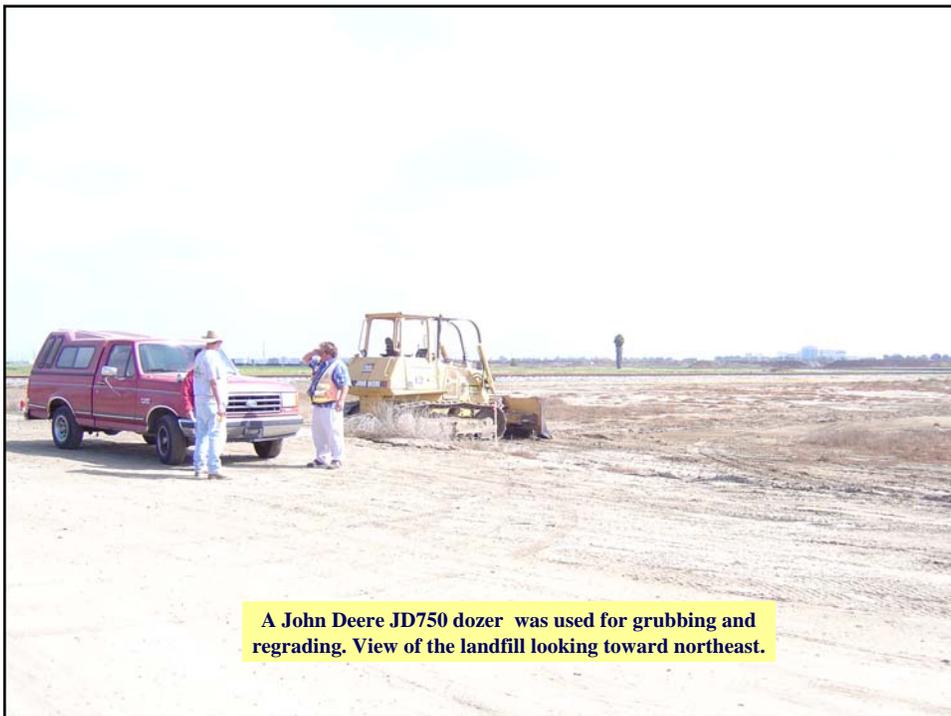
A John Deere JD750 dozer was used for grubbing and regrading. View of the landfill looking toward northeast.

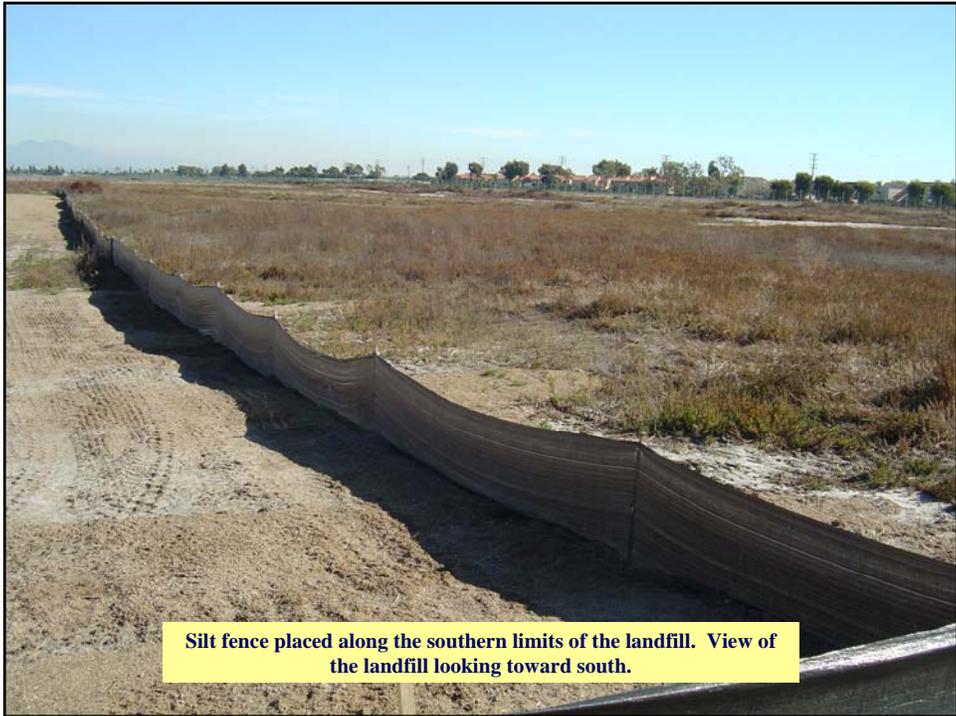
Silt fence placed along the southern limits of the landfill. View of the landfill looking toward south.

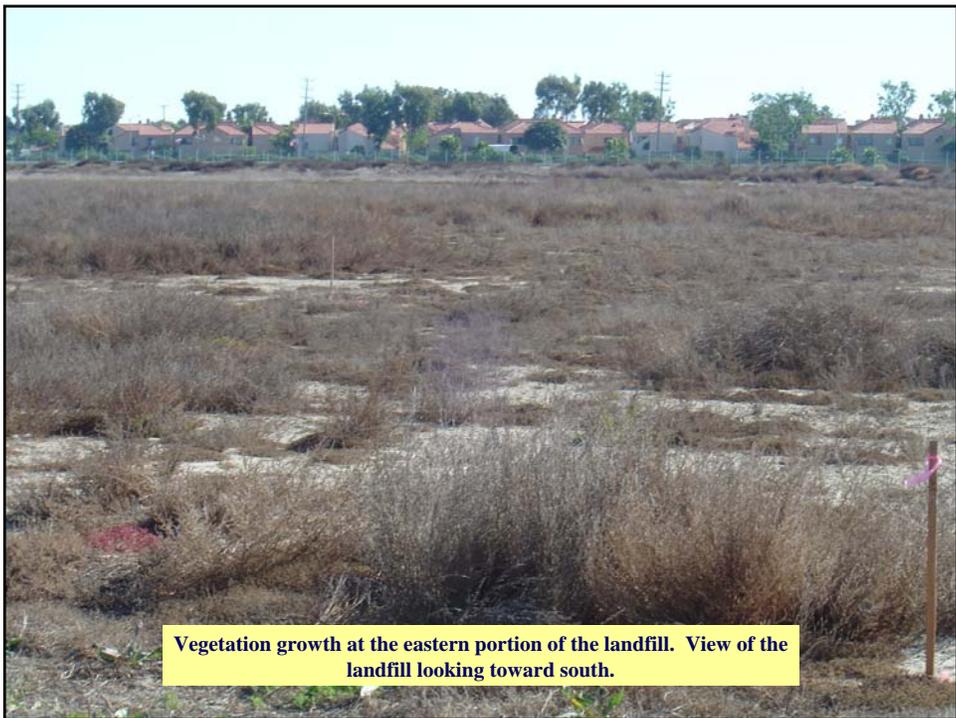
Vegetation growth at the eastern portion of the landfill. View of the landfill looking toward south.

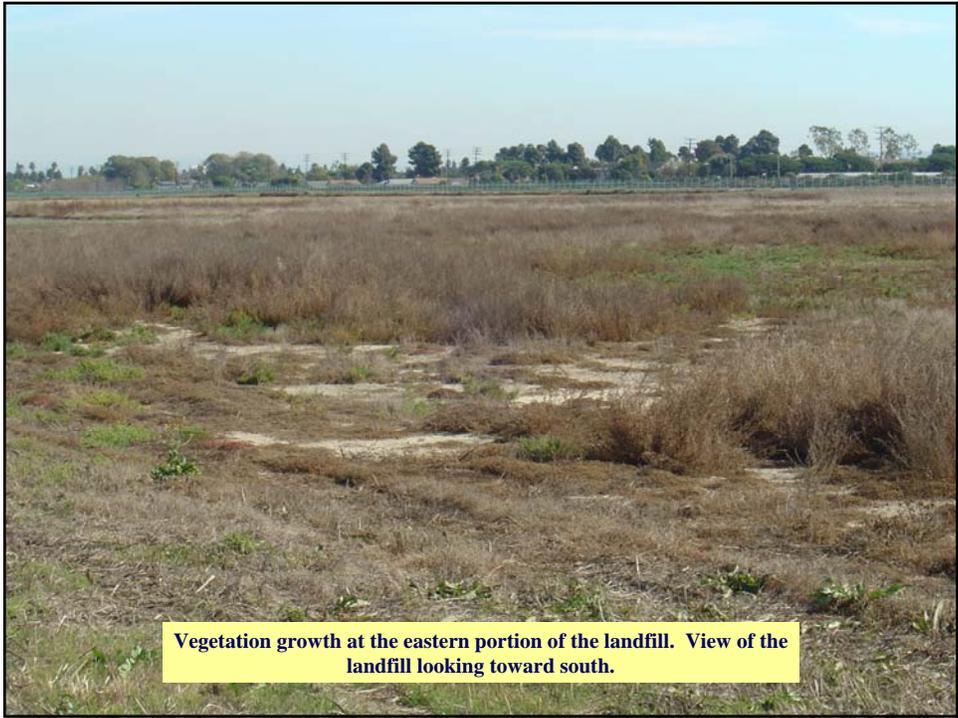
Vegetation growth at the eastern portion of the landfill. View of the landfill looking toward south.

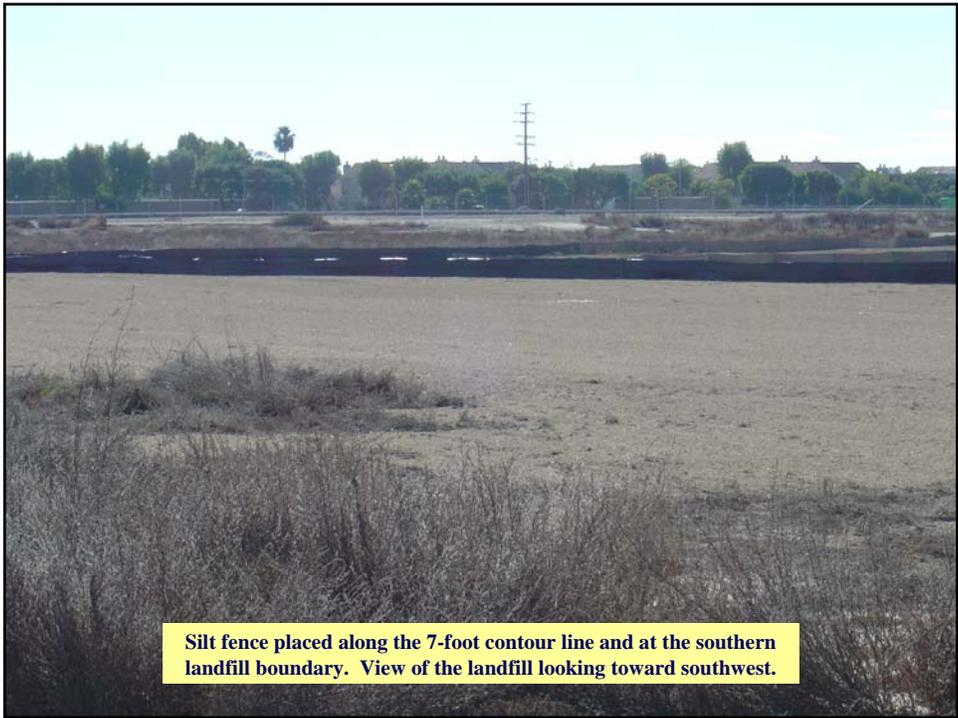
Silt fence placed along the 7-foot contour line and at the southern landfill boundary. View of the landfill looking toward southwest.
