Battlefield Evaluation of Ewa Field,
by AECOM, Charlottesville, VA
and
Inventory and Historic Contexts
by Mason Architects Inc., Honolulu, HI

March 2011

Part 1: Ewa Field Battlefield Evaluation

Part 2: Ewa Field Inventory & Evaluation

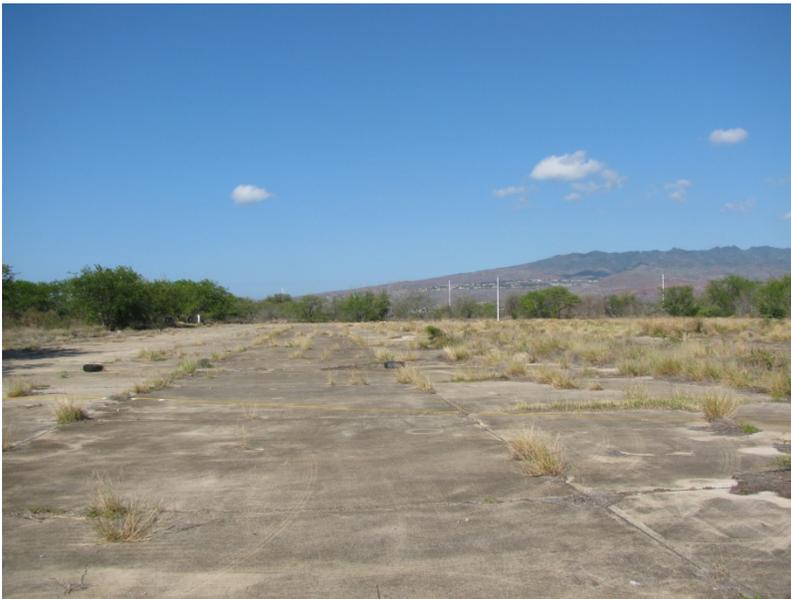
Figure 9. Concrete warm-up platform, 2010. (AECOM)

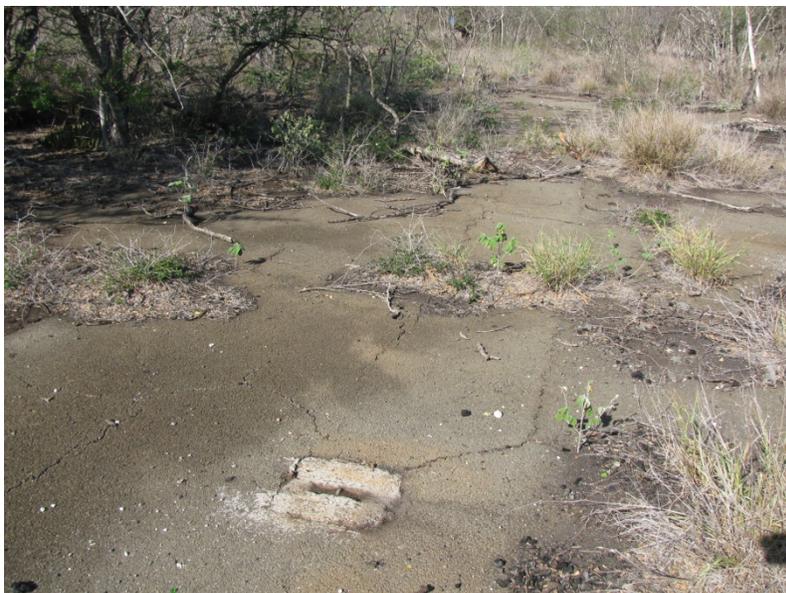
Figure 10. Macadam parking apron conditions, 2010 (note tiedown in foreground).

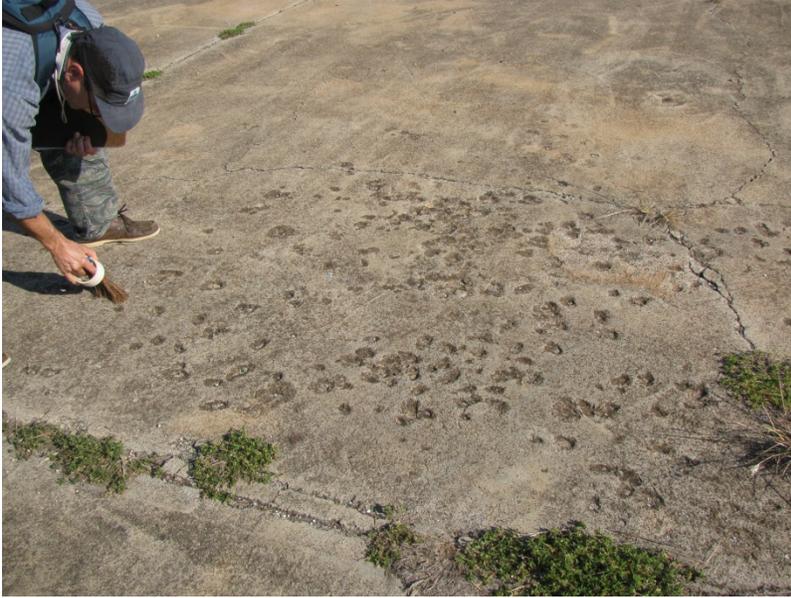
Figure 12. Concrete damage of the concrete warm-up platform caused by the attack, identified by MAI in 2010. (AECOM)

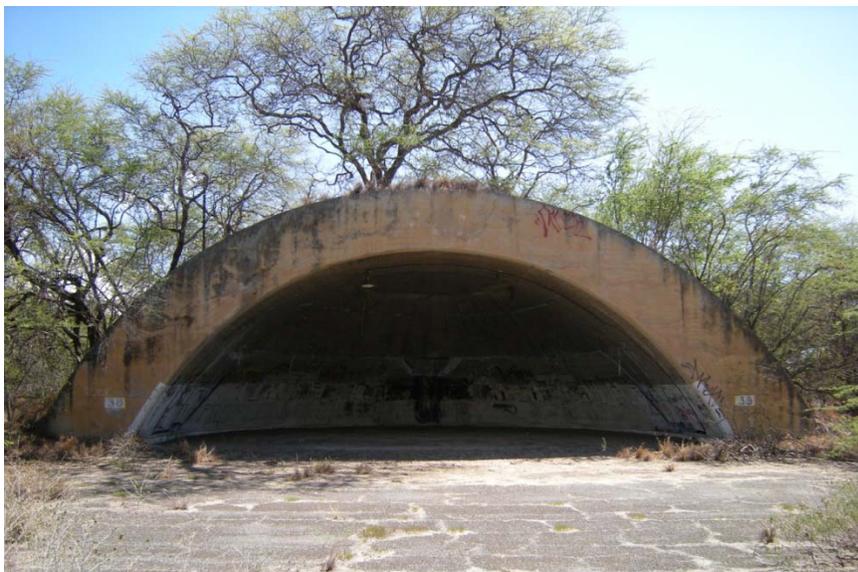
Aircraft Revetment (typical, Facility 1263)

Integrity Location – retained. Setting – partially retained, growth of vegetation surrounding the revetments and on the adjacent airfields reduces integrity of setting. Design, Materials, Workmanship – retained, no apparent alterations. Feeling, Association – partially retained.

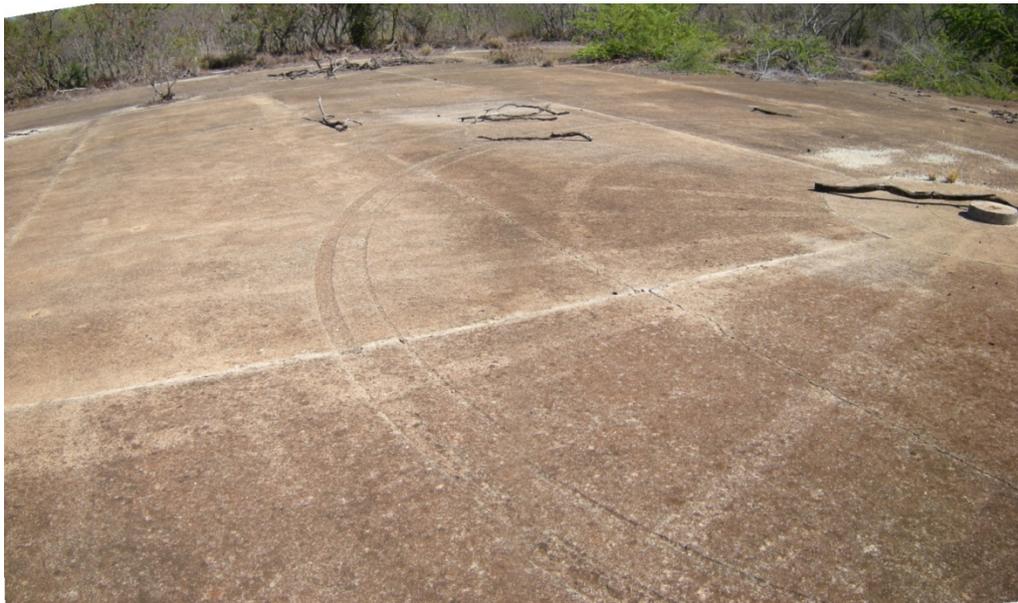
Compass Rose

Integrity Location – retained. Setting – partially retained, growth of vegetation surrounding the compass rose and on the adjacent airstrips reduces integrity of setting. Design, Materials, Workmanship – partially retained, removal of compass and concentric lines reduces integrity. Feeling, Association – partially retained.

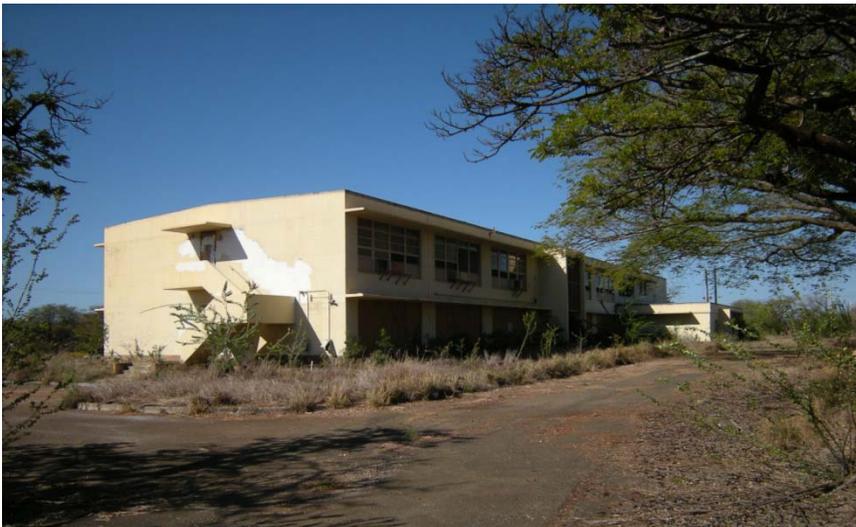
Facility 972

Integrity Location – retained. Setting – partially retained. Design, Materials, Workmanship – partially retained, some windows & doors replaced/ removed. Feeling, Association – partially retained.

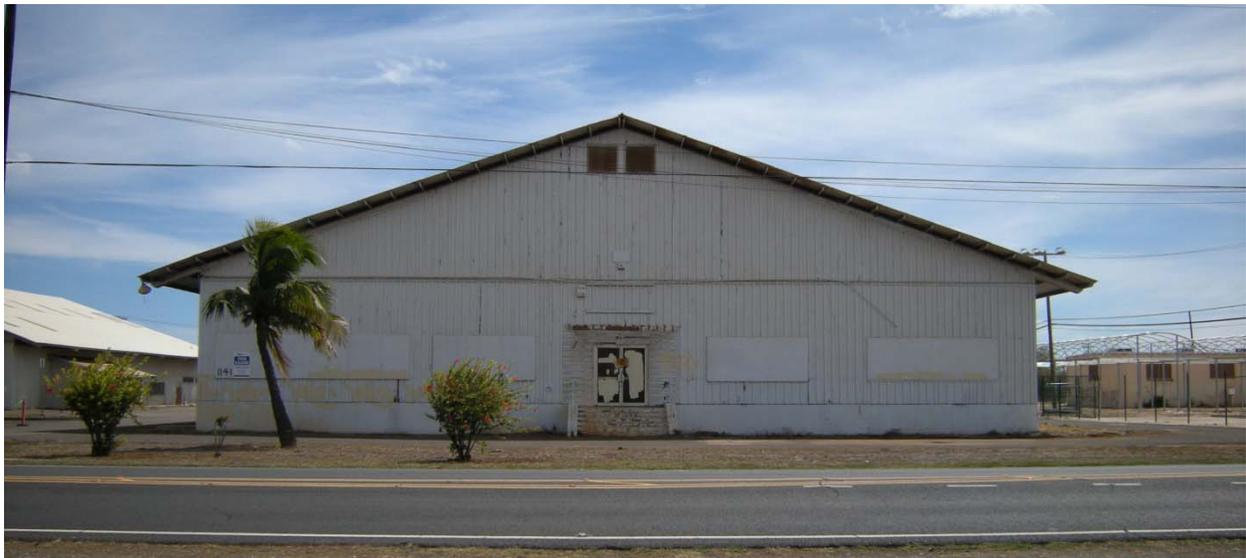
Facility 1141

Integrity Location – retained. Setting – partially retained, the removal of former buildings in the area has reduced integrity of setting. Design – partially reduced, metal roll up doors and storefront doors added. Materials – partially retained, some doors changed. Workmanship – partially retained, some doors changed. Feeling – partially retained, changed doors have reduced the expression of historic sense. Association – partially retained, conveyance of historic character is somewhat reduced by the replacement doors.

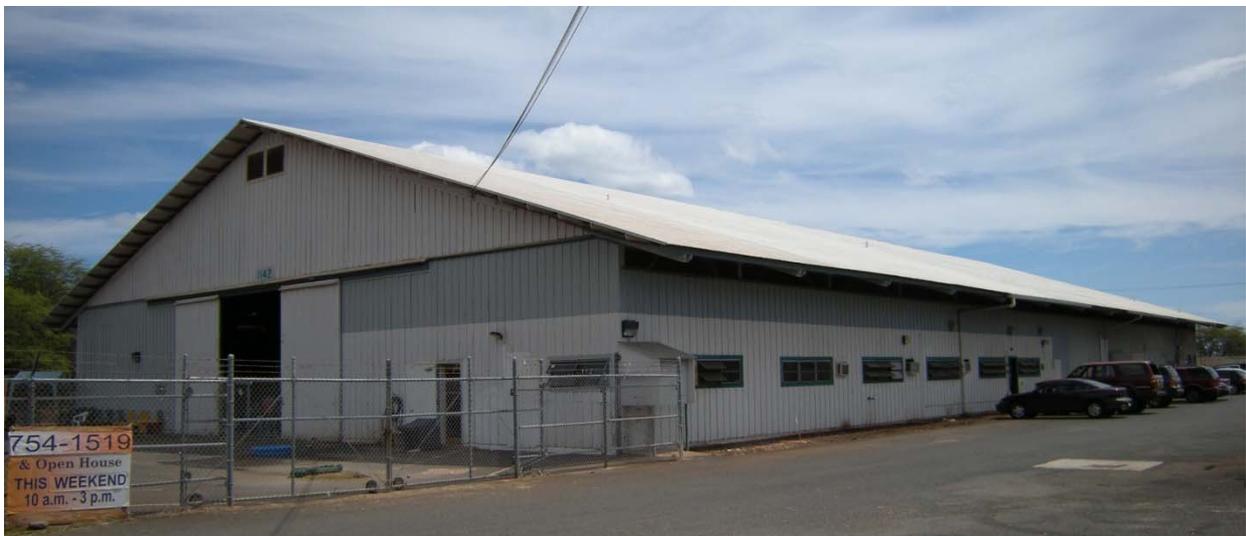
Facility 1142

Integrity Location – retained. Setting – partially retained, the removal of former buildings in the area has reduced integrity of setting. Design – partially retained, doors and windows replaced. Materials – partially retained, doors and windows replaced. Workmanship – partially retained, doors and windows replaced. Feeling – partially retained, alterations have reduced the expression of historic sense. Association – partially retained, conveyance of historic character is somewhat reduced by the replacement doors and windows.

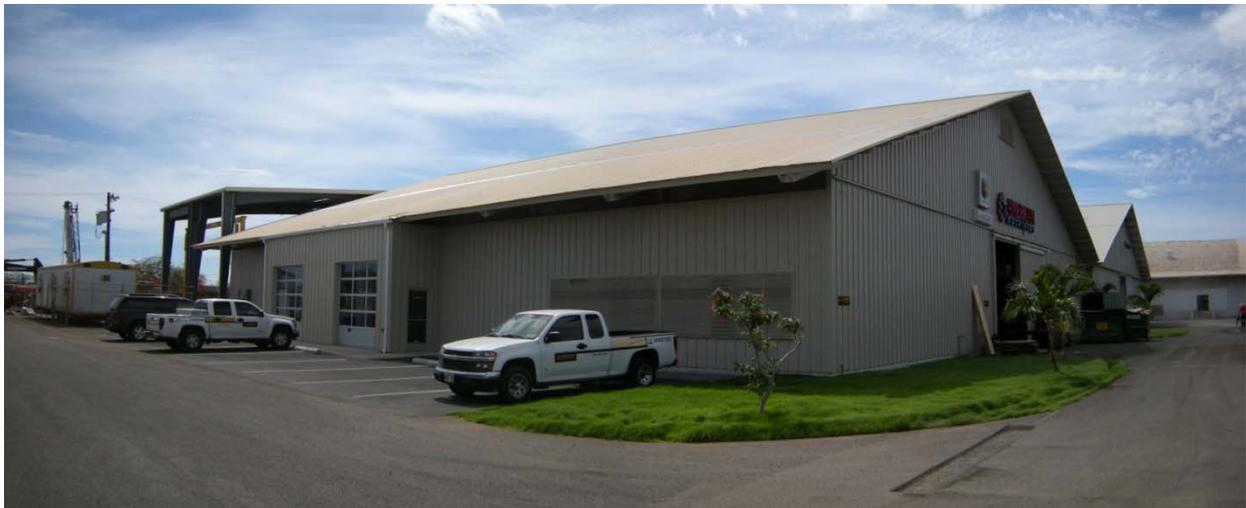
Facility 1143

Integrity Location – retained. Setting – partially retained, the removal of former buildings in the area has reduced the integrity of setting. Design – partially retained, doors and windows replaced and a storefront addition at the east side. Materials – partially retained, replacement doors and windows and storefront addition. Workmanship – partially retained, replacement doors and windows and storefront addition. Feeling – partially retained, alterations have reduced the expression of historic sense. Association – partially retained, conveyance of historic character is reduced by the alterations.

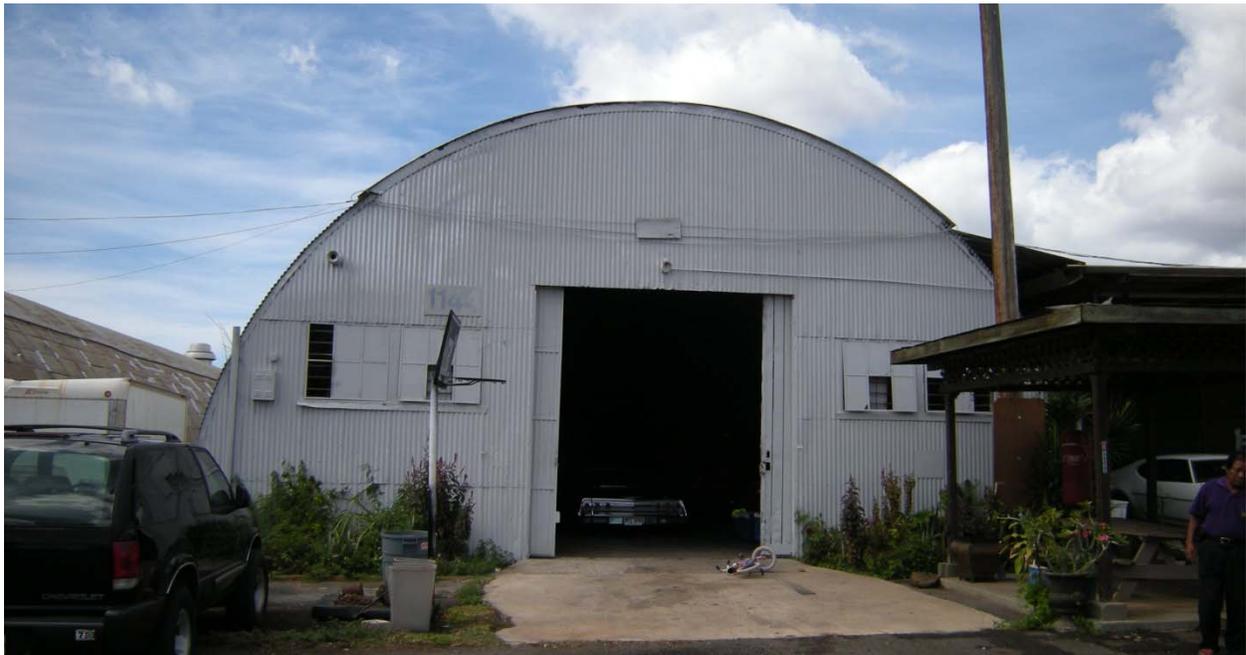
Facility 1144

Integrity Location – retained. Setting – partially retained, the removal of former buildings in the area has reduced integrity of setting. Design – partially retained, doors replaced. Materials – partially retained, doors replaced. Workmanship – partially retained, doors replaced. Feeling – partially retained, expression of historic sense is reduced by replacement doors. Association – partially retained, replacement doors somewhat reduce the conveyance of historic character.

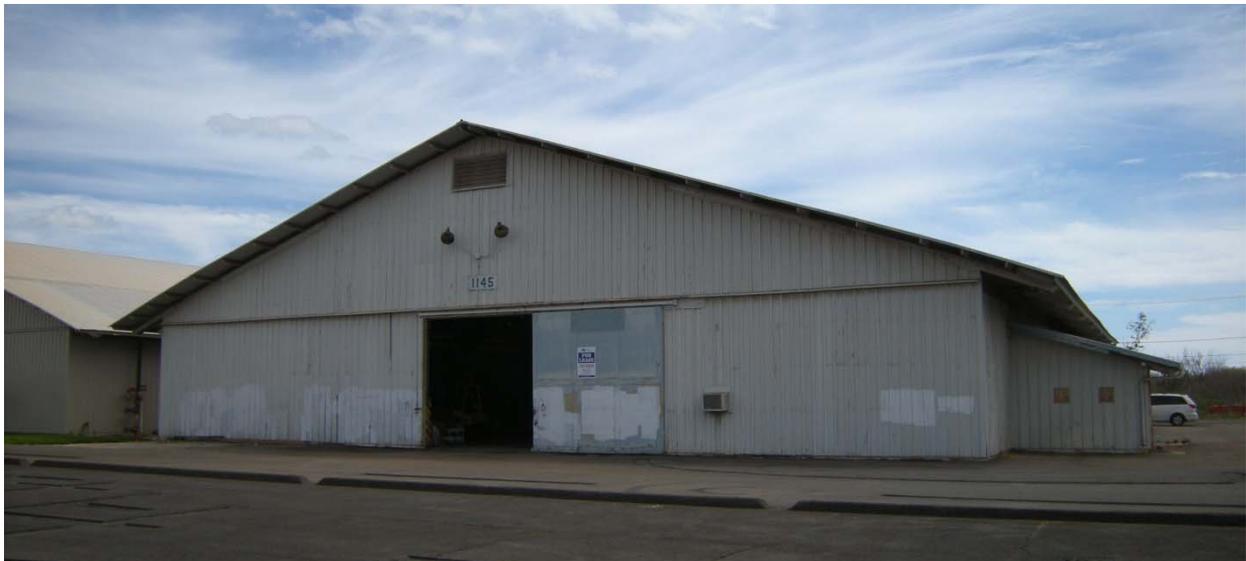
Facility 1145

Integrity Location – retained. Setting – partially retained, the removal of former buildings in the area has reduced integrity of setting. Design – partially retained, replacement doors and a small single story addition at the west side. Materials – partially retained, replacement doors and addition. Workmanship – partially retained, replacement doors and addition. Feeling – partially retained, alterations have reduced the expression of historic sense. Association – partially retained, historic character is reduced by the alterations.

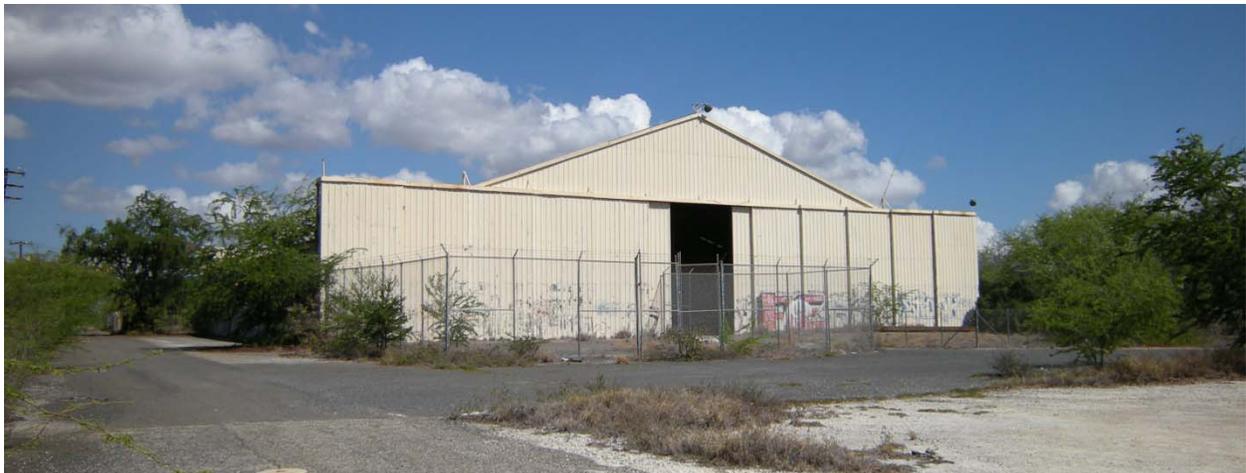
Facility 1146

Integrity Location – retained. Setting – partially retained, the removal of former buildings and growth of vegetation in the area and on the airfield has reduced integrity of setting. Design- partially retained, metal roll up door added at north end and original east side wing is demolished. Materials – partially retained, added door and demolished wing. Workmanship – partially retained, added door and demolished wing. Feeling – partially retained, alterations and setting changes have reduced the expression of historic sense. Association – partially retained, conveyance of historic character is reduced.

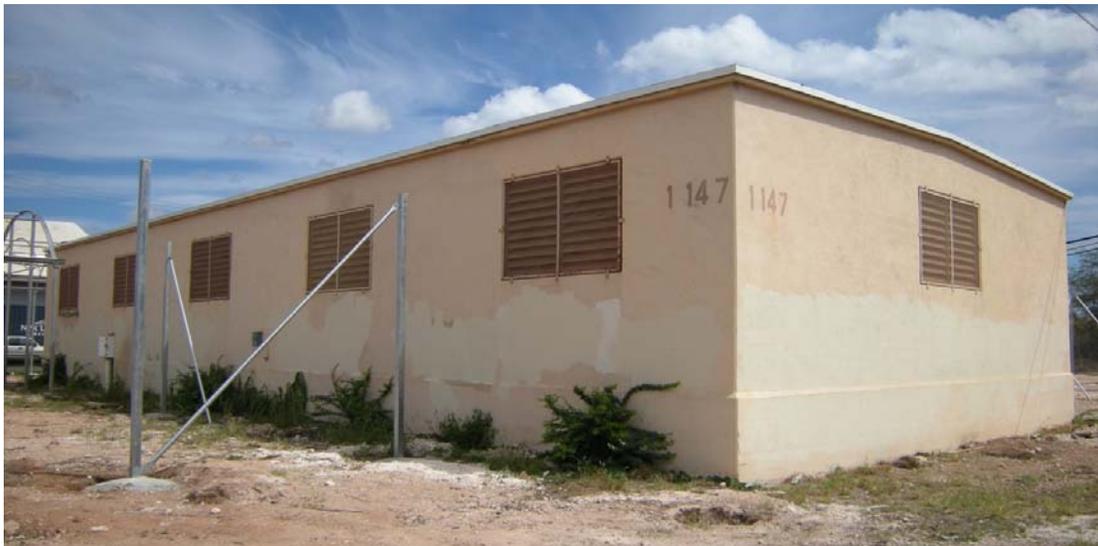
Facility 1147

Integrity Location – retained. Setting – not retained, the addition of metal- framed canopies on three sides of the building have changed the physical environment in proximity to the structure. Design. Retained, the building itself appears to have no alterations. Materials – retained, the building appears to have no alterations. Workmanship – retained, the building appears to have no alterations. Feeling – partially retained, the addition of canopies reduced the expression of the building's historic sense. Association – partially retained, canopies reduce the conveyance of historic character.

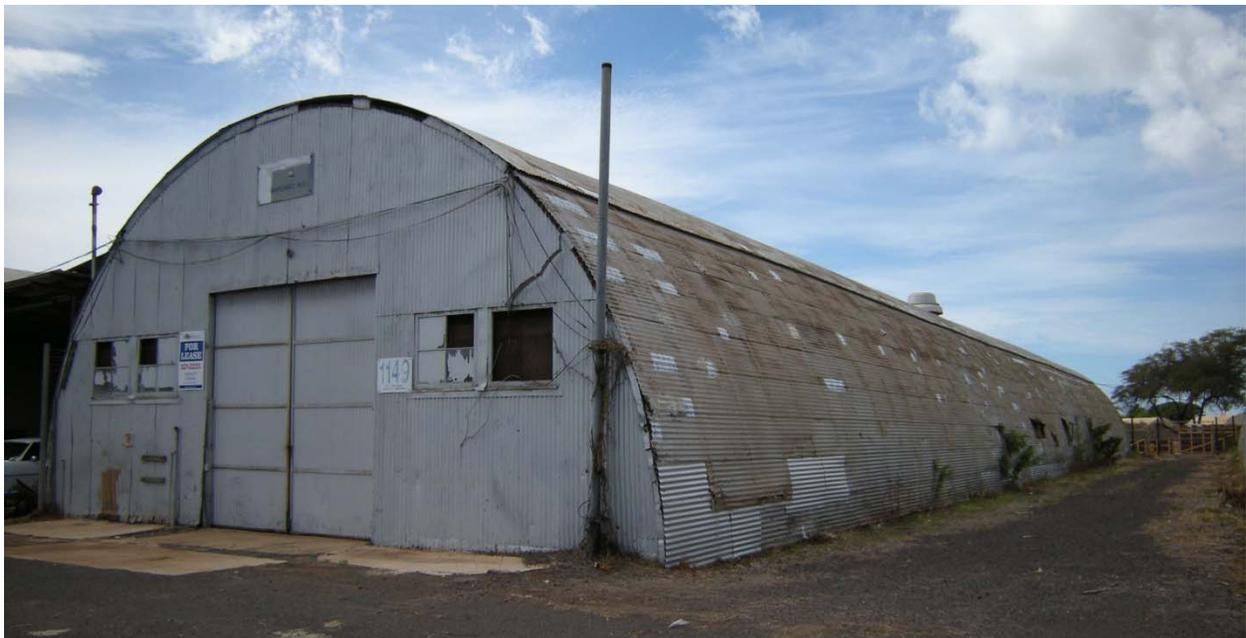
Facility 1149

Integrity Location – retained. Setting – partially retained, the removal of former buildings in the area has reduced the integrity of setting. Design – partially retained, doors replaced. Materials – partially retained, doors replaced. Workmanship – partially retained, doors replaced. Feeling- partially retained, expression of historic sense is reduced by replacement doors. Association – partially retained, conveyance of historic character is somewhat reduced by the replacement doors.

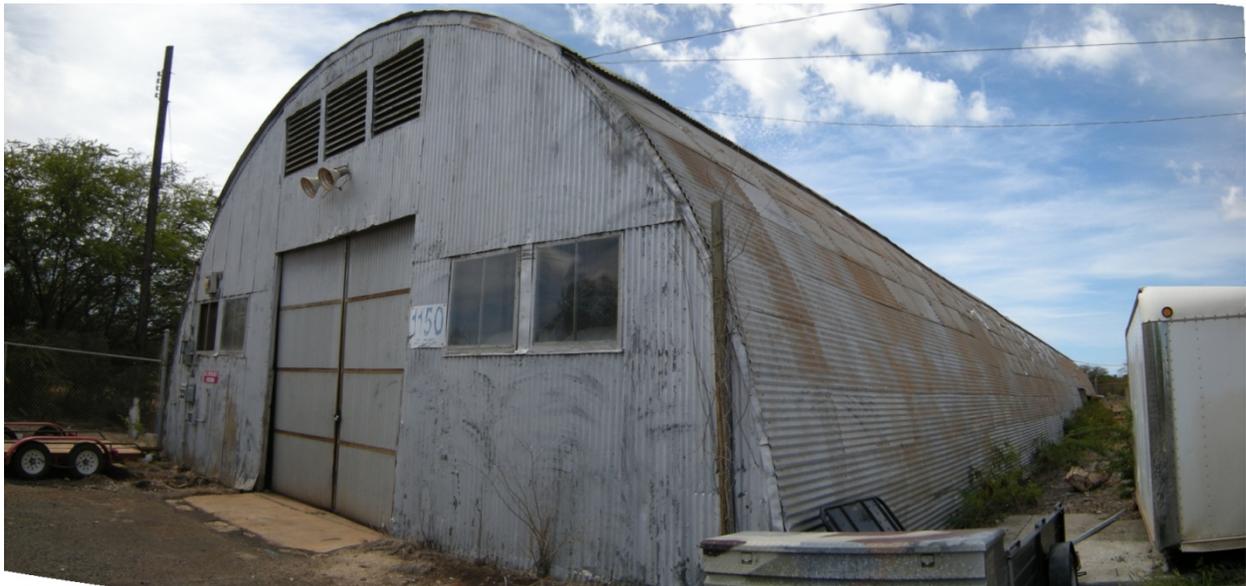
Facility 1150

Integrity Location – retained. Setting – partially retained, the removal of former buildings in the area has reduced integrity of setting. Design- partially retained, doors replaced and windows altered. Materials – partially retained, doors replaced and windows altered. Workmanship – partially retained – doors replaced and windows altered. Feeling – partially retained, expression of historic sense is lessened by alterations and changed setting. Association – partially retained, conveyance of historic character is somewhat impeded by alterations.

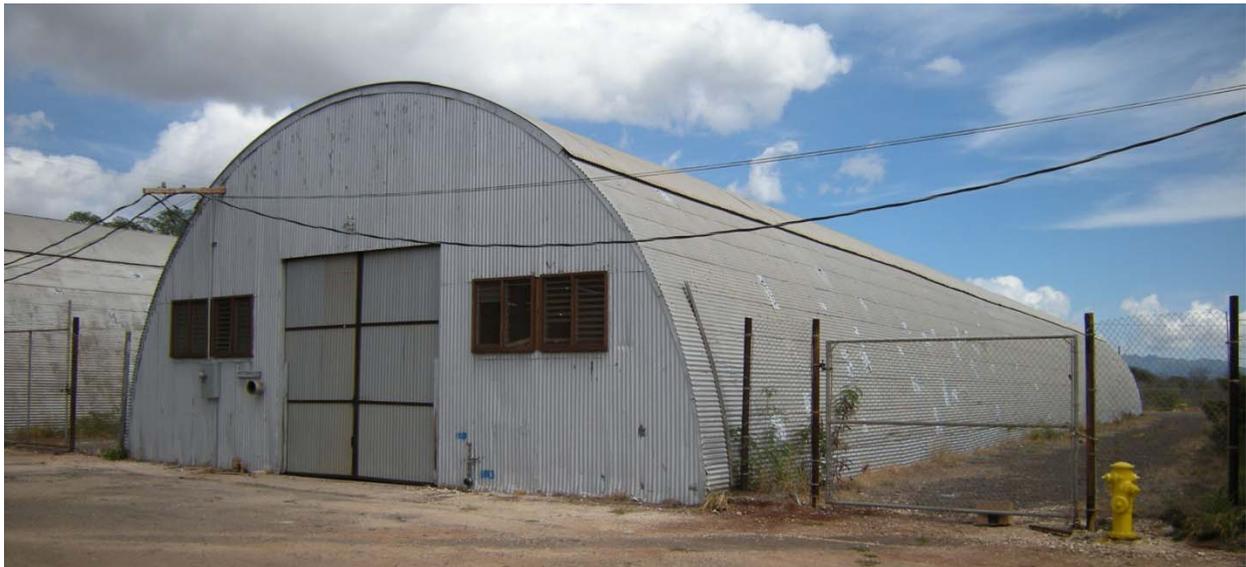
Facility 1152

Integrity Location – retained. Setting – partially retained, the removal of former buildings in the area has reduced integrity of setting. Design – partially retained, doors and windows replaced. Materials – partially retained, doors and windows replaced. Workmanship – partially retained, doors and windows replaced. Feeling – partially retained, expression of historic sense is reduced by replacement doors and windows. Association – partially retained, replacement doors and windows reduce the conveyance of historic character.

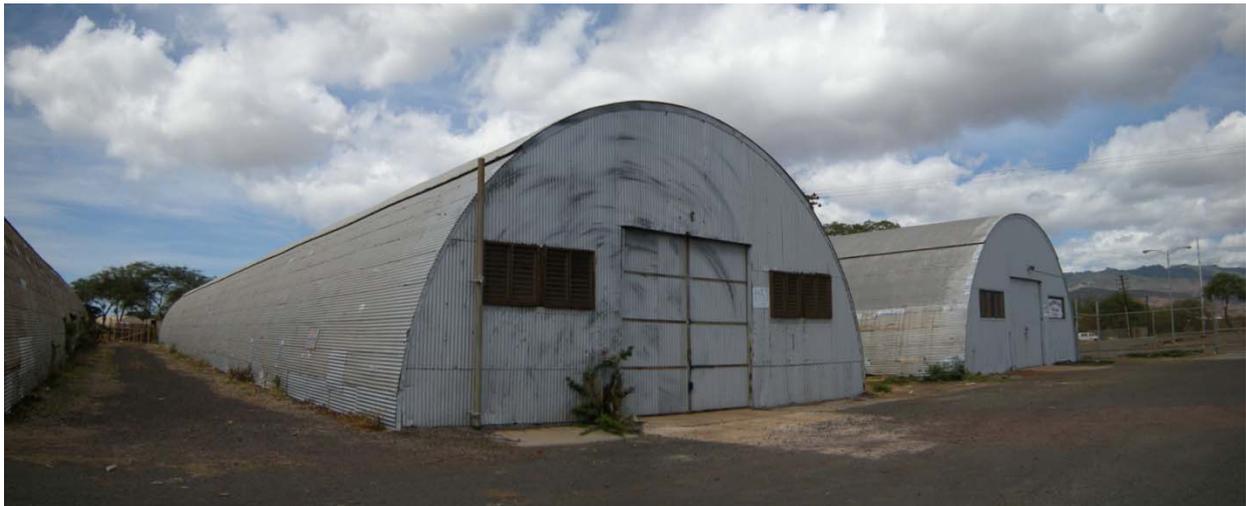
Facility 1153

Integrity Location – retained. Setting – partially retained, the removal of former buildings in the area has reduced integrity of setting. Design – partially retained, windows and doors replaced. Materials – partially retained, windows and doors replaced. Workmanship – partially retained, windows and doors replaced. Feeling – partially retained, replacement windows and doors reduce the historic sense of the building. Association – partially retained, historic character is reduced by replacement windows and doors.

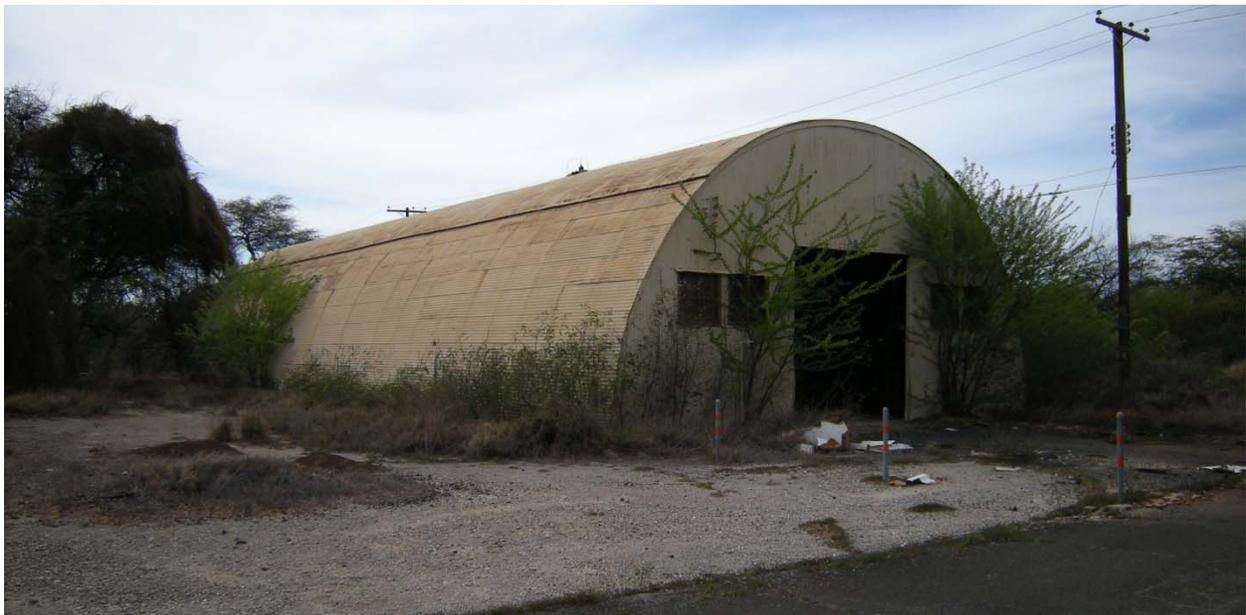
Facility 1545

Integrity Location- retained. Setting – partially retained, the removal of former bldgs to the south has reduced integrity of setting. Design – retained. Materials- retained. Workmanship –retained. Feeling – partially retained, expression of historic sense is lessened by altered setting. Association – partially retained, reduced by altered setting.

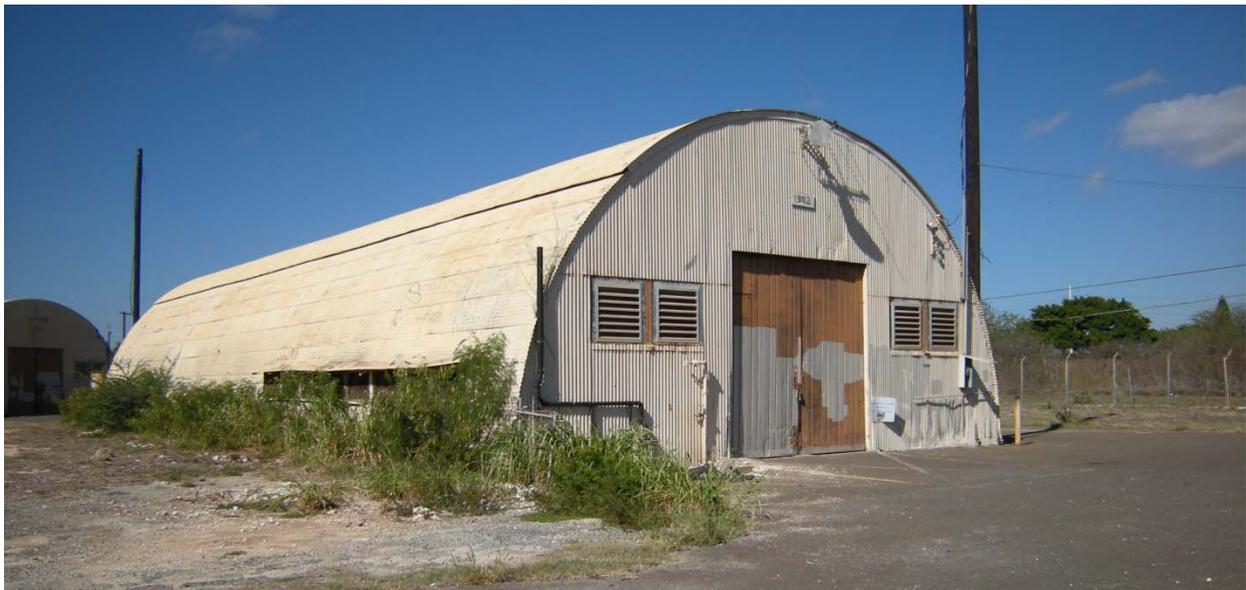
Facility 1562

Integrity Location – retained. Setting – partially retained, the removal of former buildings and growth of vegetation in the area and on the airfield has reduced integrity of setting. Design- partially retained, doors replaced, end windows replaced with louver vents. Materials – partially retained, replacement doors and windows. Workmanship – partially retained, replacement doors and windows. Feeling – partially retained, alterations and setting changes have reduced the expression of historic sense. Association – partially retained, conveyance of historic character is reduced.

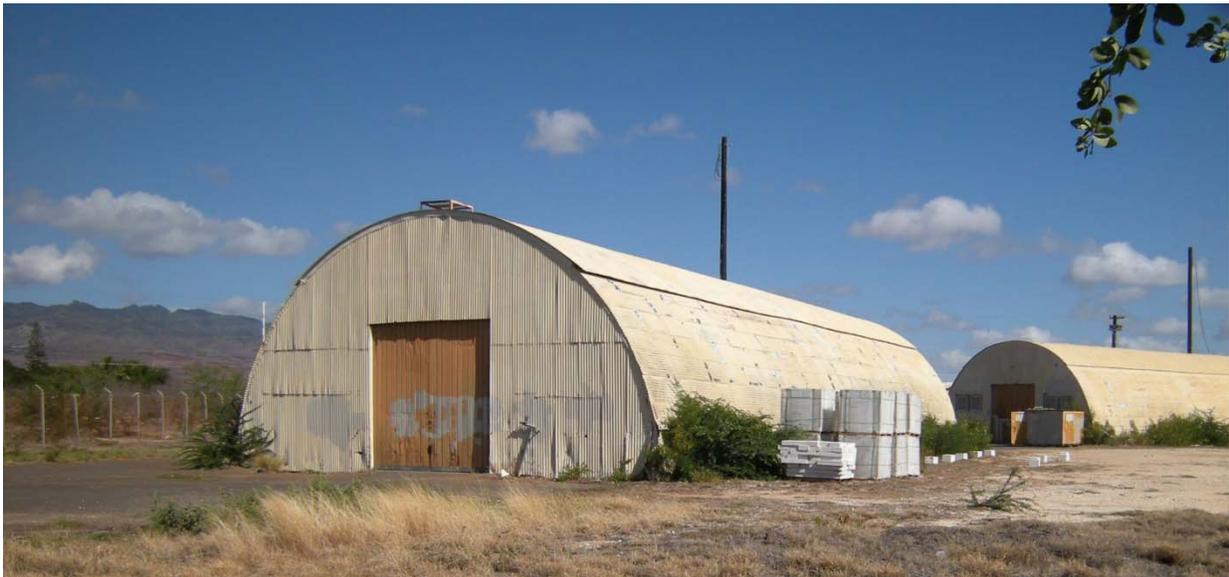
Facility 1570

Integrity Location – retained. Setting – partially retained, the removal of former buildings and growth of vegetation in the area and on the airfield has reduced integrity of setting. Design- partially retained, doors replaced, end windows (window openings only found at east end) replaced with louver vents. Materials – partially retained, replacement doors and windows. Workmanship – partially retained, replacement doors and windows. Feeling – partially retained, alterations and setting changes have reduced the expression of historic sense. Association – partially retained, conveyance of historic character is reduced.

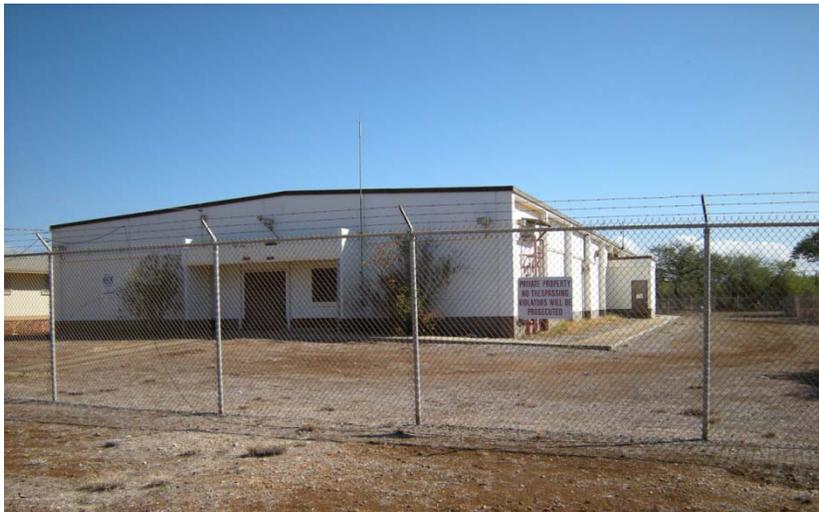
Facility 1767

Integrity Location – retained. Setting – partially retained. Design, Materials, Workmanship – partially retained, some windows & doors replaced/ removed. Feeling, Association – partially retained.

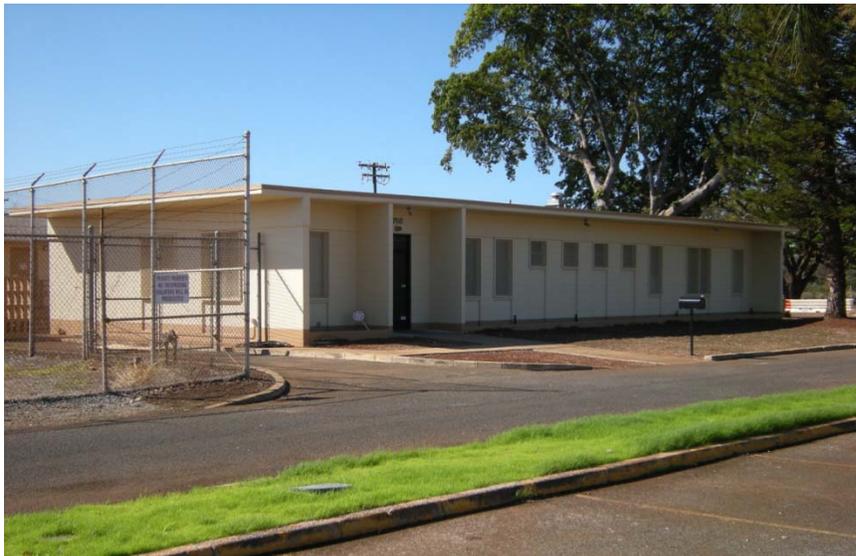
Facility 1768

Integrity Location – retained. Setting – partially retained. Design, Materials, Workmanship – partially retained, some windows & doors replaced/ removed. Feeling, Association – partially retained.

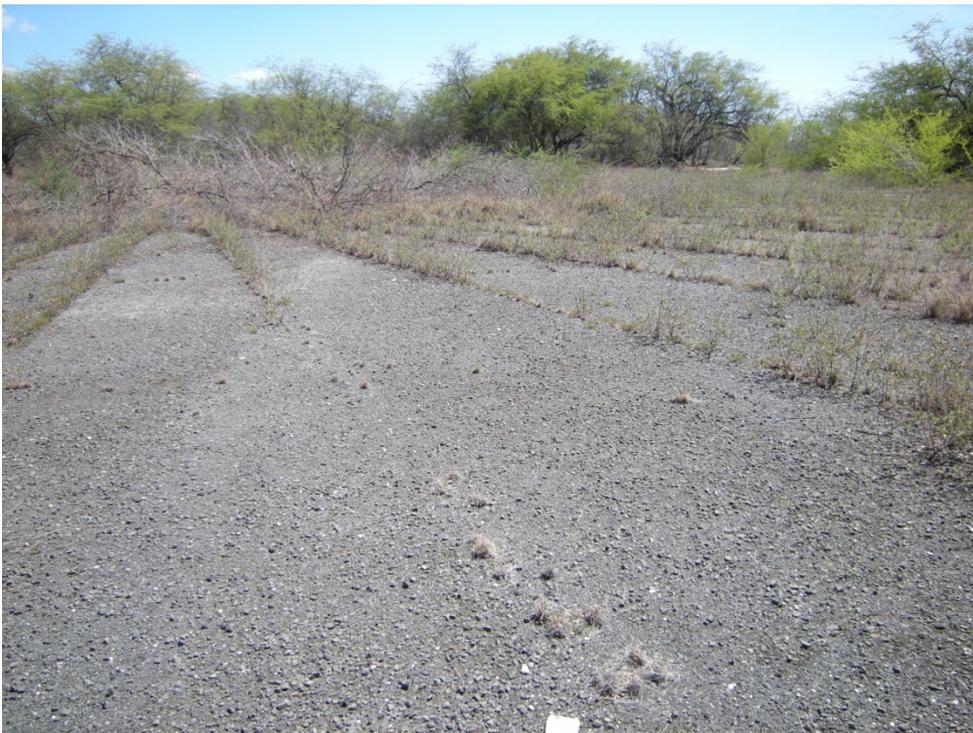
Circular feature

Integrity Appears to have retained integrity of location. Other aspects of integrity appear not retained due to partial nature of this feature.

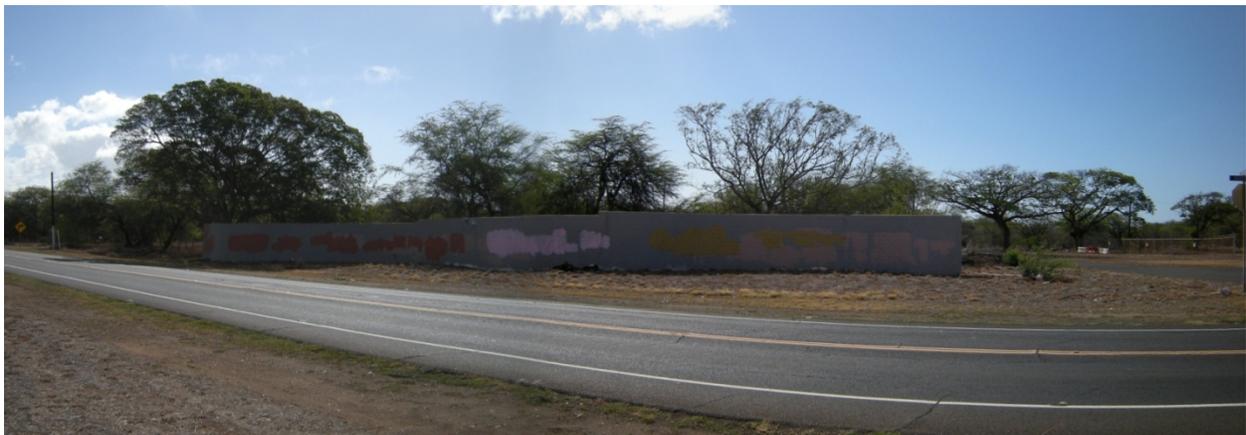
CMU wall

Integrity Location – retained. Setting - not retained, vegetation growth and demolition of surrounding buildings. Design, Materials, Workmanship – partially retained, the wall originally extended about 120' further eastward. Feeling, Association – partially retained, reduced expression of historic sense and the conveyance of historic character.

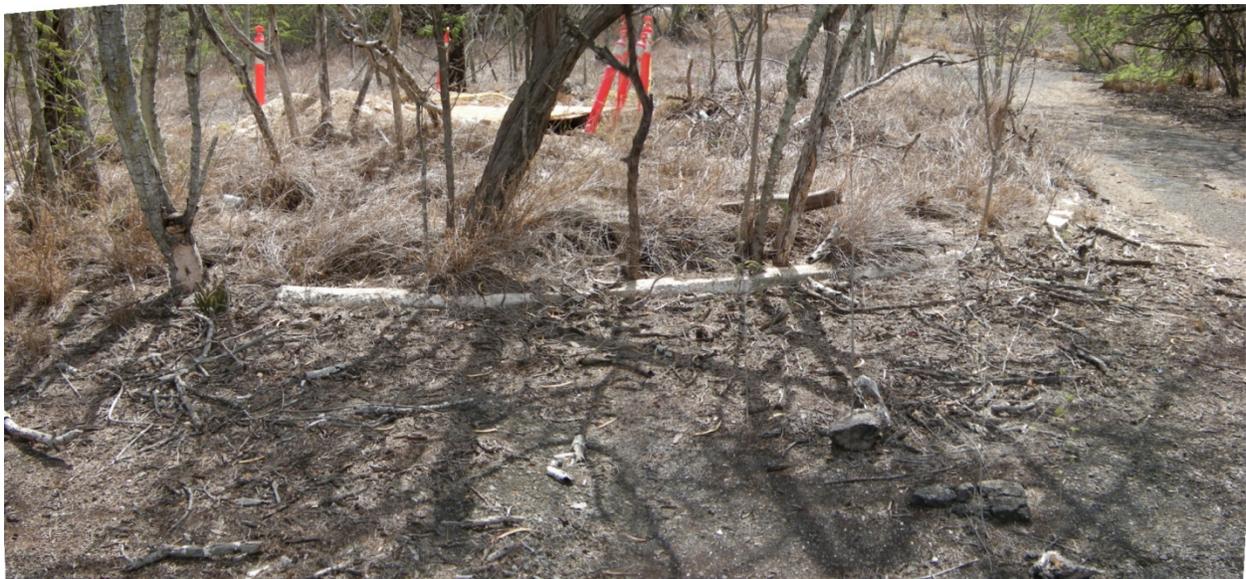
Concrete curb

Integrity Location – retained. Setting - not retained, vegetation growth and demolition of surrounding buildings. Design, Materials, Workmanship – retained, the curb appears intact. Feeling, Association – partially retained, degraded setting has interfered with the expression of historic sense and the conveyance of historic character.

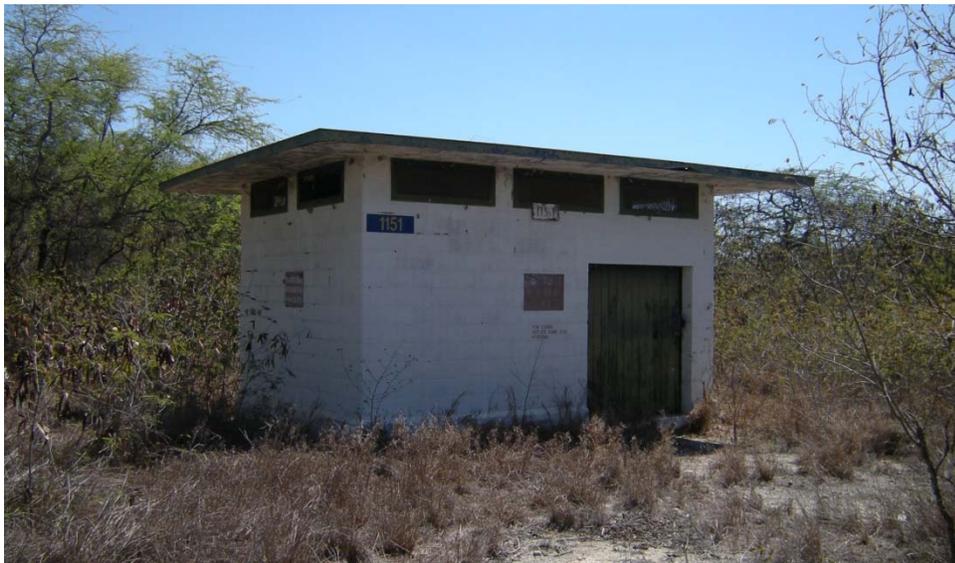
Facility 1151

Integrity Location – retained. Setting – partially retained, growth of vegetation reduces integrity of setting. Design, Materials, Workmanship – retained. Feeling, Association – partially retained.

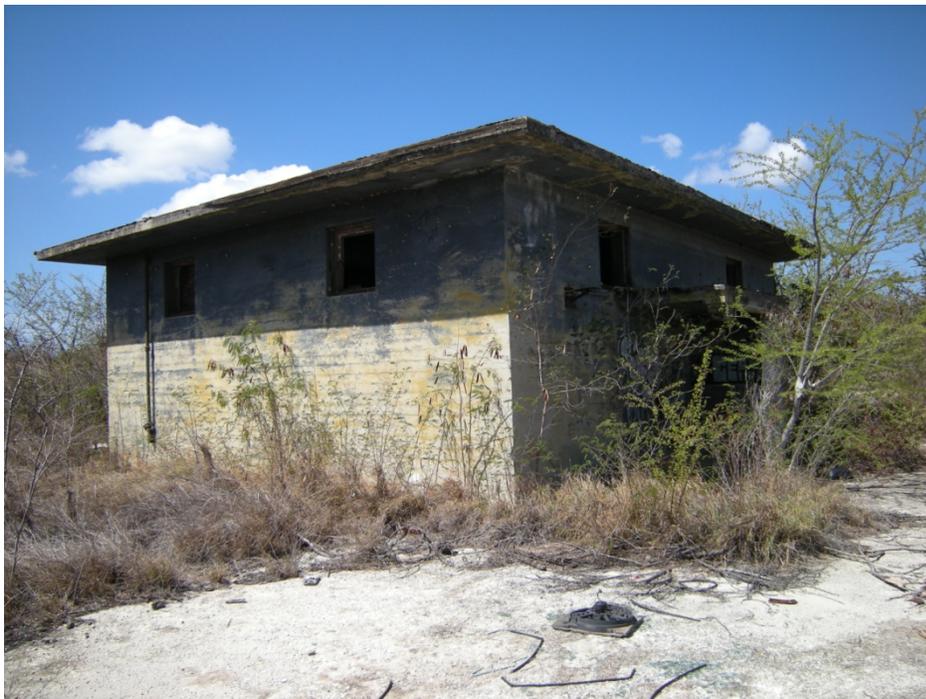
Facility 1327

Integrity Location – retained. Setting – partially retained, removal of buildings and growth of vegetation reduce integrity of setting. Design, Materials, Workmanship – retained. Feeling, Association – partially retained.

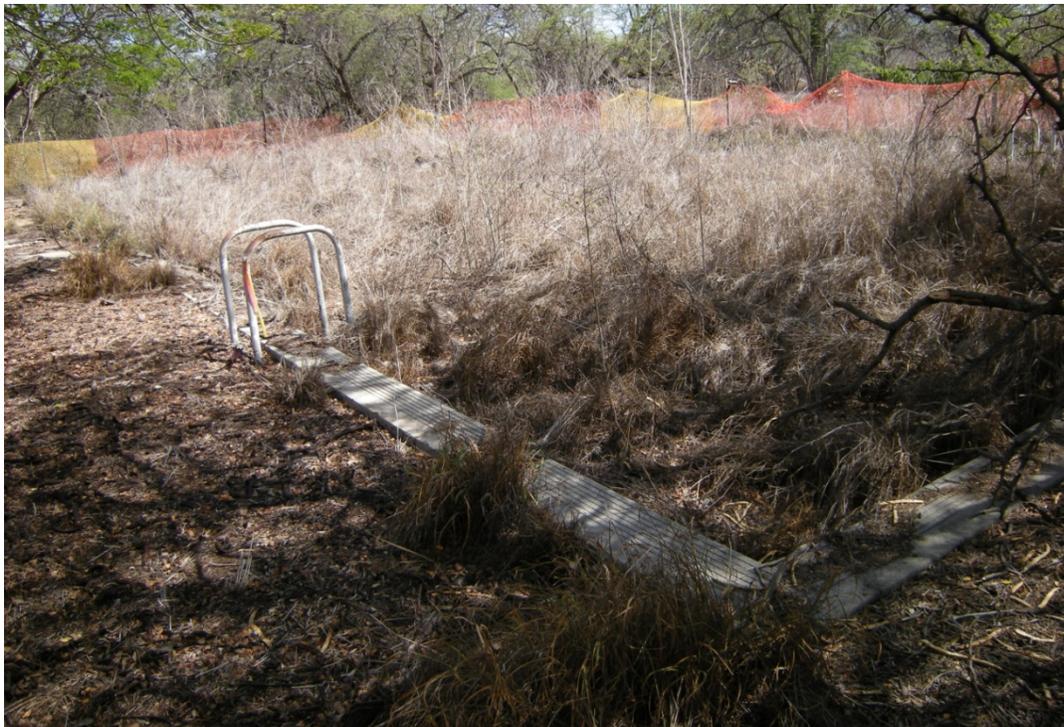
Facility S152

Integrity Location – retained. Setting - not retained, vegetation growth and demolition of surrounding buildings. Design, Materials, Workmanship – retained, the swimming pool structure appears intact. Feeling, Association – partially retained, degraded setting has interfered with the expression of historic sense and the conveyance of historic character.

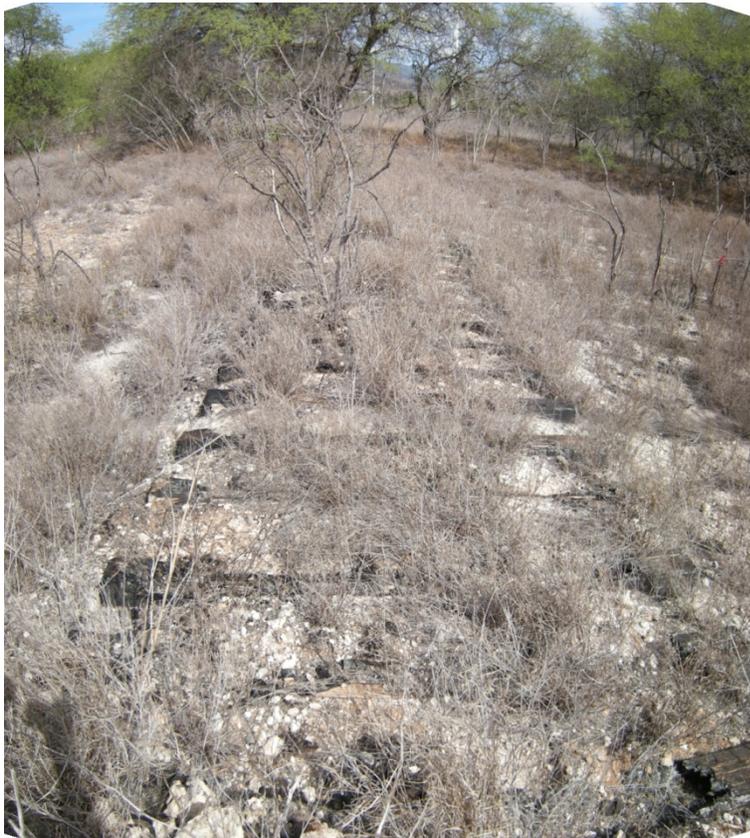
Railroad grade & tie remains

Integrity Location – retained. Other aspects of integrity appear not retained due to partial nature of this feature, no metal portions remain.

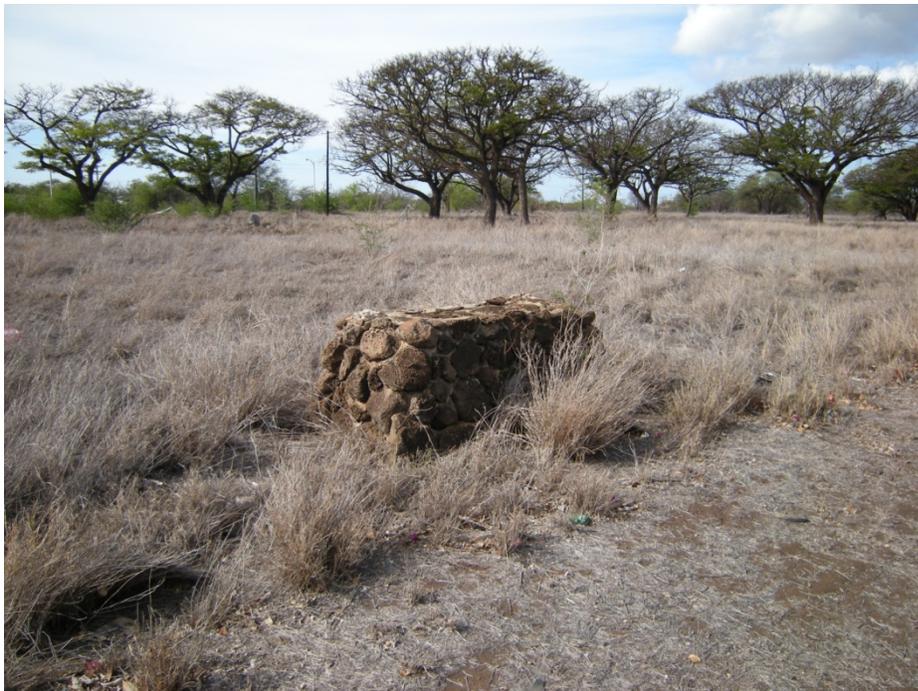
Sign Base

Integrity Location – retained. Setting - not retained, removed signage, vegetation growth and demolition of surrounding buildings. Design, Materials, Workmanship – partially retained, the removal of signage lowers integrity. Feeling, Association – partially retained, removed signage and degraded setting has interfered with the expression of historic sense and the conveyance of historic character.
