**Overview of Testing Results for Lead in Drinking Water  
and Corrective Actions for  
NSA Hampton Roads, Portsmouth Annex Child Wait Center/CDC (Building 249)**

Priority Areas Lead Testing and Corrective Actions (September 2014)  
NSA Hampton Roads, Portsmouth Annex, Child Wait Center  
Building 249

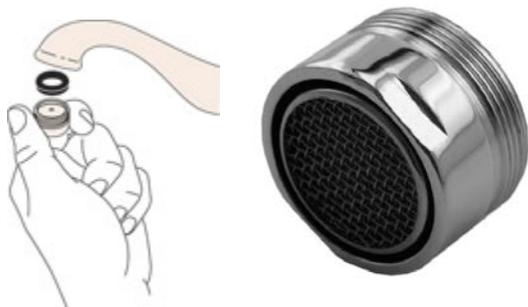
The outlet that exceeded the EPA recommended level of 20 ppb was at a kitchen sink located in Room 186, which tested at 22 ppb. This outlet was occasionally used for food preparation and dishwashing. Follow-up sampling at this outlet was conducted after removing the faucet aerator; retesting showed that the sink faucet in Room 186 was below the EPA-recommended level. A **faucet aerator** (or tap aerator) is often found at the tip of modern indoor water faucets. Without an aerator, water usually flows out of a faucet as one big stream. An aerator spreads this stream into many little droplets, which helps save water and reduce splashing. However, the aerator and screen can trap debris which can accumulate lead.

**After removing the faucet aerators, retesting showed that the sink faucet in Room 186 was below the EPA-recommended level.**

- If the lead concentration of the 30 second flush sample resulted in lower than 20 ppb lead, the aerator was the source of lead and the outlet can be used for drinking if the aerator is cleaned or replaced. ***The sink in Room 186 fits in this category.***
- If the lead concentration of the resampled first draw (but not the follow up 30 second flush) was greater than 20 ppb, the fixture was the source of lead. These fixtures can be

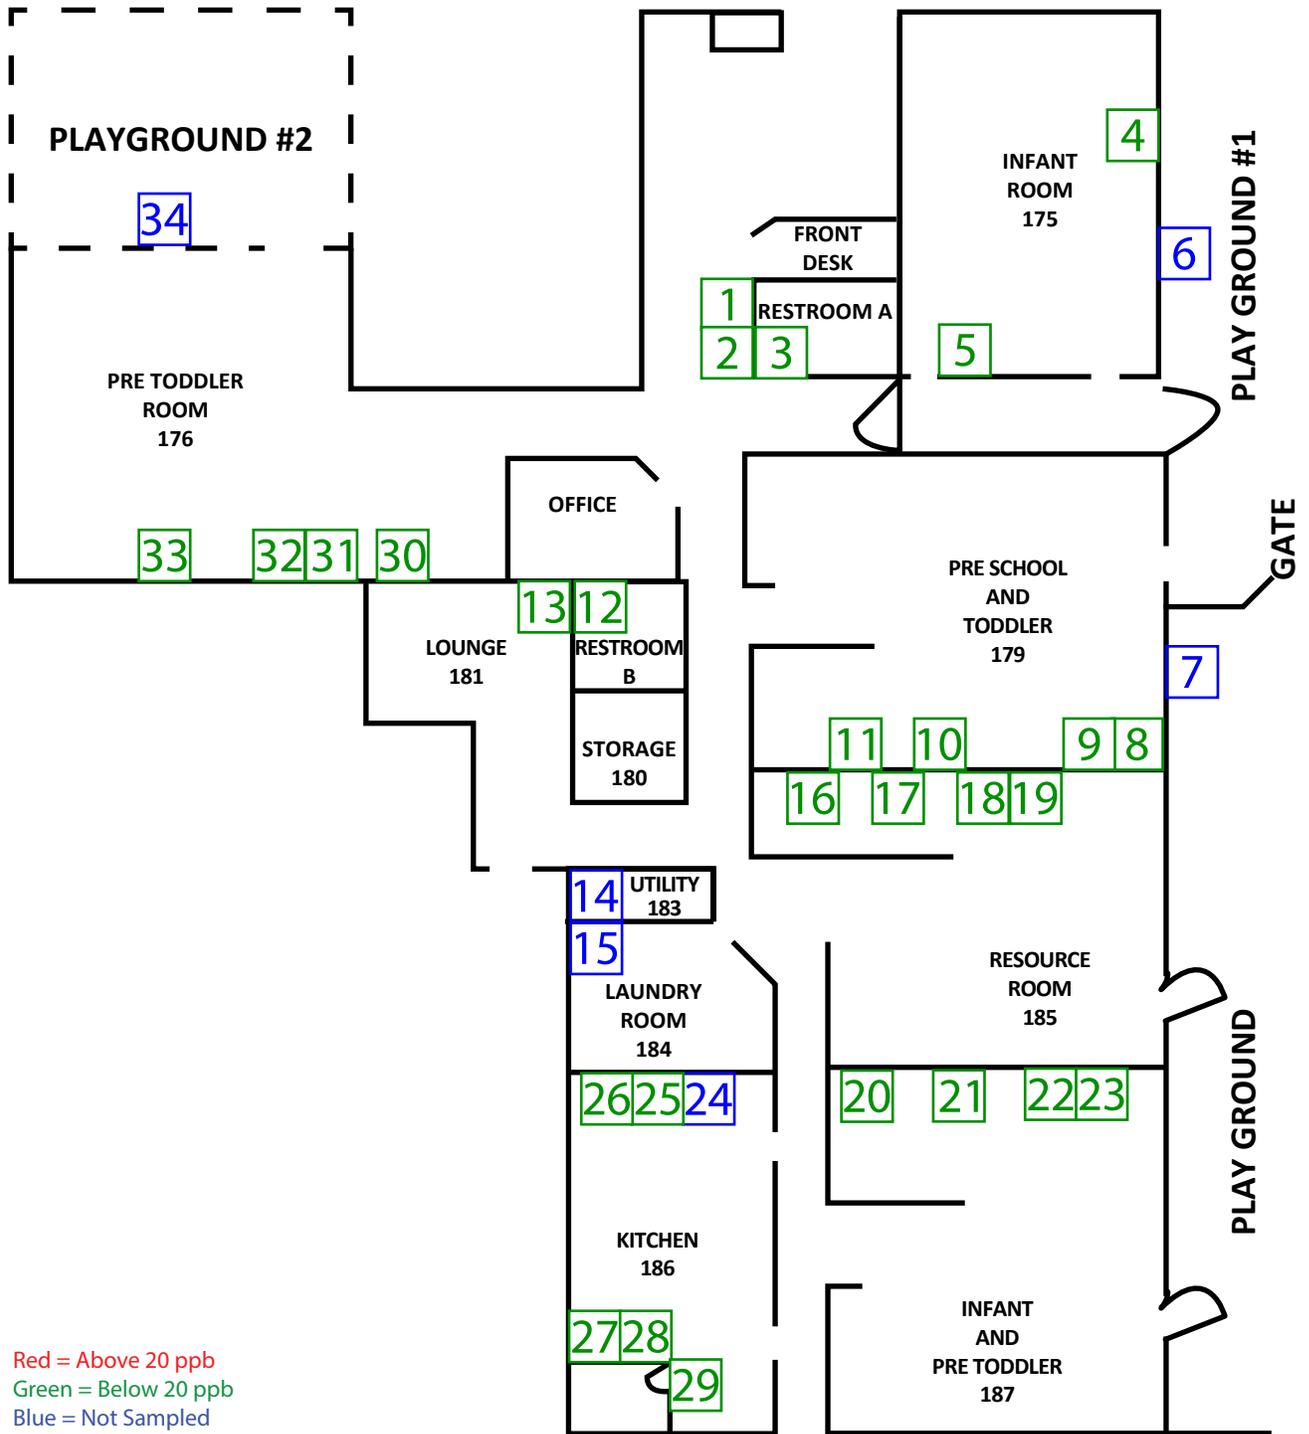
FRONT ENTRANCE

A floor plan of the Portsmouth Annex Child Wait Center/CDC has also been included to show the location for the fixture that exceeded 20 ppb.

Red = Above 20 ppb  
Green = Below 20 ppb  
Blue = Not Sampled
