## Testing Results for Lead in Drinking Water for *SUBASENLON* Youth Center

**NAVY YOUTH CENTER ADDITION DRINKING WATER TESTING**  
**29 HICKORY DRIVE, GROTON, CT 06340**  
**DECEMBER 2013/JANUARY 2014/SEPTEMBER 2014**

NAVY YOUTH CENTER DRINKING WATER TESTING  
 29 HICKORY DRIVE, GROTON, CT 06340  
 SEPTEMBER 2014

NAVY PRIORITY AREA WATER TESTING PROGRAM  
YOUTH CENTER ADDITION (CH905)  
SUBMARINE BASE NEW LONDON  
SAMPLING LOCATIONS

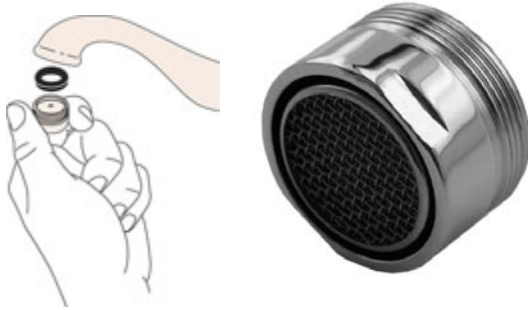
Youth Center staff routinely check and clean aerators throughout the facility to ensure that the water remains safe. A **faucet aerator** (or tap aerator) is often found at the tip of modern indoor water faucets. Without an aerator, water usually flows out of a faucet as one big stream. An aerator spreads this stream into many little droplets, which helps save water and reduce splashing. However, the aerator and screen can trap debris which can accumulate lead. Consequently, it is very important to ensure that the aerators are checked and kept clean.
