Corrected Final
Environmental Conditions of Property,
Environmental Site Investigation of
Proposed Wind Turbine Sites

Naval Station Newport
Newport, Rhode Island

February 2013

CH2MHILL / CLARK•NEXSEN
Architecture & Engineering
(a joint venture)

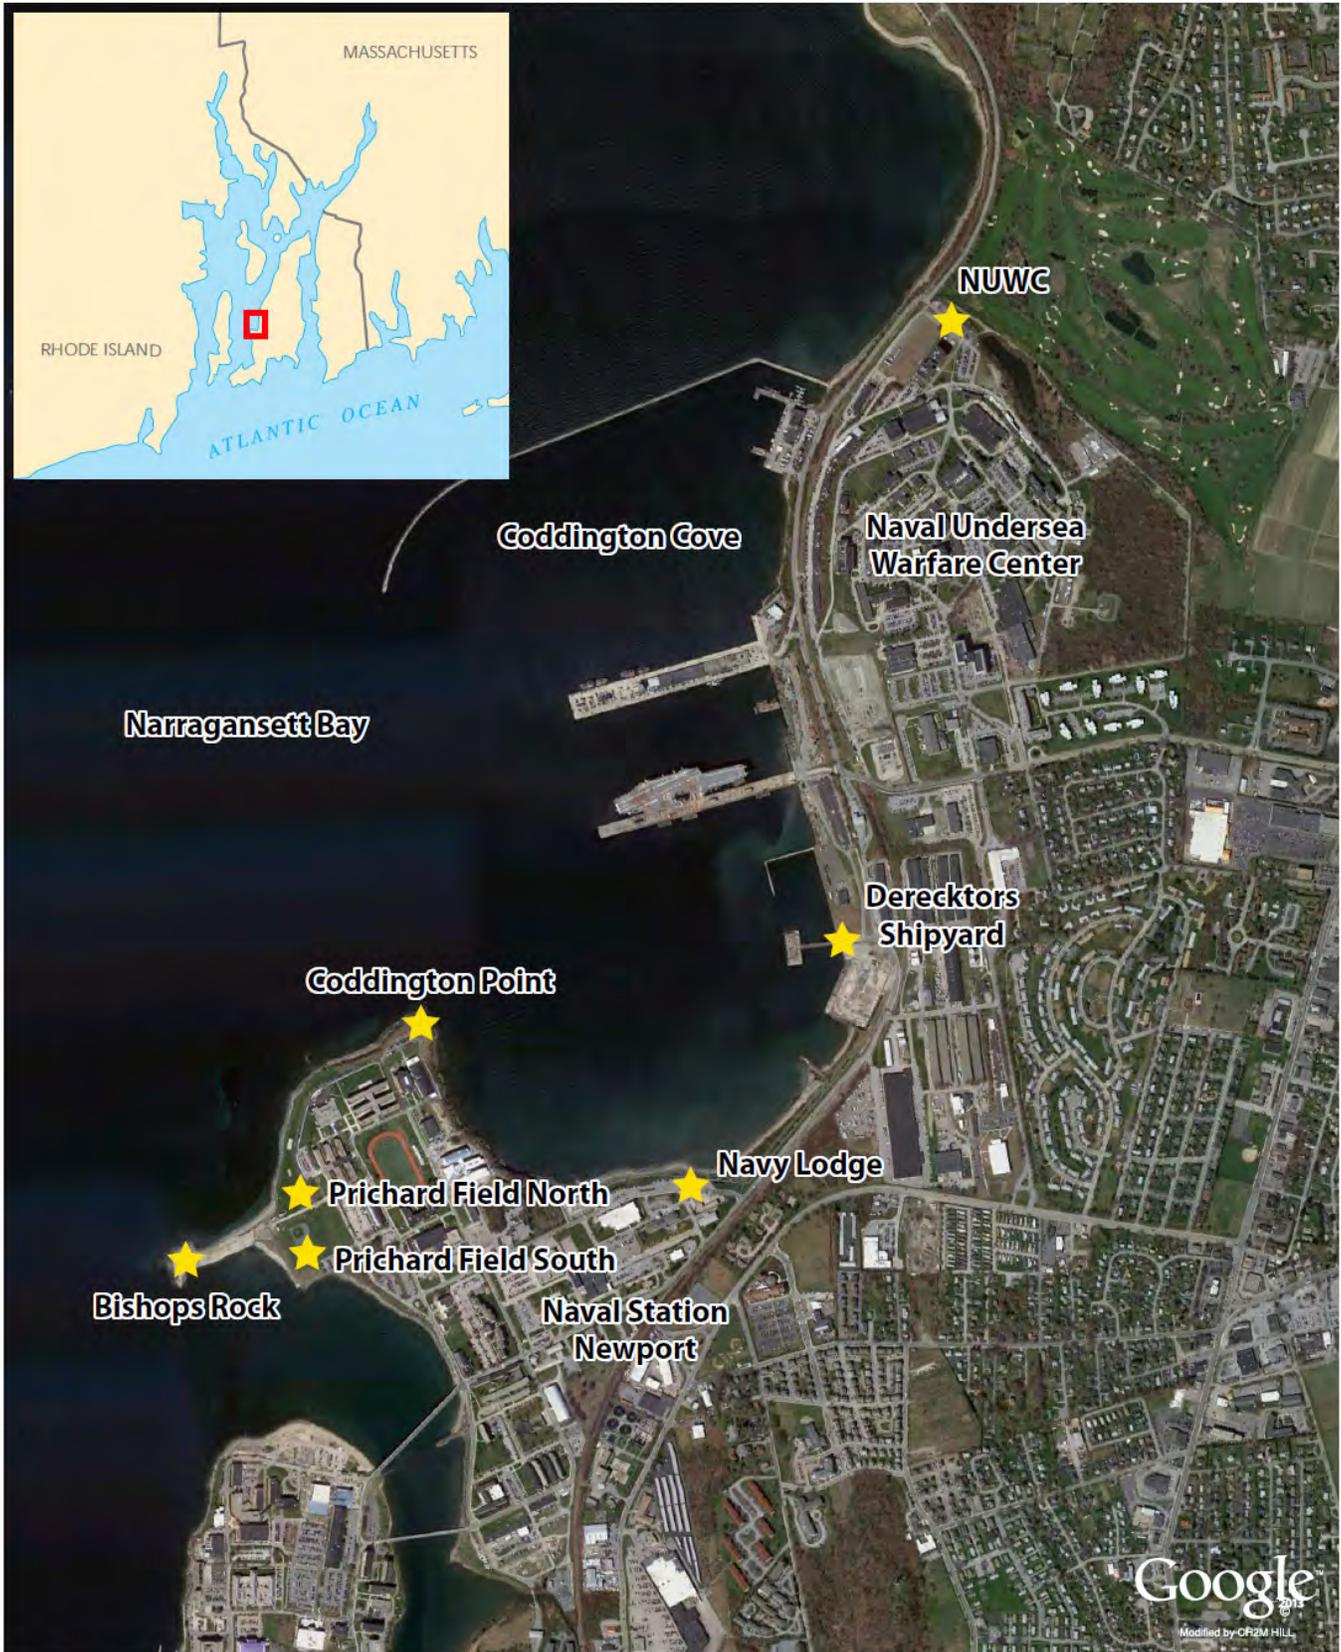
FIGURE 1

Proposed Wind Turbine Sites at NAVSTA Newport

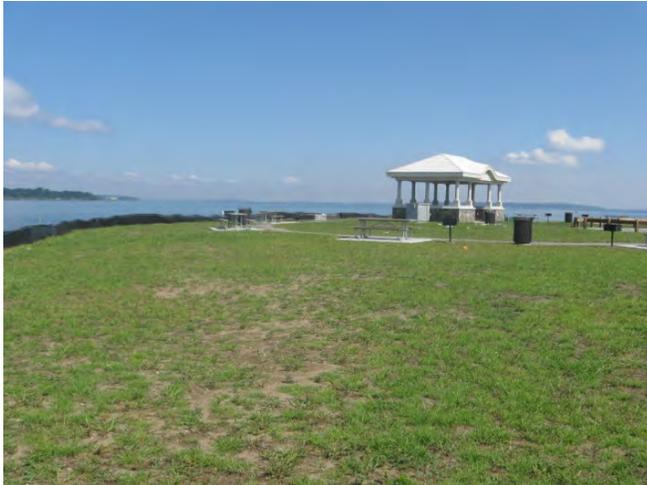
Bishops Rock looking to the north

Bishops Rock is located at the tip of a jetty at the end of Barschow Street. The site includes a small gazebo and roundabout gravel driveway.

- No easements or rights-of-way are located on the parcel.
- Soil excavated from the site may be classified as hazardous due to elevated toxicity characteristic leaching procedure (TCLP) lead and asbestos concentrations based on sample results. Additionally, interview notes indicated construction rubble containing asbestos and lead were part of the fill used to develop the parcel.
- Worker exposure to elevated lead and asbestos in the soil will need to be addressed before any future construction activities are conducted on the parcel.

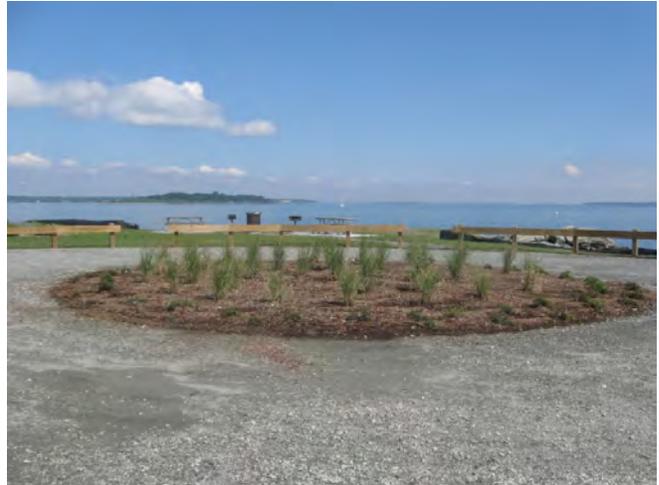
Bishops Rock roundabout driveway

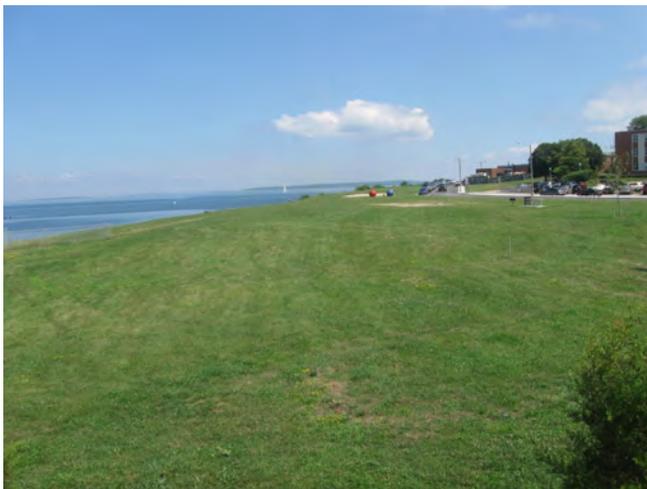
Prichard Field North looking to the north

Prichard Field North is the area bounded by Barschow Street to the South, Copodanno Drive to the east, and the bay to the northwest. The site has had numerous structures on it in the past and currently includes grassy areas with walkways and a sanitary sewer lift station that includes an exterior concrete platform supporting a backup generator in the southwest corner.

- Soil excavated from the site may be classified as hazardous due to the potential of encountering buried asbestos materials and debris painted with lead-based paint. Interview notes indicated construction rubble containing asbestos and lead were part of the fill used to develop the parcel.
- Worker exposure to elevated lead and asbestos in the soil will need to be addressed before any future construction activities are conducted on the parcel.

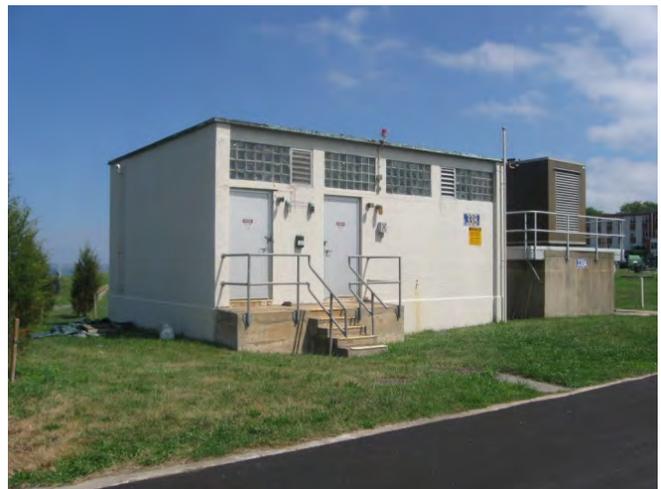
Prichard Field North utility building

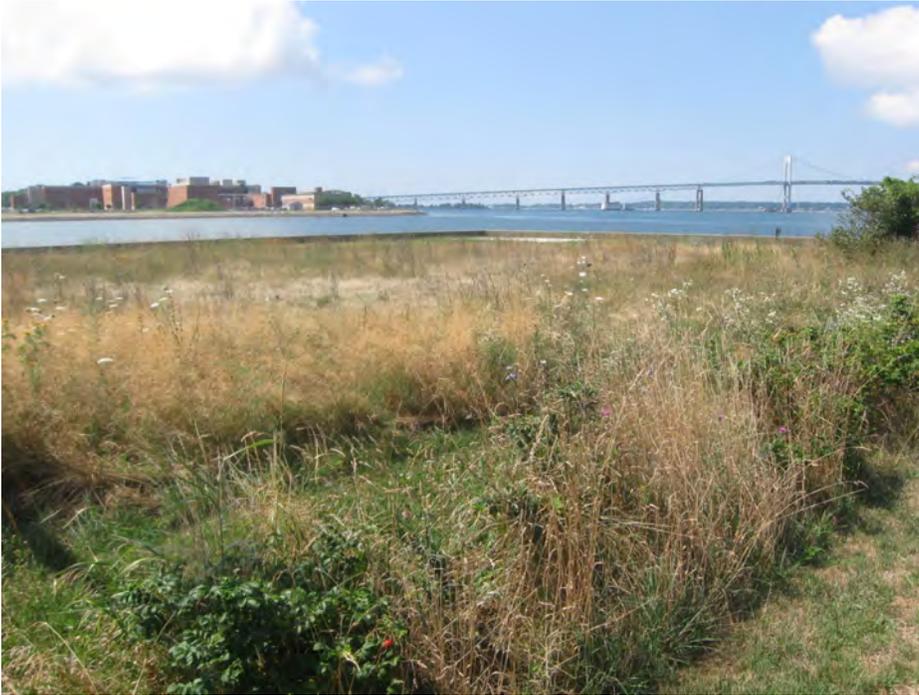
Prichard Field South looking to the south

Prichard Field South includes a baseball field to the north and the bay to the south. A concrete retaining wall bounds the southern portion and the remainder is covered by a running path, grassed areas, and a concrete pad.

- No easements or rights-of-way are located on the parcel.
- Soil excavated from the site may be classified as hazardous due to the potential of encountering buried asbestos materials and debris painted with lead-based paint. Interview notes indicated construction rubble containing asbestos and lead were part of the fill used to develop the parcel.
- Worker exposure to elevated lead and asbestos in the soil will need to be addressed before any future construction activities are conducted on the parcel.

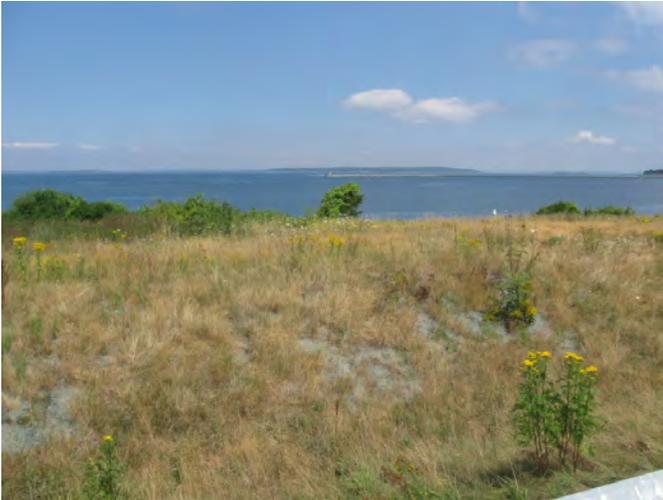
Coddington Point looking to the northeast

Coddington Point is on the western tip of Coddington Cove. A drainage swale runs along the southern perimeter of the site and the remainder is covered by grassed areas and a running path.

- No easements or rights-of-way are located on the parcel.
- Soil excavated from the site may be classified as hazardous due to asbestos and lead concentrations. Interview notes indicated construction rubble containing asbestos and lead-based paint were part of the fill used to develop the parcel.
- Worker exposure to elevated lead and asbestos in the soil will need to be addressed before any future construction activities are conducted on the parcel.

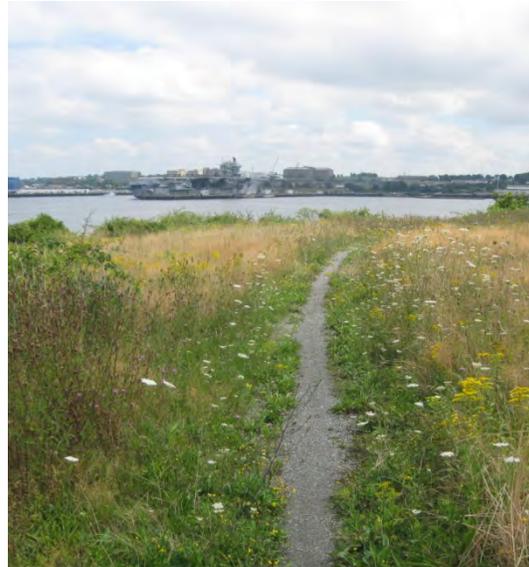
Coddington Point running path

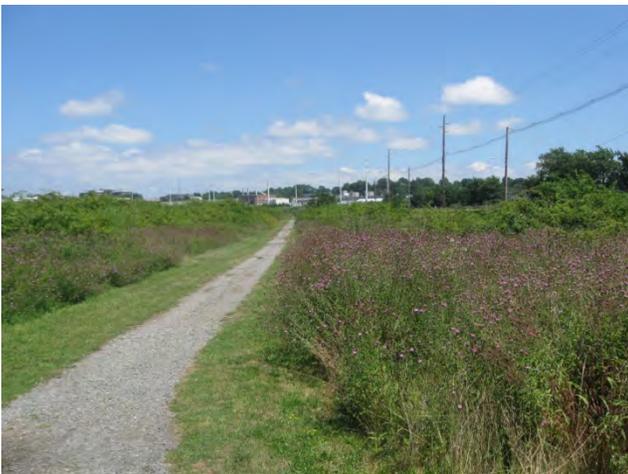
Navy Lodge looking east

Navy Lodge lies in between Whipple Street and Coddington Cove. An aboveground steam pipe runs along the perimeter of the site. The remainder of the site is covered by grassed areas and a running path.

- Two anomalies were identified during the ground-penetrating radar survey that may have an impact on wind turbine construction activities.
- Though unlikely, the potential exists for encountering contaminated soils, particularly petroleum, lubricant, and oil-impacted, as a result of historical leaking tanks upgradient of the parcel.

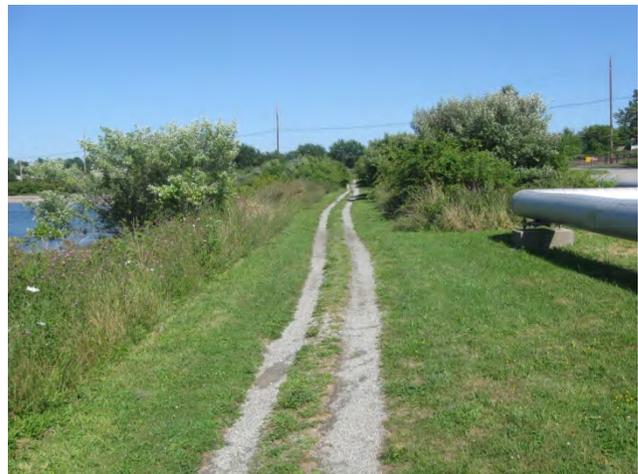
Navy Lodge path and steam line

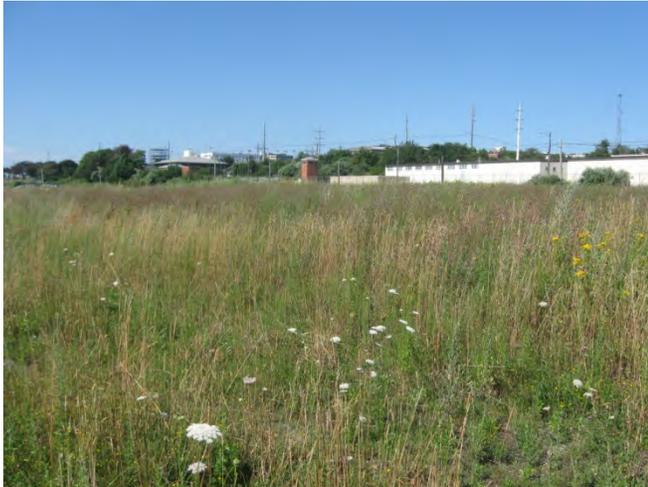
Derecktor looking northeast

The Derecktor site is located between Burma Road to the east and Coddington Cove to the west. The site includes paved and grassed areas.

- No easements or rights-of-way are located on the parcel.
- Soil excavated from the site may be classified as hazardous due to the potential of encountering contaminants.
- The parcel is part of a National Priorities List (NPL) site with an ongoing remedial action. Construction activities will require coordination with the investigation.
- Worker exposure to elevated polycyclic aromatic hydrocarbons (PAHs), polychlorinated biphenyls (PCBs), and metals in the soil will need to be addressed before any future construction activities are conducted on the parcel.

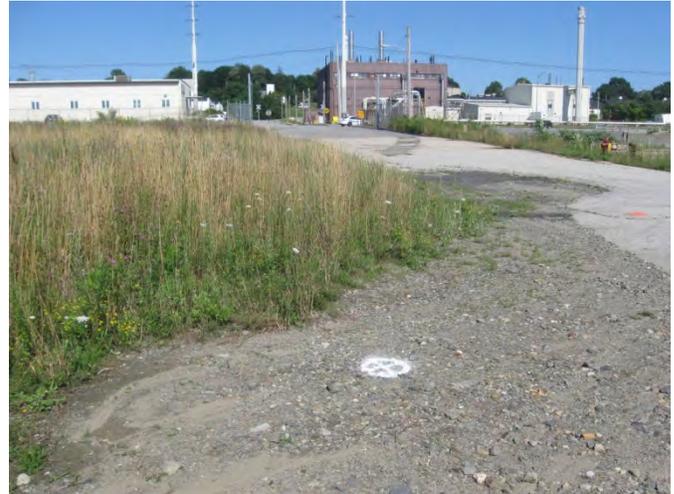
Derecktor looking toward paved area

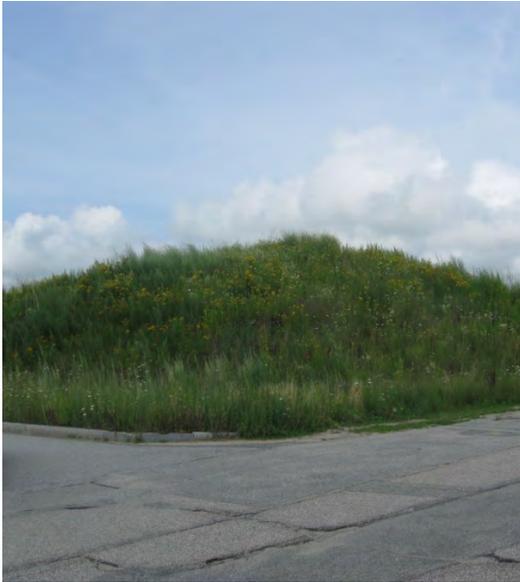
NUWC looking northeast

NUWC is located on the northern limits of the Naval Undersea Warfare Center property with access roads to the west and south and a small pond to the north and east. The site is mainly a soil stockpile.

- No easements or rights-of-way are located on the parcel.
- The available information did not identify any current or historical use of hazardous or petroleum products on the parcel.
- The available information did not identify any spills or hazardous material disposal on the parcel. Soil excavated from construction activities on the Base are stockpiled on the parcel.
- There is no documentation of contaminated soil being placed in the stock pile. However, soil placed there could have been associated with the removal of excess excavated soil from contaminated areas of the Base.

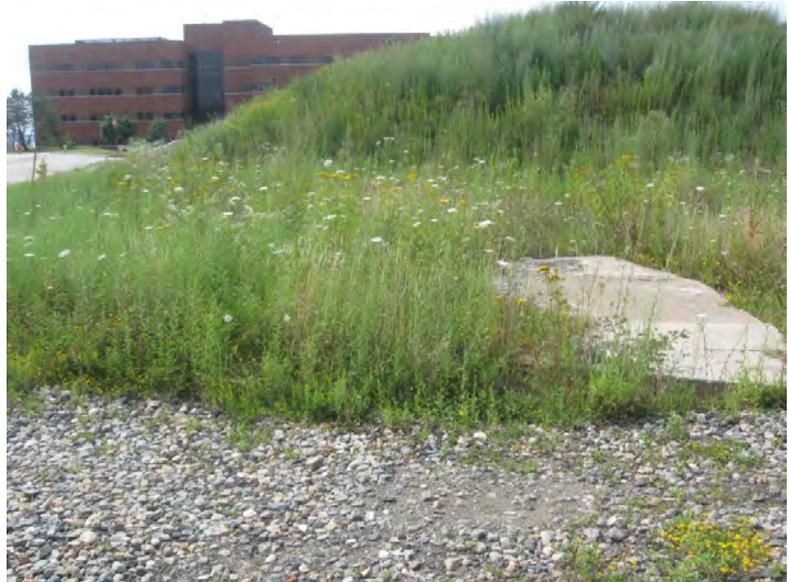
NUWC concrete structure
