## Munitions Response Program Preliminary Site Inspection

Naval Weapons Station Seal Beach,  
Seal Beach, CA

August 2008

**DRAFT  
PRELIMINARY SITE INSPECTION  
NAVAL WEAPONS STATION SEAL BEACH  
SEAL BEACH, CALIFORNIA**

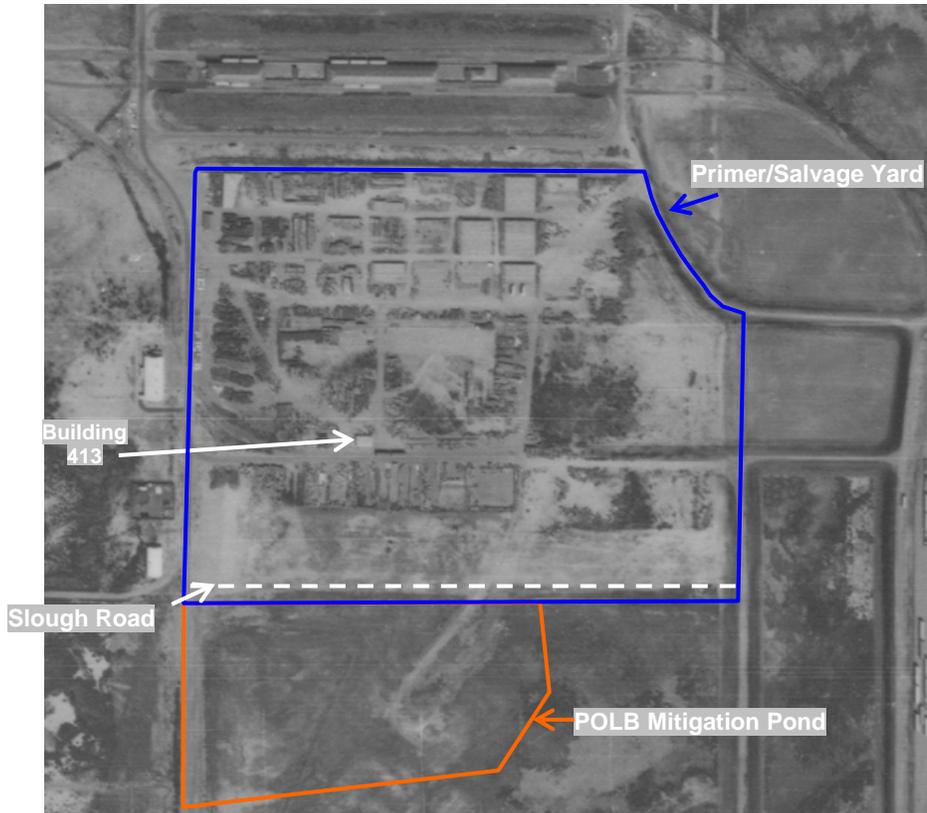
**Figure 5.1-1: 1965 aerial photograph showing extent of Primer/Salvage Yard and the POLB Mitigation Pond**

The Primer/Salvage Yard (IRP Site 16) boundaries initially were defined in the Installation Assessment Survey (IAS) (NEESA, 1985) (Figure 5.1-2). As evaluated in this PSI, the Primer/Salvage Yard is roughly 46 acres, as shown in Map 5.1-2 and Figure 5.1-1. The site includes an area south of Bolsa Avenue, east of 7th Street, and west of 9th Street and the Marshalling Yard. The southern boundary for the site is marked by the edge of the north bank of the POLB Mitigation Pond.

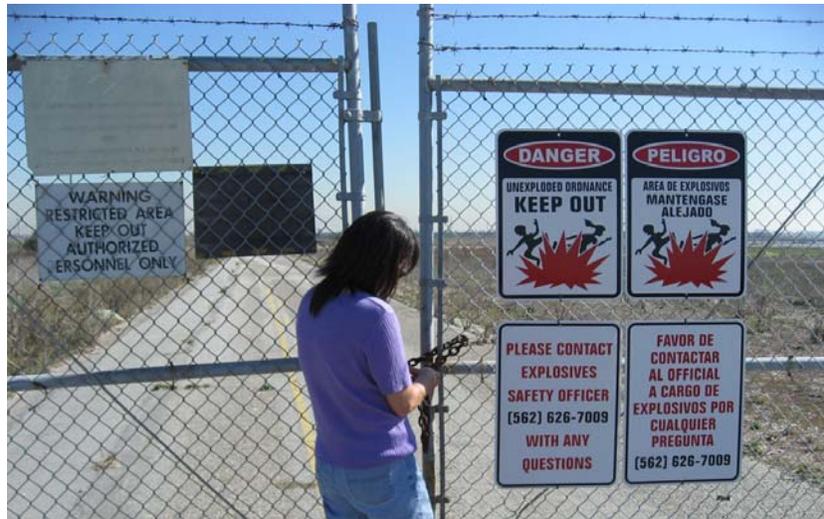
The 24-acre fenced portion of the Primer/Salvage Yard has a locked gate (Figure 5.1-3) and was predominantly surfaced with decomposed asphalt or overlain by a thin layer of gravel. The unfenced area of the site was unpaved and maintained as unused land. The unpaved portions of the site consisted of sandy flat habitat that was vegetated with low and sparse grass with some areas devoid of vegetation. The only structure on site was a broken 1-ton scale (Figure 5.1-4). Two monitoring wells were observed just north of Slough Road.

**Figure 5.1-3: View of the locked gate entering the fenced yard, facing east (Photograph taken during the November 2007 on-site visual survey.)**

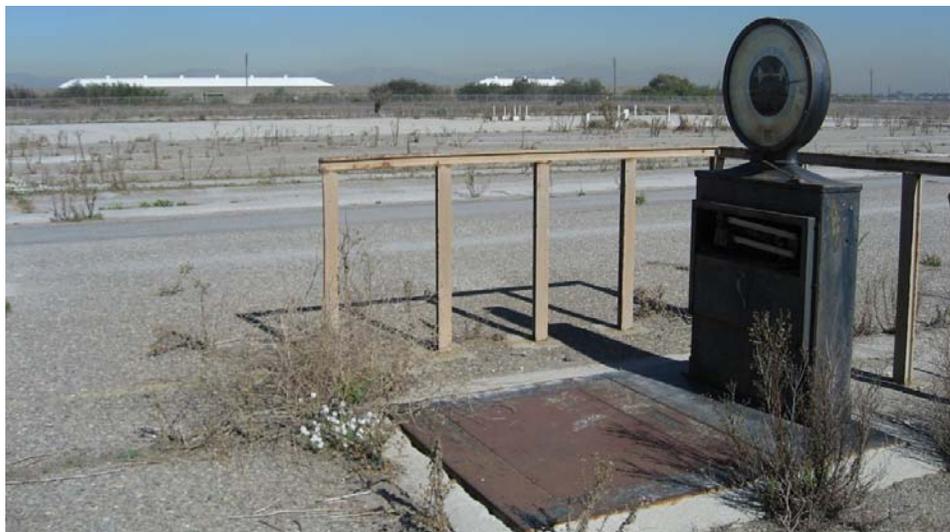
**Figure 5.1-4: View of the paved area inside the fenced yard looking north. Scale is likely Building 412 (adjacent to Building 413). (Photograph taken during the November 2007 on-site visual survey.)**

A broken scale is located in the currently fenced area of the Primer/Salvage Yard (Figure 5.1-4). A blockers and bracers shop is located nearby to the west.

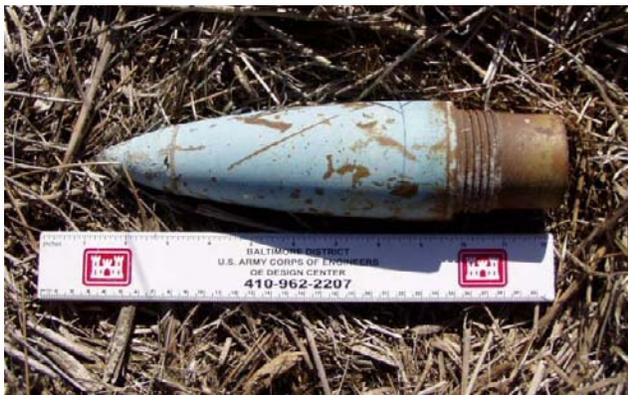
Various MEC related items were noted inside the fenced yard. MEC related items identified during the site reconnaissance included 1) a 2.75-inch high explosive style warhead, colored blue, with inert filling; 2) an intact submunition BLU63 T-1 series (baseball size), colored blue; 3) an expended point detonating fuze (PD fuze); and 4) expended powder train time fuzes (PTTFs). In addition, numerous half shells from M30 or M40 series submunitions (golf ball size) and 5.56-mm small arms and .50-caliber casings were found (Figure 5.1-5 through Figure 5.1-10). Additional munitions related items were noted along the northern boundary of the site outside of the fenced portion of the Primer/Salvage Yard.

**Figure 5.1-5: 2.75-Inch practice warhead, colored blue (Photograph taken during the November 2007 on-site visual survey.)**

During the November 2007 site visit, numerous munitions related items were observed (Section 5.1.2). These items were reported to EOD Mobile Unit 3, and a detachment responded with an emergency action on 14 December 2007 that blew in place four MEC items reported as not safe to handle or move (EODC Sonnenberg and EODC Scroggins, 2007; Ms. Tamashiro, pers. comm.).

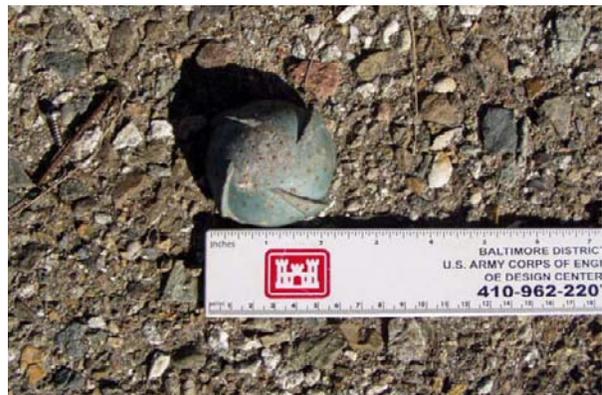
**Figure 5.1-6: BLU-36 (T-1) half hemisphere (Photograph taken during the November 2007 on-site visual survey.)**

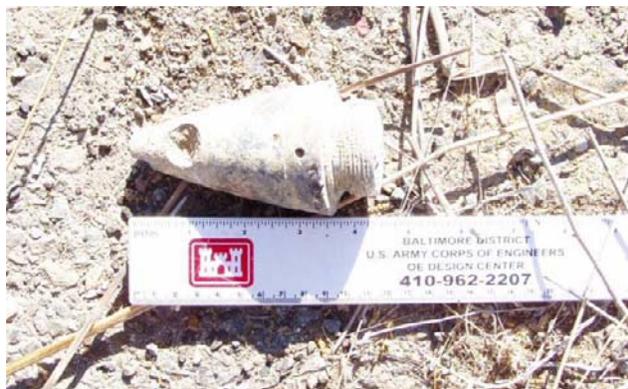
**Figure 5.1-7: Expended PD fuze (Photograph was taken during the November 2007 on-site visual survey.)**

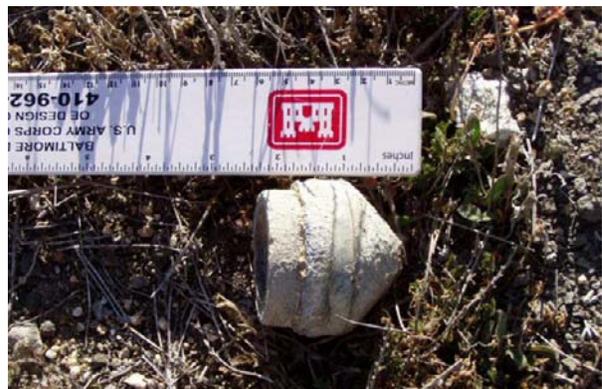
**Figure 5.1-8: Expended PTTF (Photograph was taken during the November 2007 on-site visual survey.)**

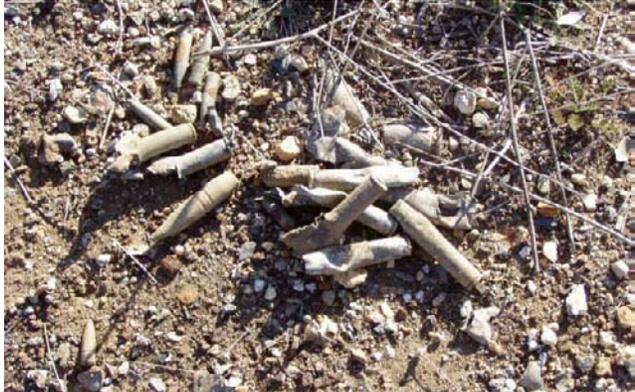
**Figure 5.1-9: 5.56-mm small arms casings**  
(Photograph was taken during the November 2007 on-site visual survey.)

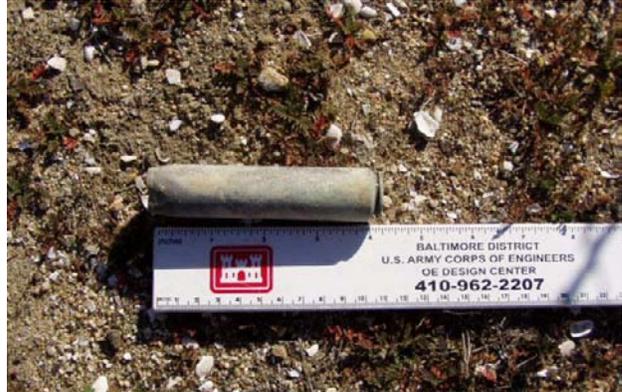
**Figure 5.1-10: 50-caliber cartridge casings**  
(Photograph was taken during the November 2007 on-site visual survey.)

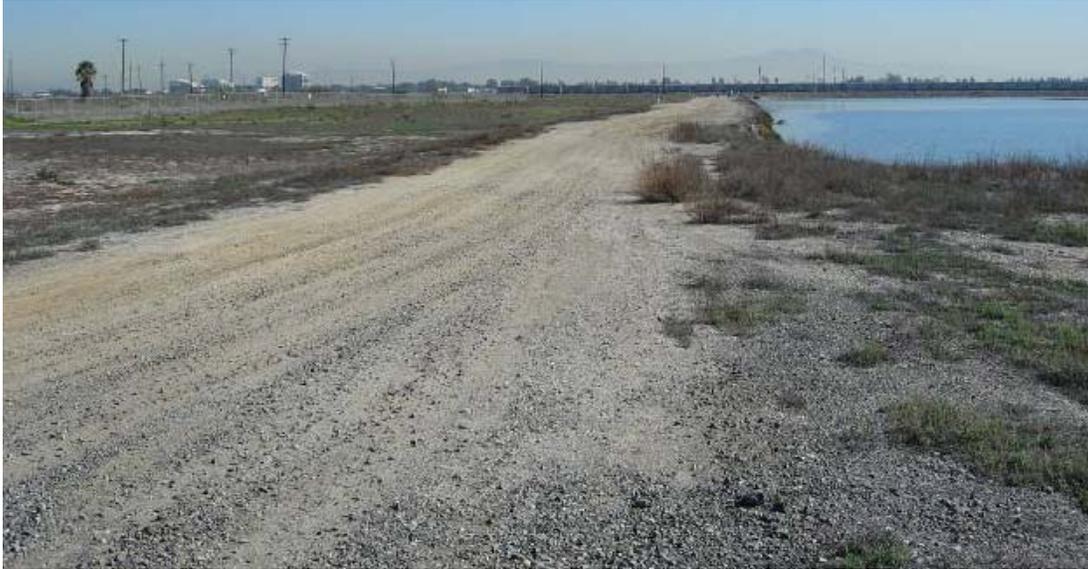
A visual survey of the POLB Mitigation Pond was conducted on 14 and 15 November 2007 (Figure 5.2-1 and Figure 5.2-3). During the visual survey, the following Malcolm Pirnie team members were present: Ms. Caruso (Team Leader), Mr. Schulman, Mr. Storrs (UXOSS), Ms. Gerritzen, and Mr. Asakawa. The following Navy representatives were present during the visual survey: Ms. Tamashiro and Mr. Gordon. The field team conducted the visual survey by walking the entire perimeter of the pond. During the visual survey, the data collection team observed numerous 40-mm cartridge cases sticking out of the north bank of the pond and within the pond along the north and west banks (Figure 5.2-5). The entire perimeter of the POLB Mitigation Pond was walked, and the banks and shallow portions of water were visually surveyed.

**Figure 5.2-3: View the northern bank of the POLB Mitigation Pond**  
(Photograph was taken during the November 2007 on-site visual survey.)

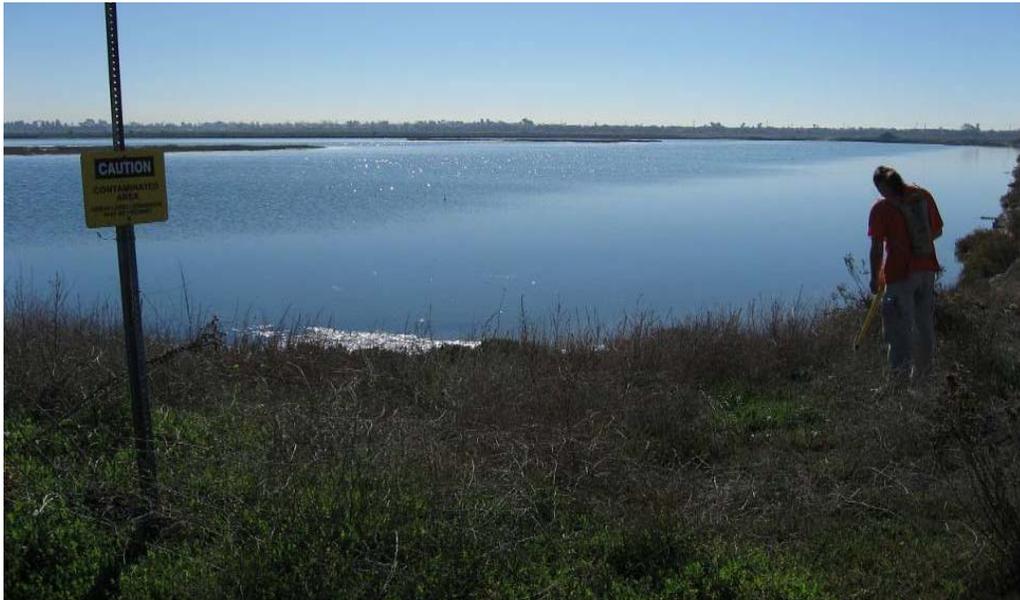
**Figure 5.2-4: View of the POLB Mitigation Pond from the northwest bank,  
facing southeast**  
(Photograph was taken during the November 2007 on-site visual survey.)

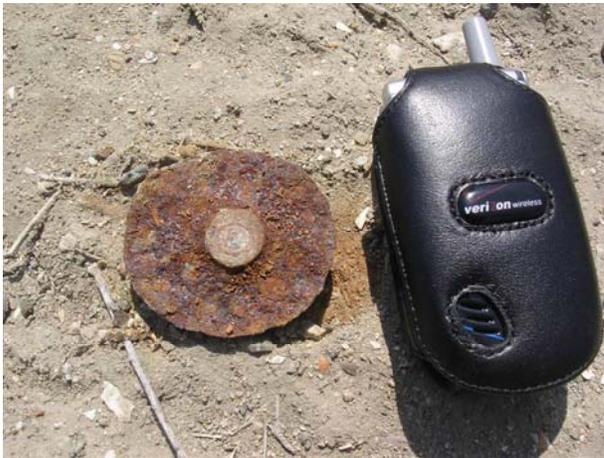
In addition to the November 2007 visual survey, a site reconnaissance was conducted of the POLB Mitigation Pond in September 2007 as part of an Explosives Safety Inspection. During that time, a base plate with likely live primer in it and a partial 20-mm cartridge were observed (Figure 5.2-6; Figure 5.2-7).

**Figure 5.2-6: View of a base plate with a live primer**

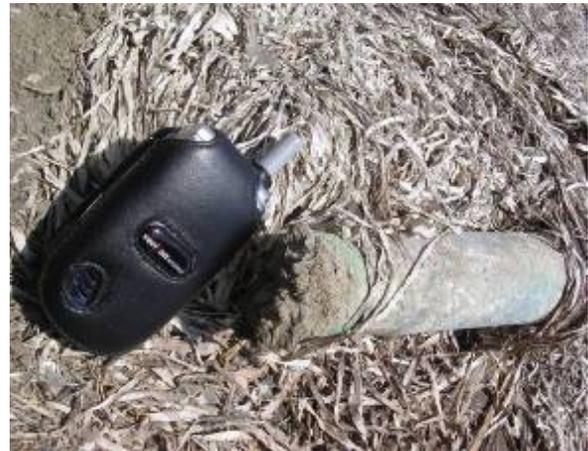
**Figure 5.2-7: Partial 20-mm cartridge**  
(Photograph was taken during September 2007 Explosives Safety Inspection.)

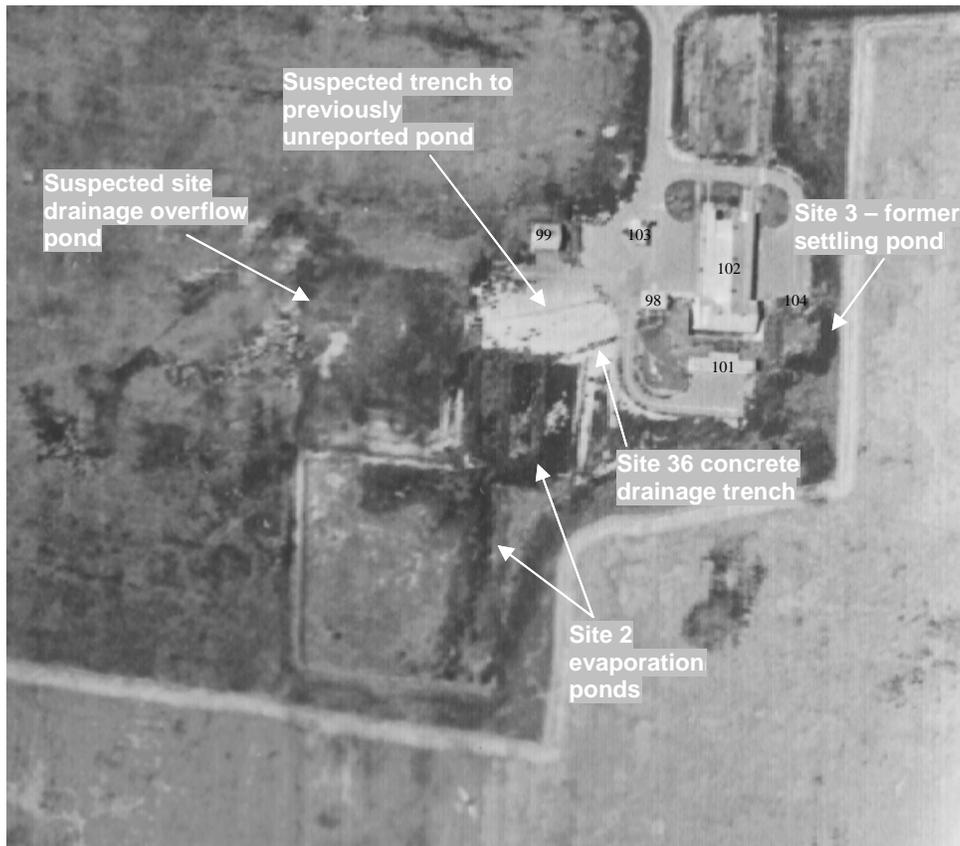
- d) The location of IRP Site 3 was incorrectly determined and sampled (Figure 5.3-3 and Figure 5.3-4).
- e) Soil samples collected from IRP Site 36 were too shallow, as the concrete basin had a concrete floor and was filled with roughly 2 feet of assumed clean fill.
- f) A 4-foot-square pit used for an unknown purpose and filled with earth has not been investigated (Additions to Explosive D Stream Out Shed, Bldg 98, 1958).

**Figure 5.3-4: 1956 aerial photograph showing evaporation ponds and site configuration**

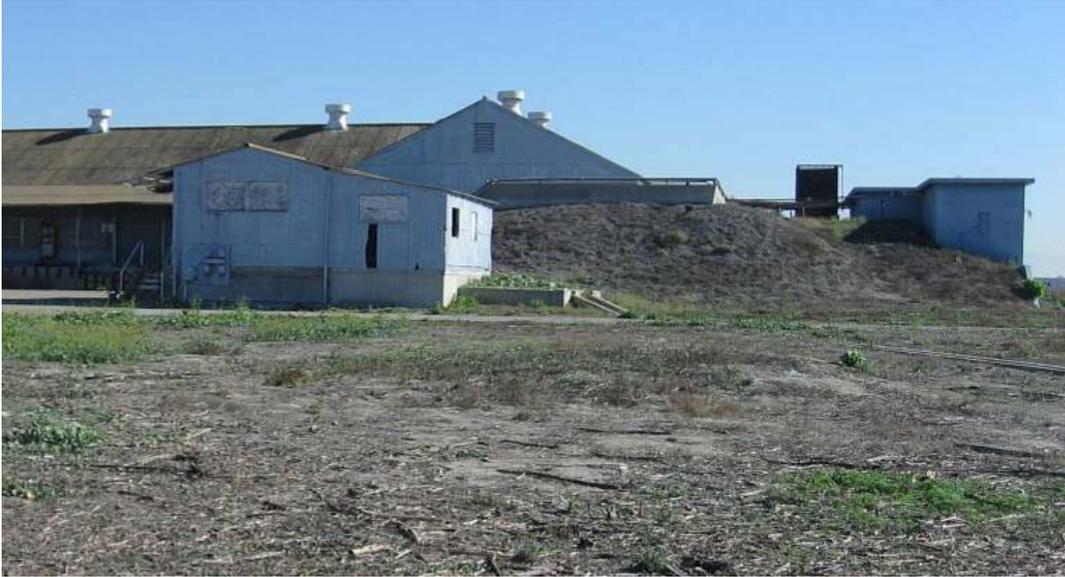
Building 98 is a three-sided corrugated metal shed built on a concrete slab (Figure 5.3-5). Behind Building 98 on the south side was a concrete baffled basin (IRP Site 36) filled with earth (Figure 5.3-6). Buildings 101 and 102 were both single-story with concrete floors. Building 99 formerly housed a generator. Building 103 was labeled for paint/flammable storage, and Building 104 was small locked magazine. None of the buildings were in use, and only Buildings 99 and 101 were unlocked.

**Figure 5.3-5: View of east side of Building 98 with concrete basin on southern side**  
(Photograph was taken during the November 2007 on-site visual survey.)

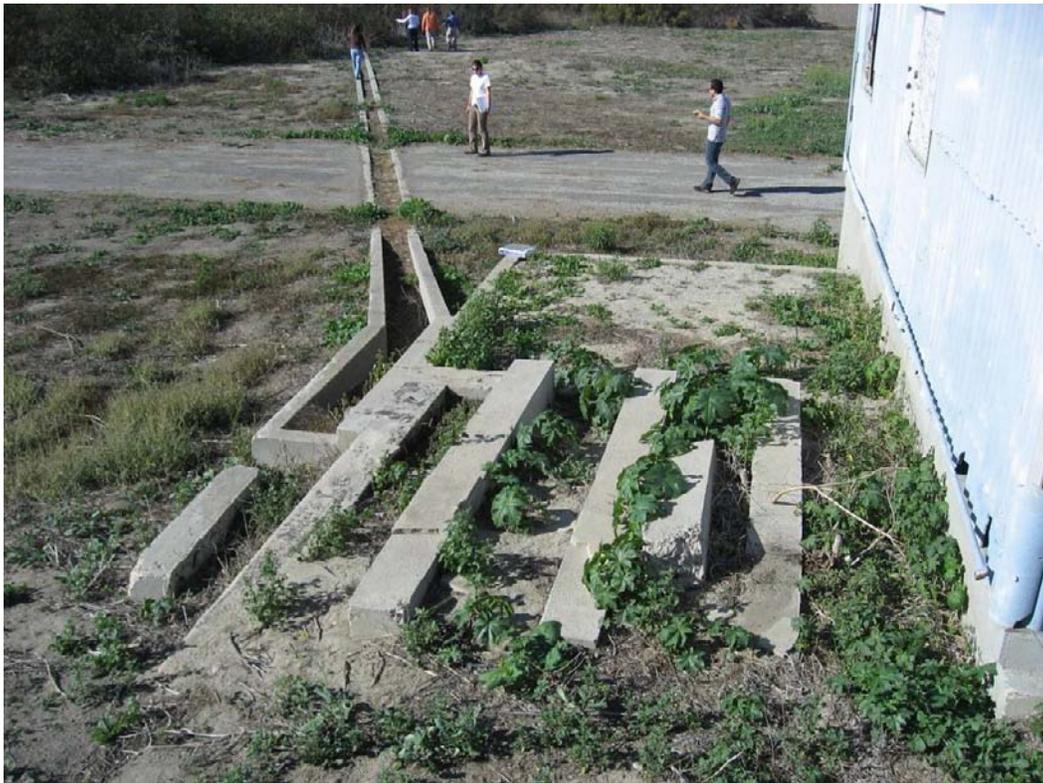
**Figure 5.3-6: View of concrete settling basin and former concrete tank cradles on south side of Building 98. Concrete channel drains to IRP Site 2 evaporation ponds.**  
(Photograph was taken during the November 2007 on-site visual survey.)

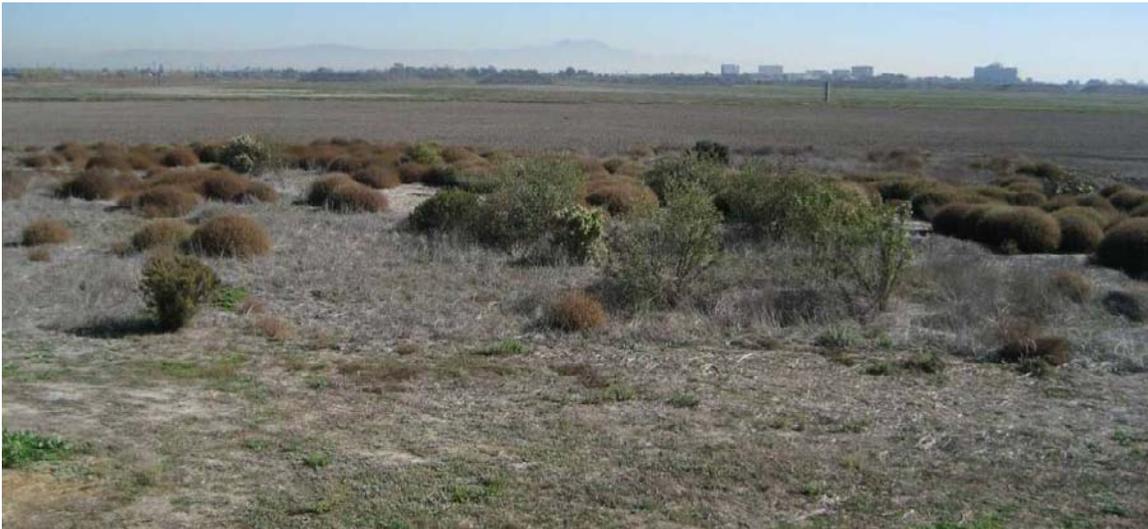
The IRP Site 2 evaporating ponds and perimeter berm were heavily overgrown by vegetation. The east side of the ponds was being used to raise honey bees with a number of beehive boxes and bees present. The concrete settling basin behind Building 98 (IRP Site 36) was present and filled with earth. The concrete trench originating from the concrete basin extended to the northeast vegetated corner of the IRP Site 2 evaporation pond, where it split in two directions (Figure 5.3-6). At the time of the site visit, the agricultural lands adjacent to the site had recently been plowed and the surface was soft bare earth. There was no indication of the former IRP Site 3 evaporation pond near Buildings 101-102 (Figure 5.3-7).

**Figure 5.3-7: View east of Buildings 101-102 Explosive D former wash water pond (IRP Site 3)**

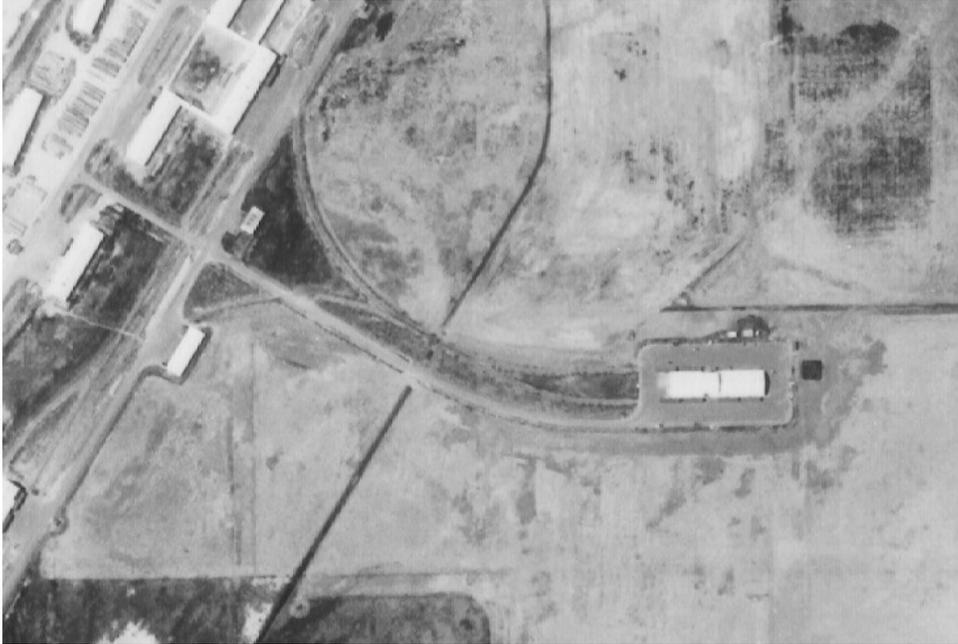
**Figure 5.4-2: 1947 aerial photograph with settling basin visible to the east of Building 94**

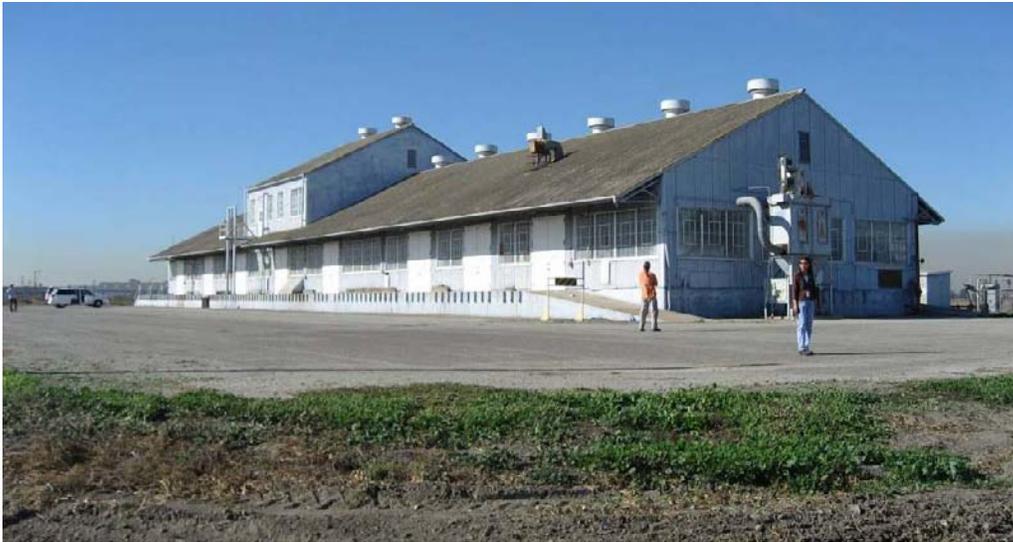
Building 94 was locked and no longer in use. A sign that read “Danger Blast Area Keep Clear” was posted on the east side of the building. The visible portions of the inside of the building were largely empty, with only fixed tables and processing equipment remaining. No signs of MEC were present. The former settling basin was no longer visible, and its location had been graded and cultivated. The adjacent agricultural field was approximately 2 feet lower in elevation relative to Building 94. At the time of the site visit, the agricultural field had just been plowed, and the surface was soft, bare earth. A water well cap was noted to the east side of the asphalt pavement roughly 50 feet south of the site. The well location corresponds to Navy Well 2.

**Figure 5.4-3: View of southeast side of Building 94**  
(Photograph was taken during the November 2007 on-site visual survey.)

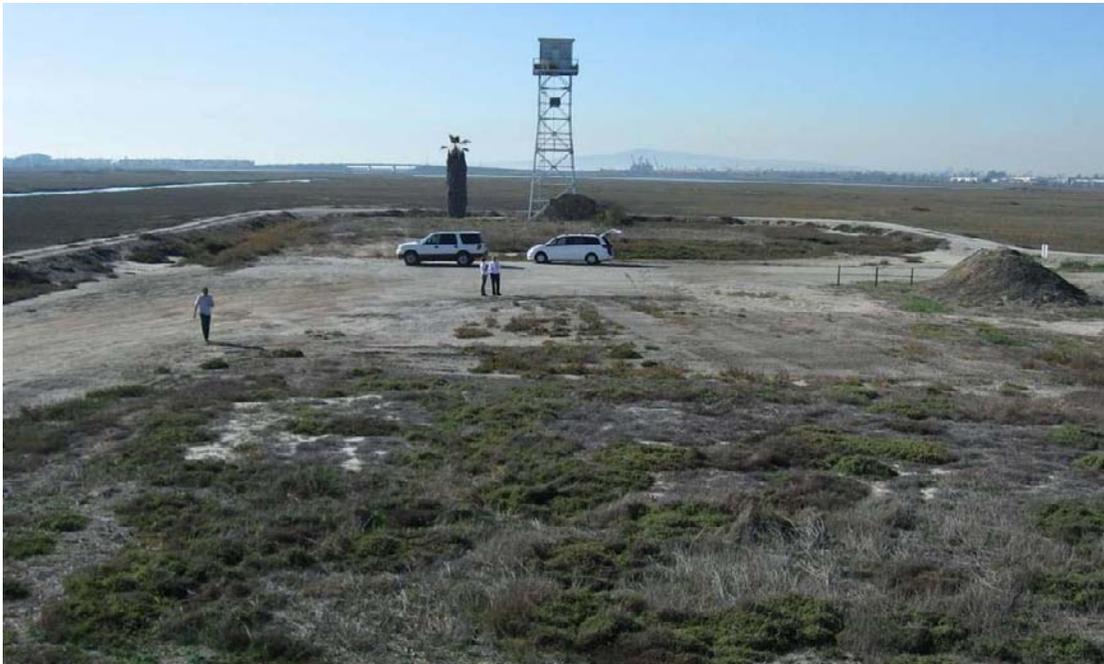
**Figure 5.5-3: View of the east side of the Explosives Drop Test Tower and bermed surroundings**  
(Photograph was taken during the November 2007 on-site visual survey.)

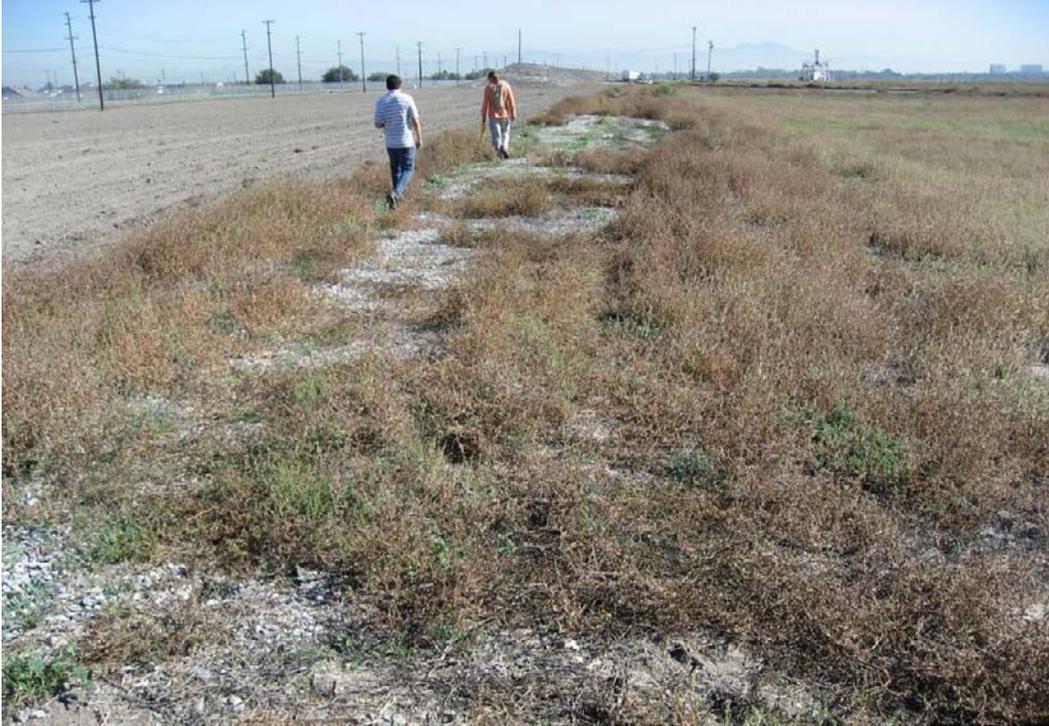
**Figure 5.6-1: Looking east from Westminster Street.**  
(Photograph was taken during the November 2007 on-site visual survey.)

A visual survey of the POLB fill area south of Westminster Avenue was conducted on 15 November 2007. During the visual survey, the following Malcolm Pirnie team members were present: Ms. Caruso (Team Leader), Mr. Schulman, Mr. Storrs (UXOSS), Ms. Gerritzen, and Mr. Asakawa. The following Navy representatives were present during the visual survey: Ms. Tamashiro and Mr. Gordon. The field team conducted the visual survey by walking a meandering path roughly 6,500 feet to the west and 3,000 feet to the east of Westminster Street. In total, approximately 2,500 feet of the western portion of the Westminster POLB Fill Area were walked, representing 35 acres of the 180-acre site. Approximately 20% of the site was visual surveyed. The area was not in use and had bare earth and low vegetation cover (Figure 5.6-1 and Figure 5.6-2). No signs of MEC or metal debris were observed.
