Re: Inspection Report
US Navy, Naval Construction Battalion Center
Gulfport, Mississippi
Harrison County
GP-MS4 Coverage No. MSRMS4036

Mississippi Department of Environmental Quality
Office of Pollution Control
Water Compliance Inspection Report

Site Name: US Navy, Naval Construction Battalion Center

Evaluation Type: Compliance Evaluation Inspection - NPDES

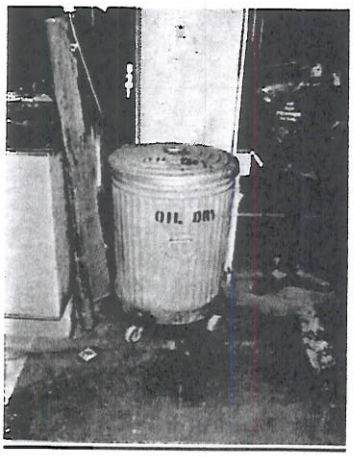
Inside Shop C of the Construction Equipment Division, oil dry and spill kits were throughout.

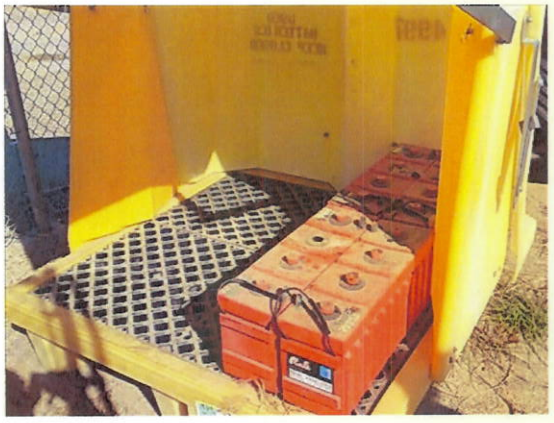
Diesel and fuel tanks are double-walled in addition to being placed in secondary containment. The base recently performed maintenance on the secondary containment areas, applying sealant to address cracks in the concrete structures.

Examples of secondary containment used throughout sites on the Base

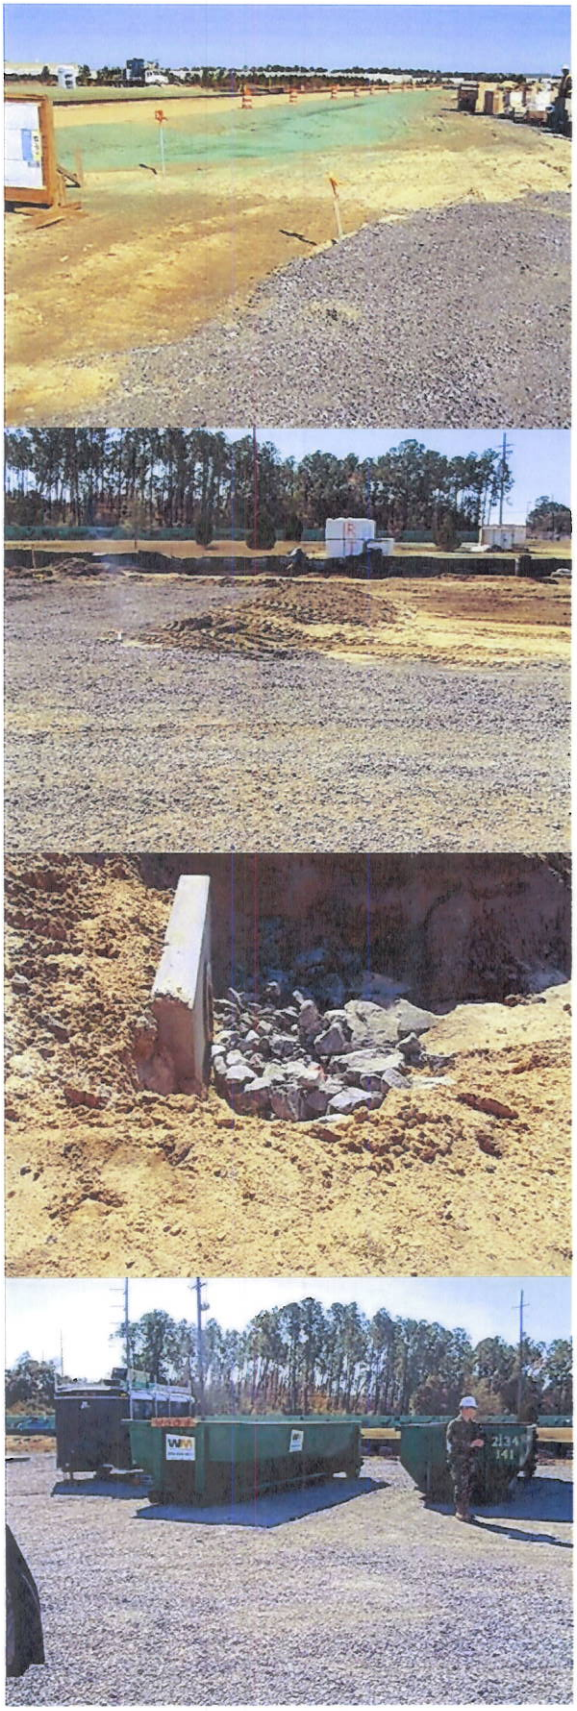
Proper Use of BMPs at the construction site of the Battalion Maintenance Facility project, including hydro-seeding for stabilization, use of coarse gravel, correctly installed silt fences, rip rap along channels, and recycle bins for construction materials. The site was in accordance with the SWPPP.
