**ENGINEERING SURVEY OF
U.S. NAVY PETROLEUM FACILITIES
AT PEARL HARBOR**

BECHTEL CORPORATION

12, May 1949

Subj: Engineering Survey of U. S. Navy Petroleum Facilities
at Pearl Harbor, Report on

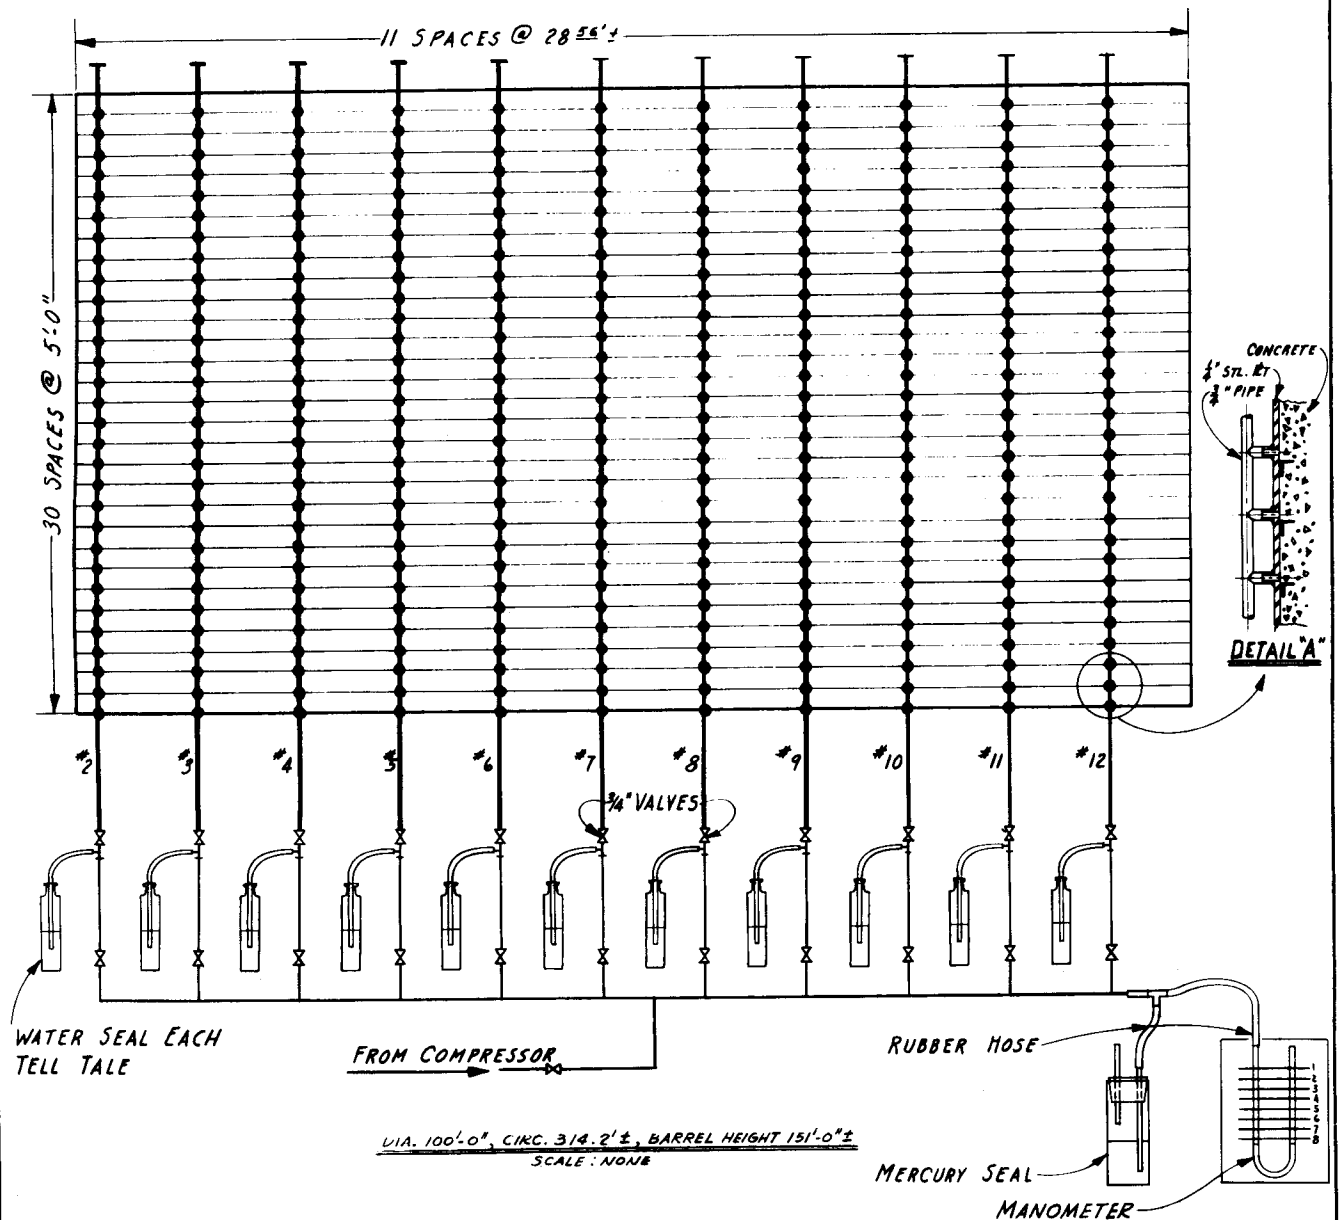
SECT. VI-RED HILL-SKETCH 6
DEVELOPMENT OF BARREL SECTION
SHOWING TELL TALES TANK NO 16

This vessel was suspected of leaking in the bottom dome because of oil seepage spots on the face in the lower gallery. Test holes were driven into the gunite at this location without materially affecting the flow which was continuous at approximately 4 oz. per day.

Inspection of the interface between the sheets in the bottom and first course and the concrete indicated minor quantities of oil at several locations. No defects were found in the sheets or welds up to the half way mark, where a standing test verified the examination by showing no drop in water level during a test period of five days.
