**DRAFT
WINTER 2008/2009 SEMIANNUAL POST-CLOSURE
INSPECTION AND MAINTENANCE REPORT
May 6, 2009**

**INSTALLATION RESTORATION PROGRAM SITE 7
(FORMER STATION LANDFILL)
NAVAL WEAPONS STATION SEAL BEACH
SEAL BEACH, CALIFORNIA**

DCN: ECSD-3211-0008-0004

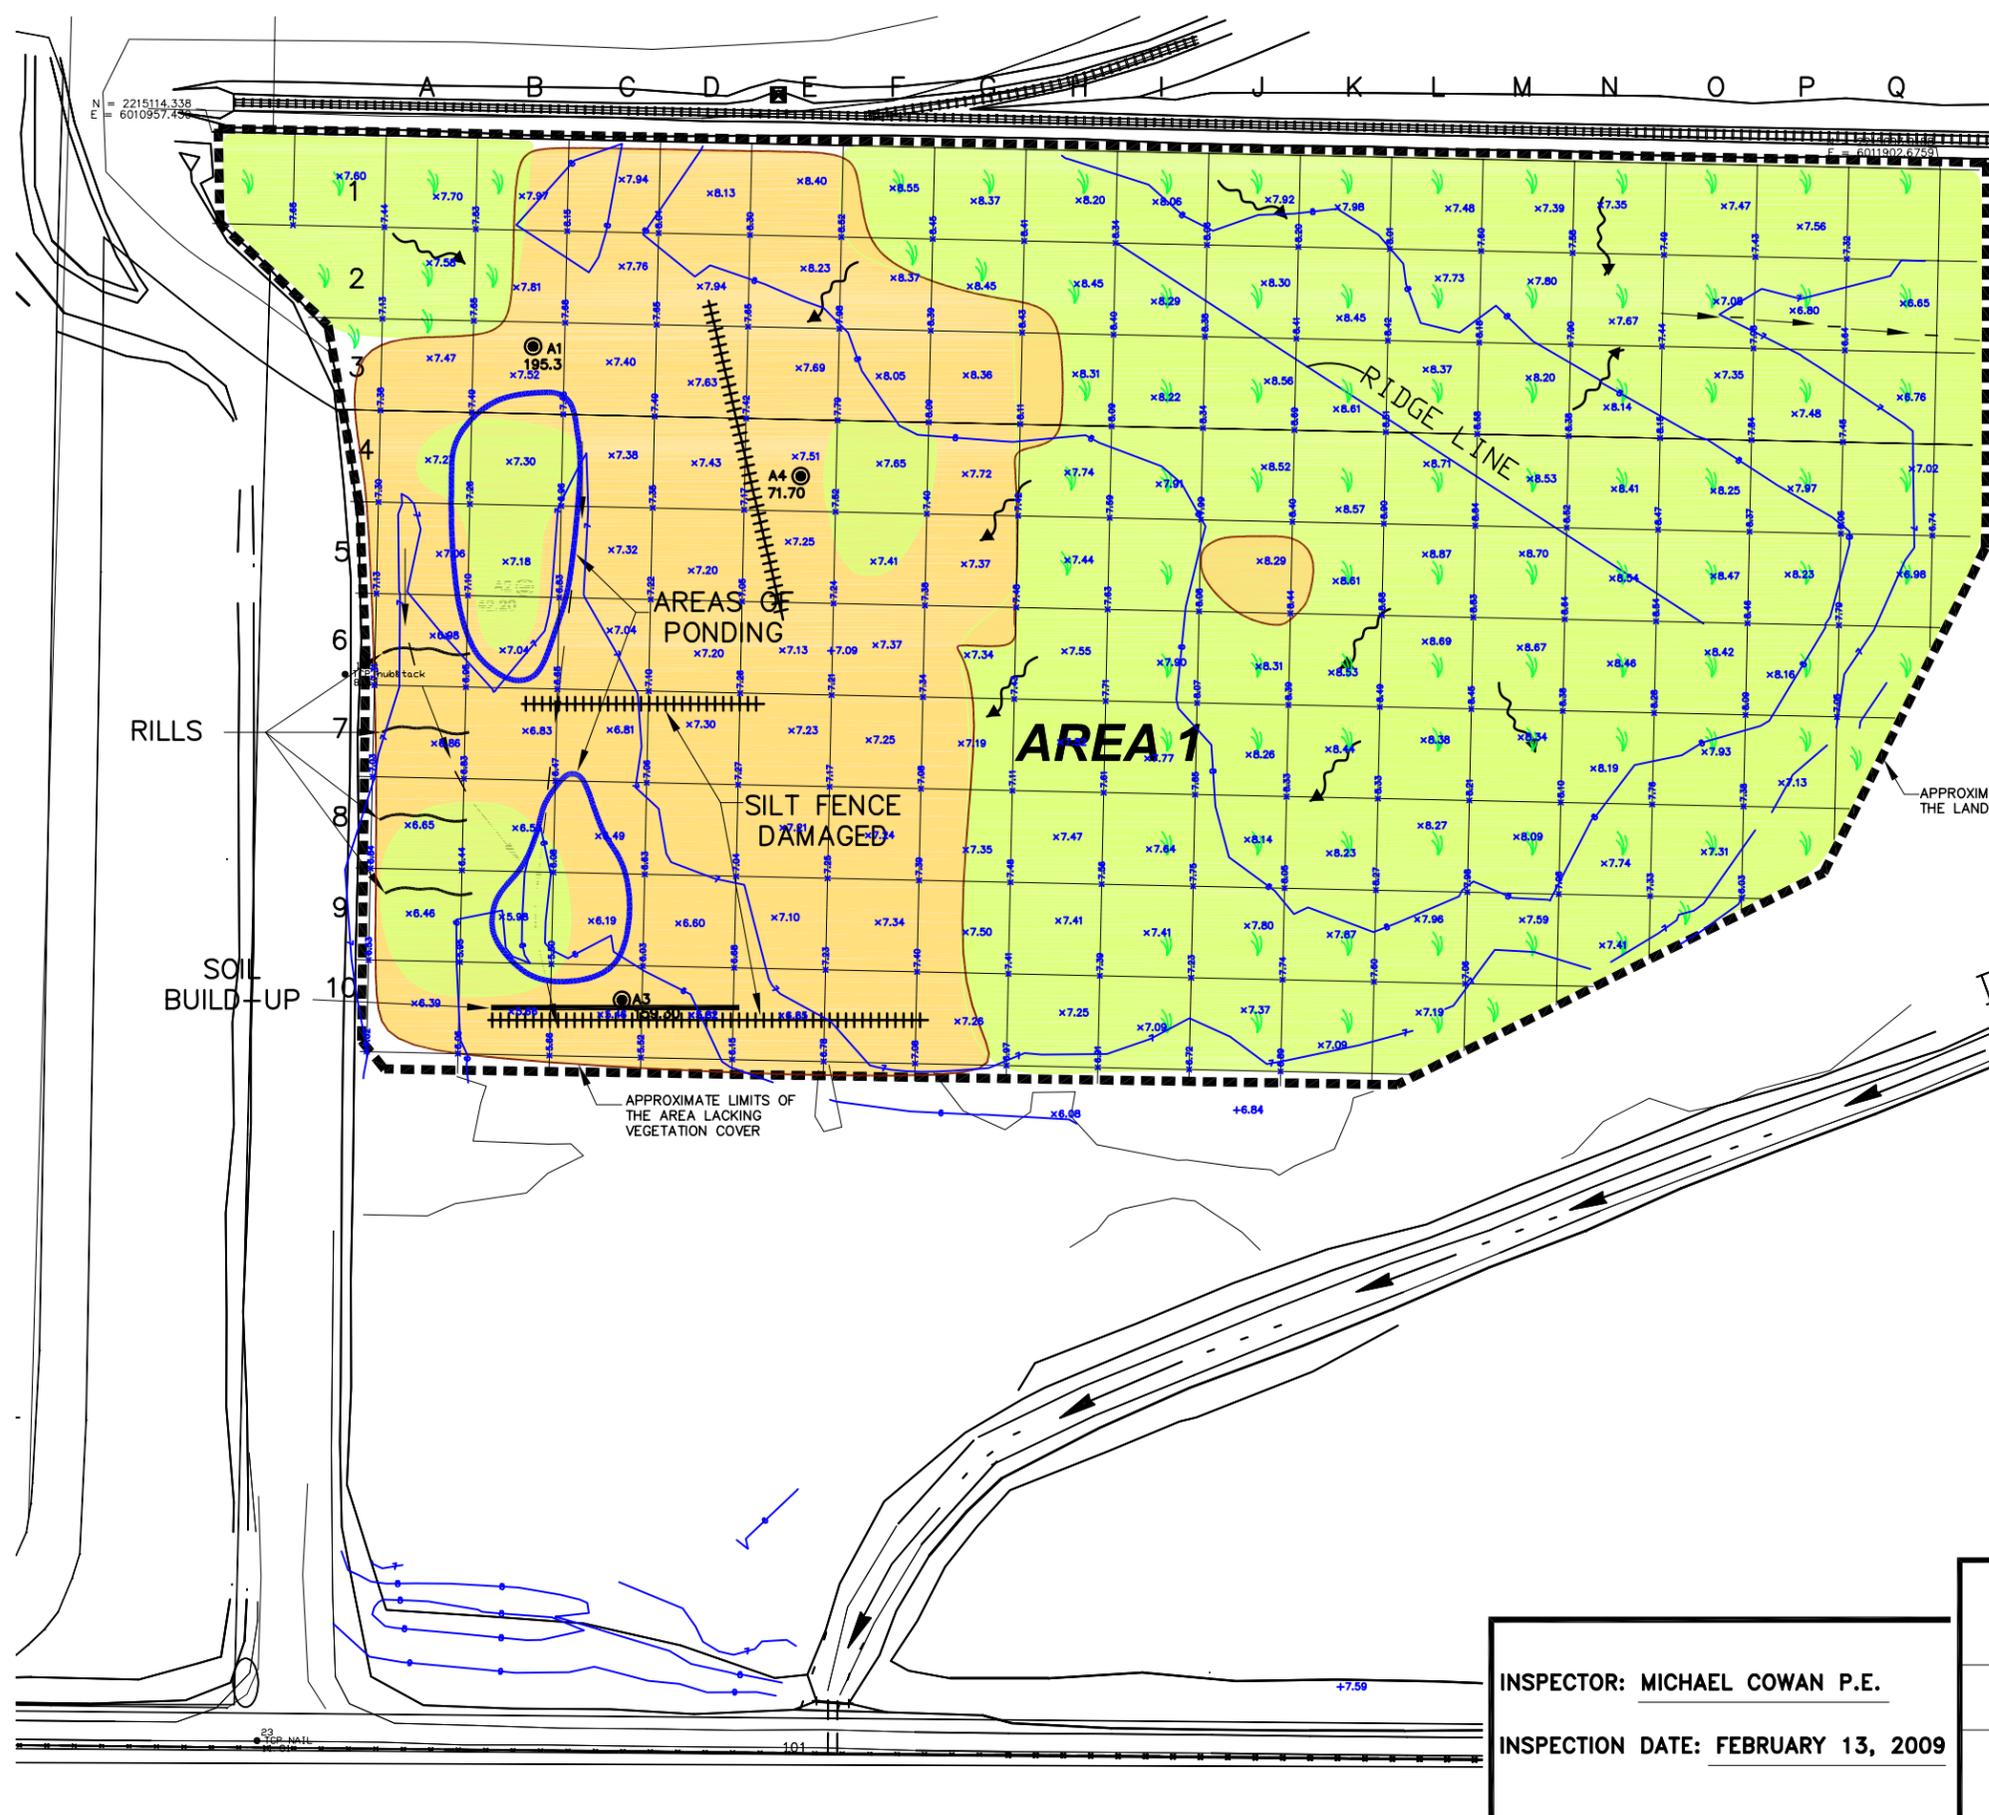
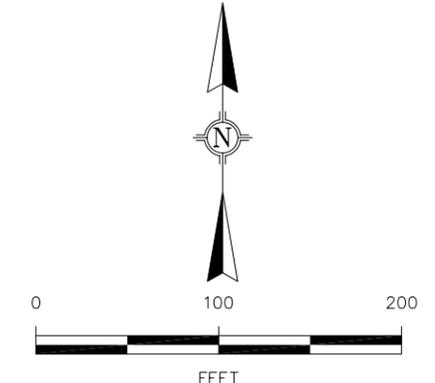
Shallow ponding area noted in southwestern corner as shown on the attached Figure A-1c.

Lack of positive slope is believed to have resulted in ponding (wet area). Standing water with less than 3-inches in depth was noted at the time of inspection.

Silt fences were damaged from wind and rain and require repair or replacement. Sediment build-up along the southern silt fence was also noted.

Repair silt fence and replace or improve vegetative ground cover soils in the western and southwestern area of the site to avoid soil loss.

B) Repair or replace silt fence with straw rolls or wattles. Wattles require less maintenance in comparison to silt fence that are prone to wind damage.

C) Collect soil samples from the cover and conduct agronomic analysis to determine soil conditions and ability to establish vegetation.

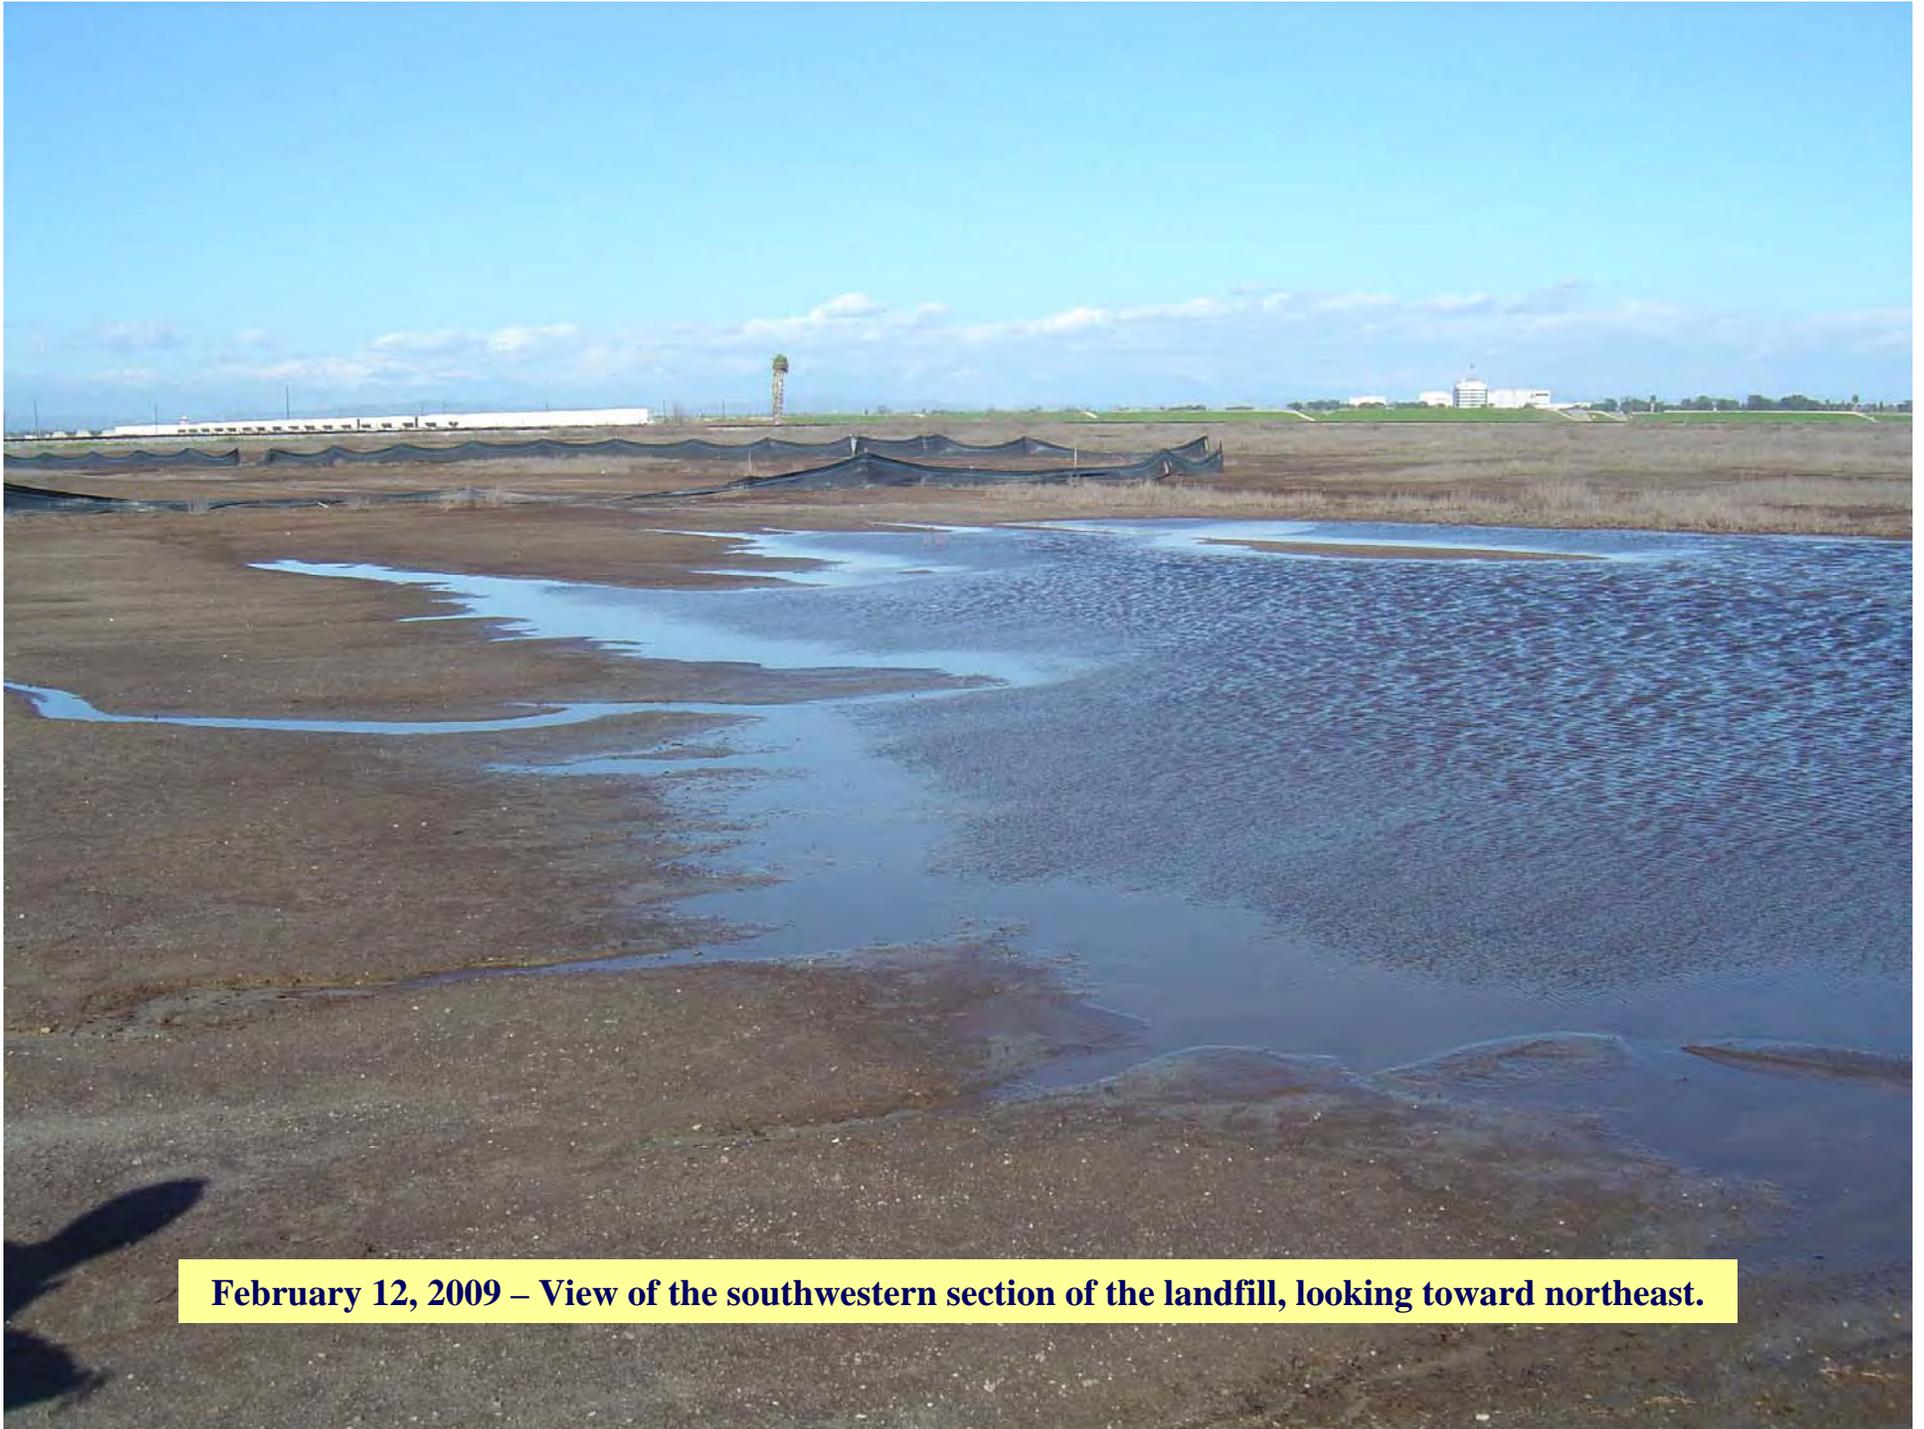
February 12, 2009 – View of the southwestern section of the landfill, looking toward northeast.
