**FALL 2009 & WINTER 2010 ANNUAL POST-CLOSURE
INSPECTION AND MAINTENANCE REPORT**

May 21, 2010

**INSTALLATION RESTORATION PROGRAM SITE 7 AREA 1
(FORMER STATION LANDFILL)
NAVAL WEAPONS STATION SEAL BEACH
SEAL BEACH, CALIFORNIA**

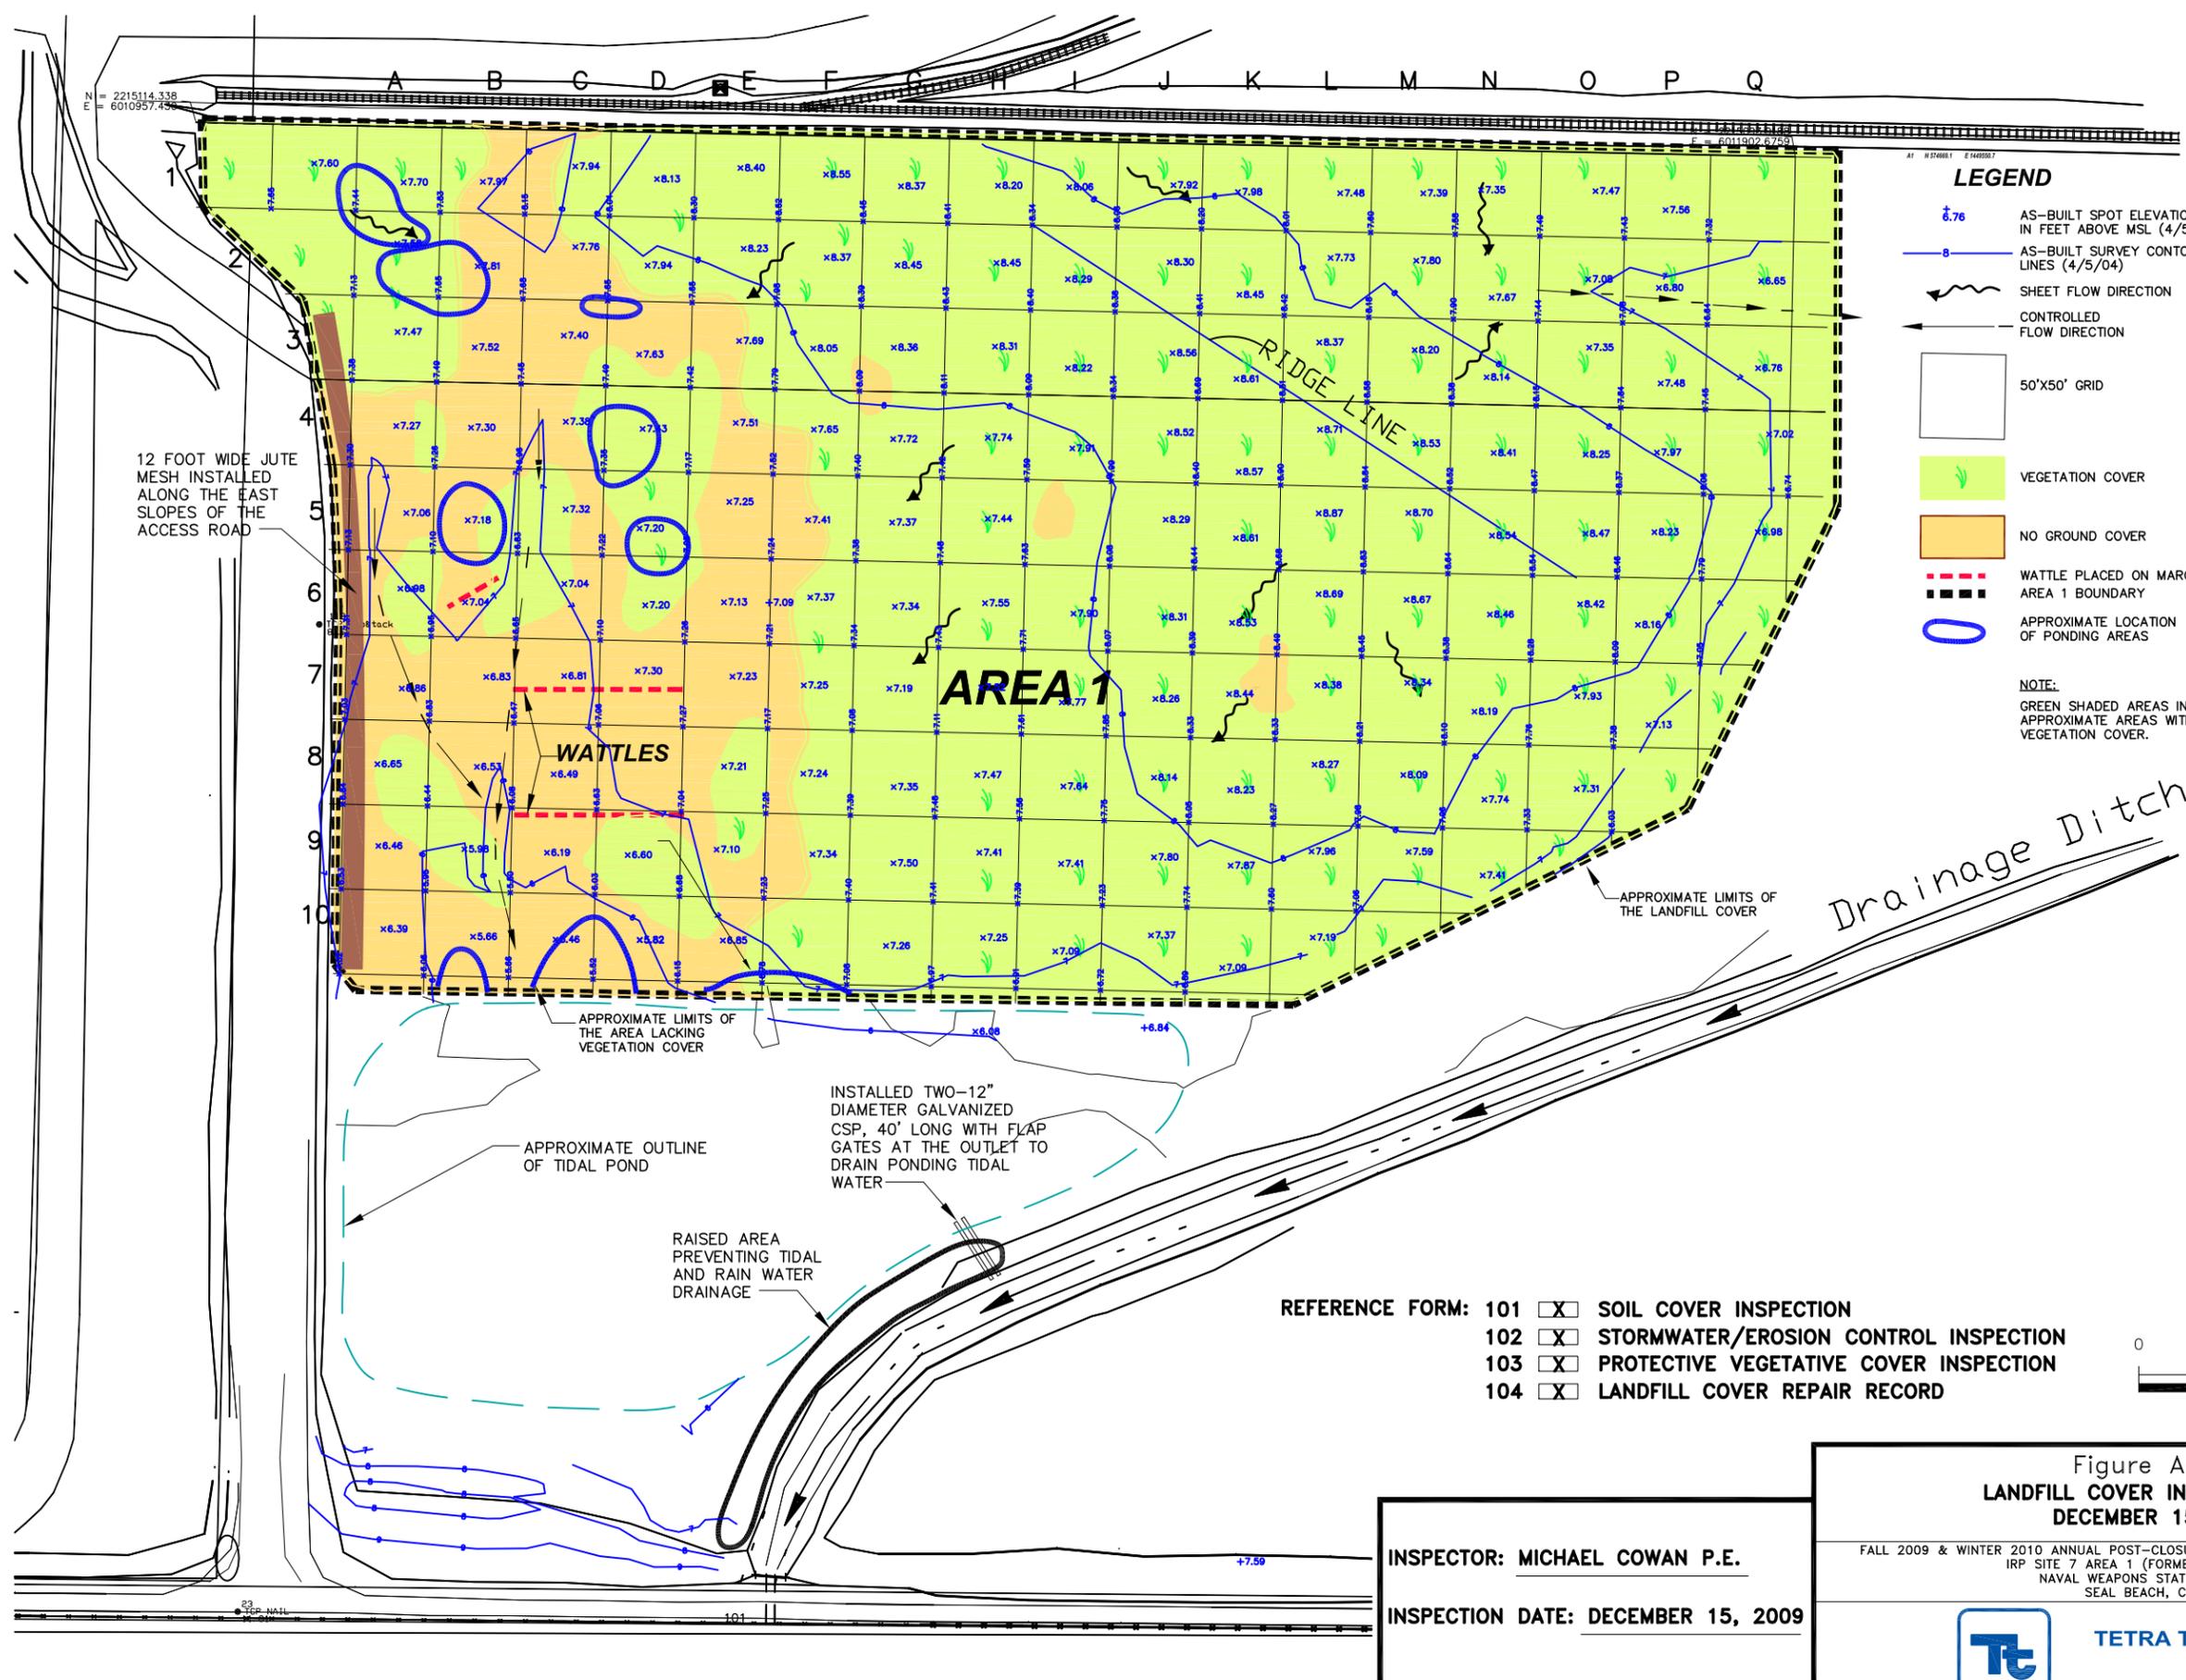
TYPE OF DEFICIENCY: _____
Small areas of ponding (less than 6" in depth) were noted after the first major storm event (November 2009).

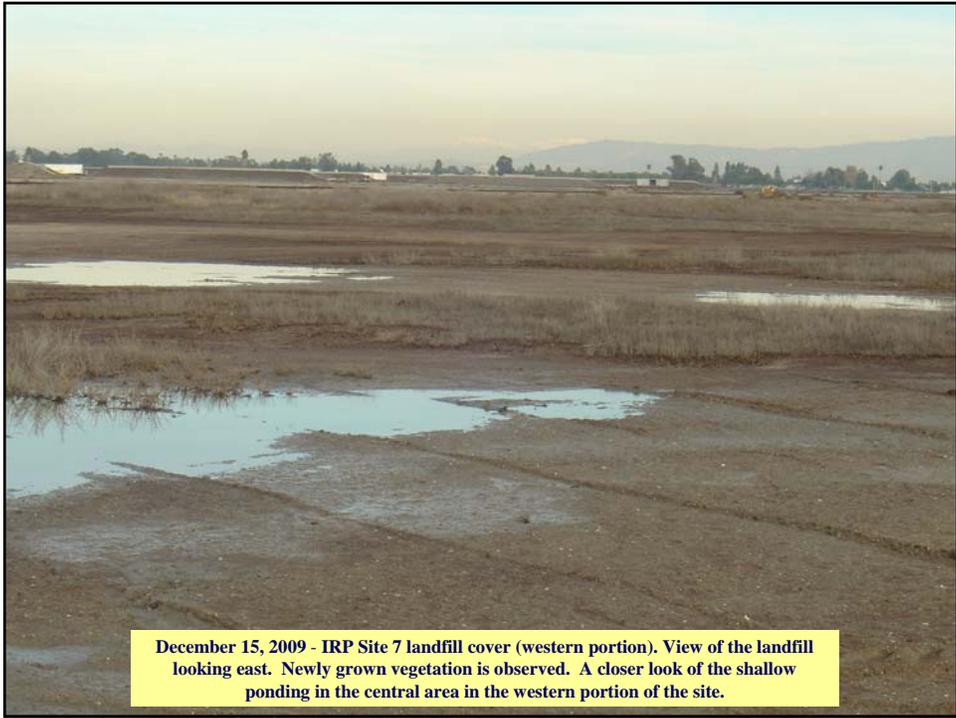
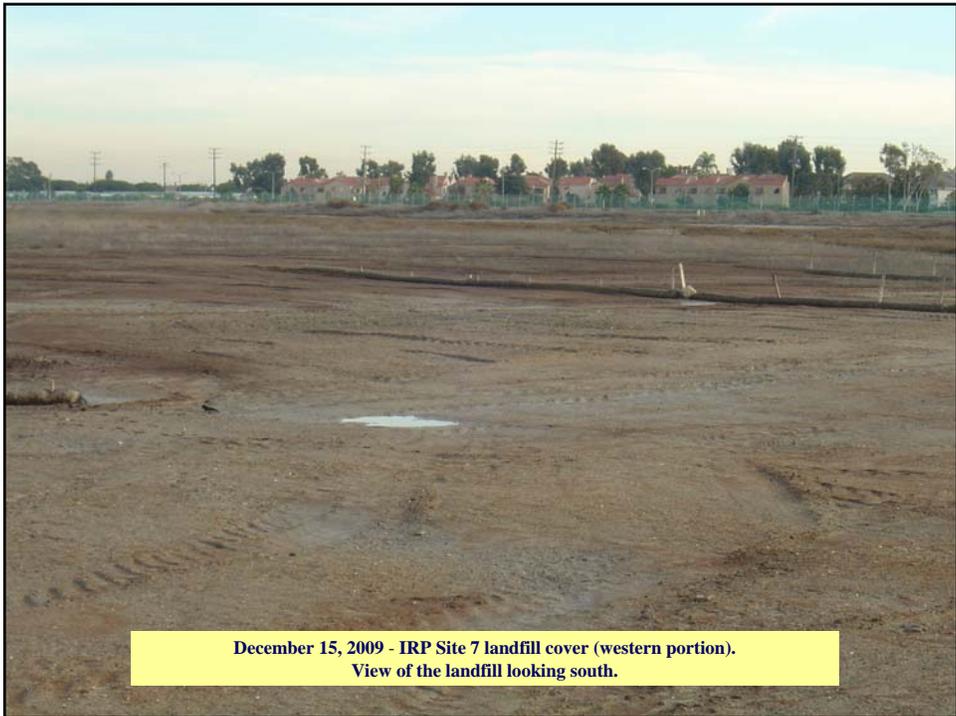
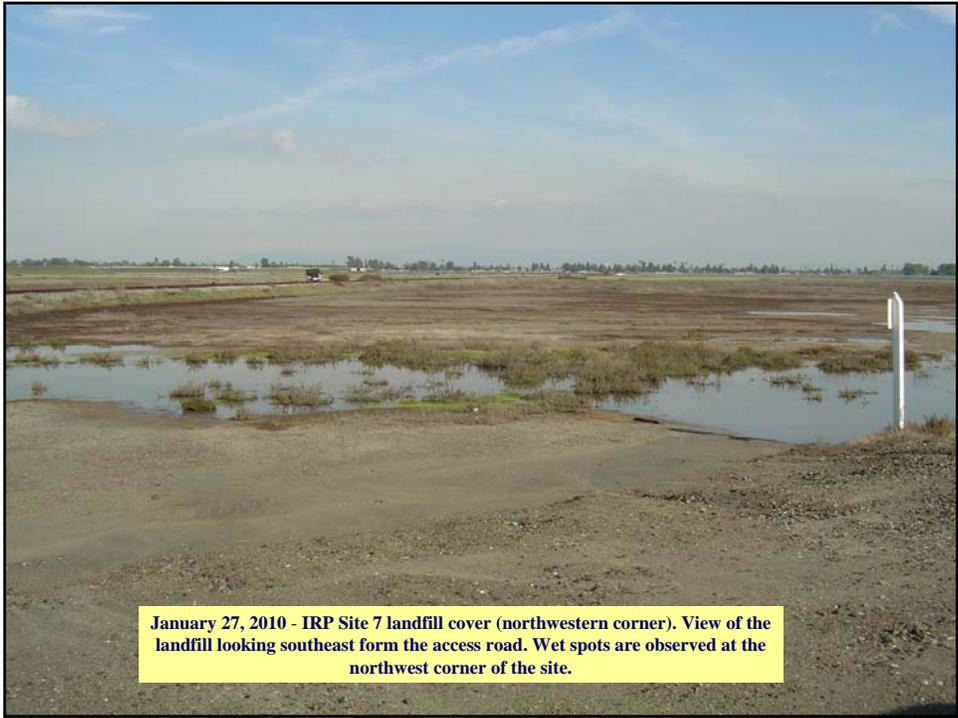
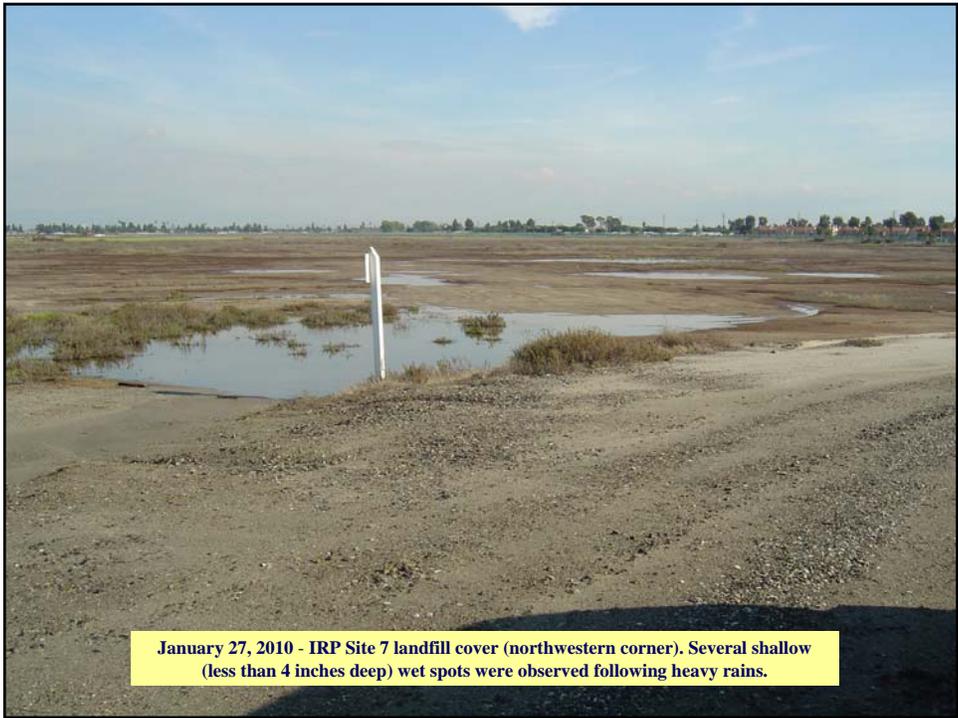
December 15, 2009 - IRP Site 7 landfill cover (center of the western portion). Several shallow (less than 4 inches deep) wet spots were observed following heavy rains.
