FINAL
2005 SECOND SEMIANNUAL POST-CLOSURE
INSPECTION AND MAINTENANCE REPORT
Revision 1

April 17, 2006

INSTALLATION RESTORATION PROGRAM SITE 7
(FORMER STATION LANDFILL)
NAVAL WEAPONS STATION SEAL BEACH
SEAL BEACH, CALIFORNIA

DCN: FWSD-RAC-06-0341

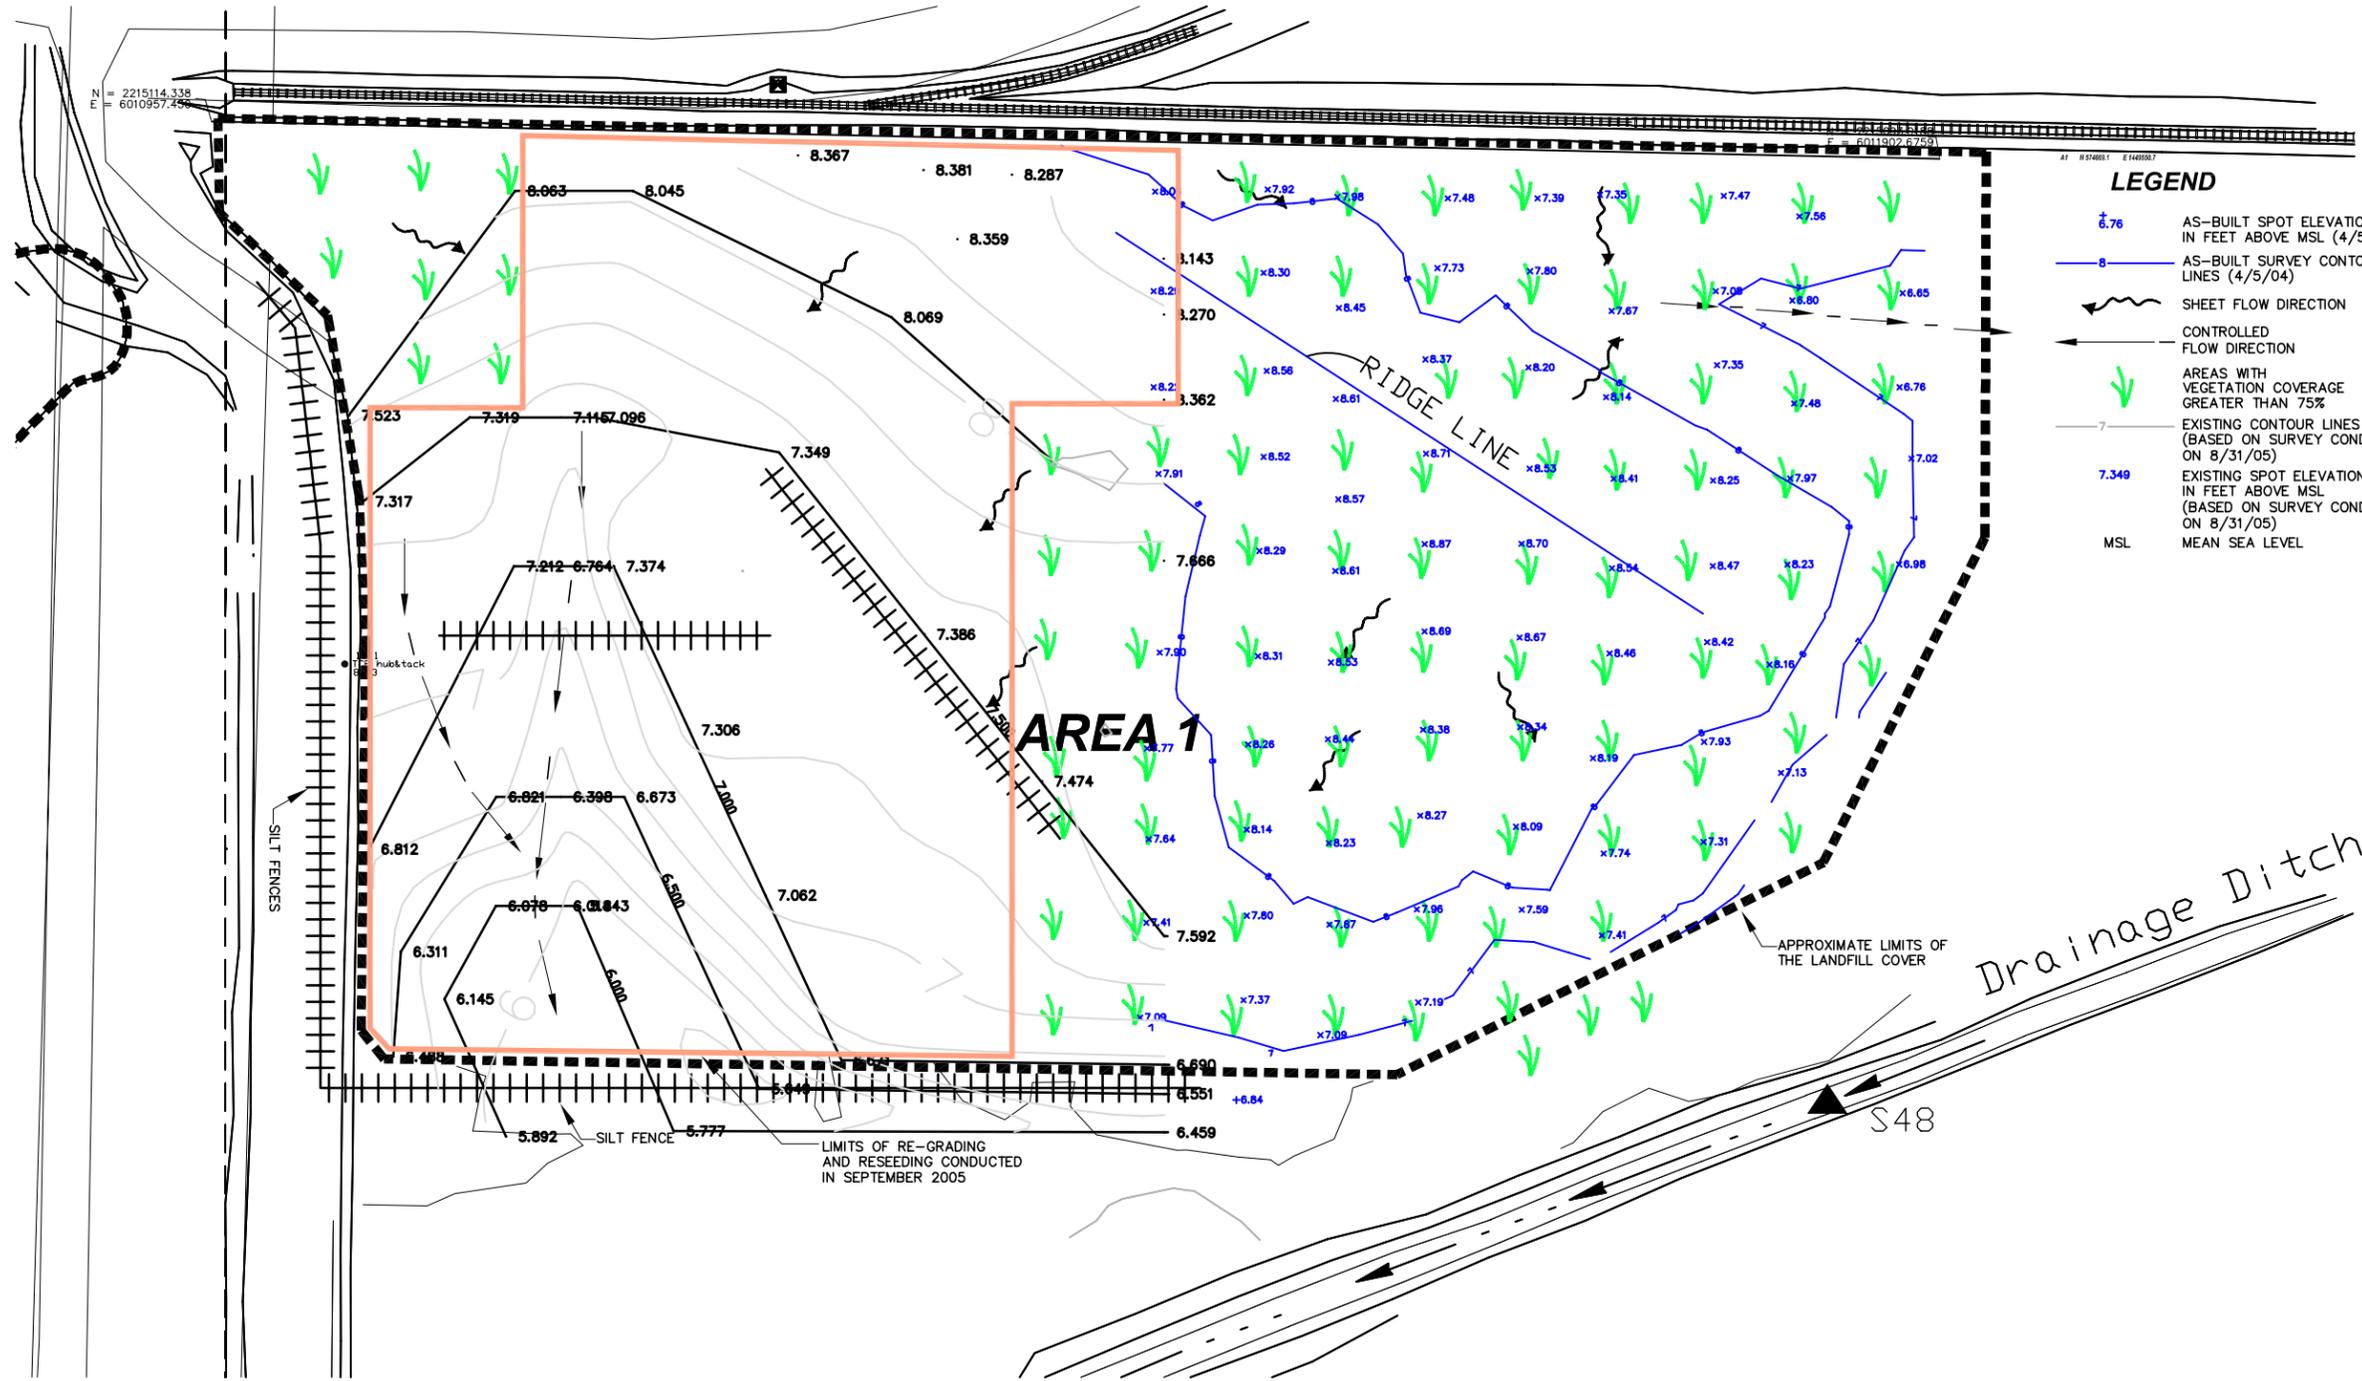
The soil cover was found to be in good condition. The soil cover on the western portion of the landfill was recently regraded and seeded. Vegetation cover in this area has not yet been established, since this area was recently reseeded in September 2005. No signs of soil losses or washouts that would expose the waste were evident. No subsidence, settlement, or ponding were evident. No sediment build up was evident.

The vegetation cover should establish by the end of March. However, if following any rain event, soil loss is observed in low vegetation cover or bare areas of the cover, and the soil loss form rills or gullies that are greater than 2 inches in depth, hay covering or jute-mat should be installed on the potential high erosion areas before the heavy February rains.

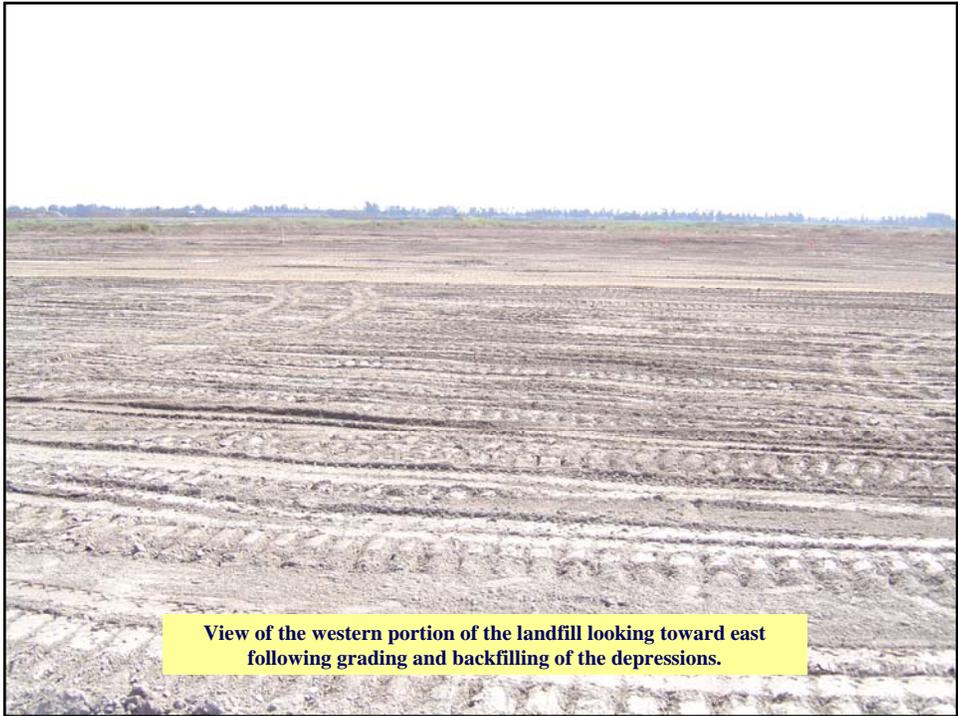
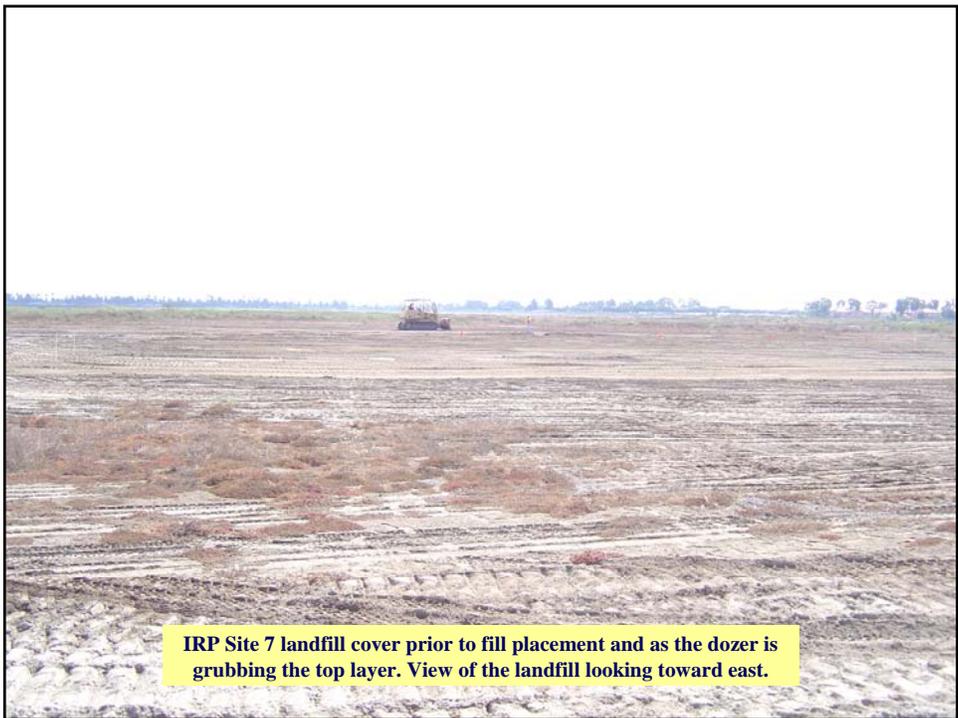
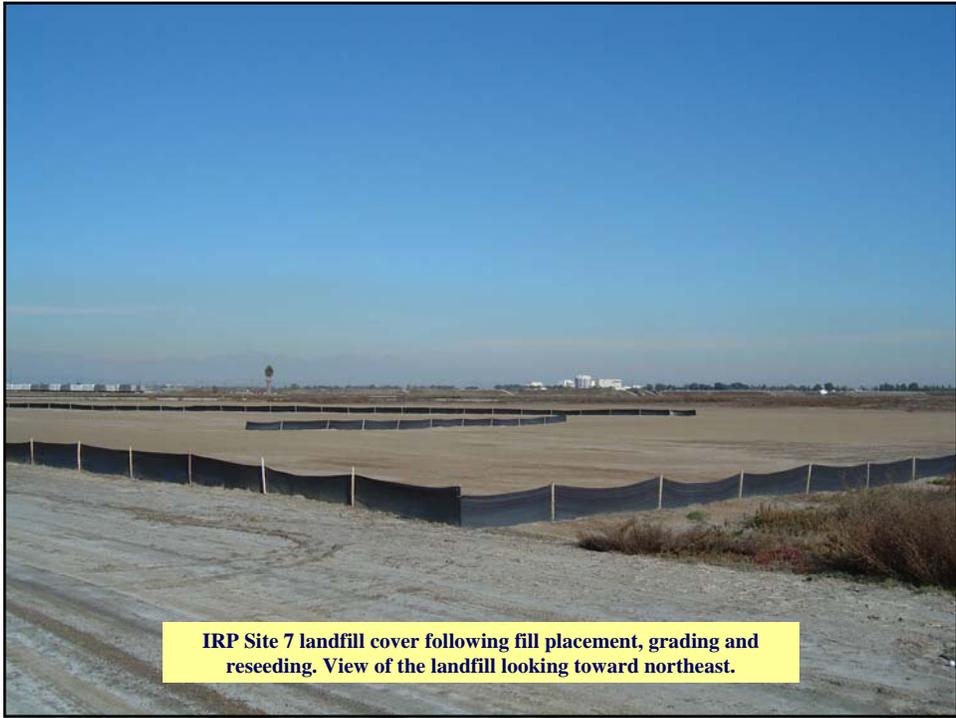
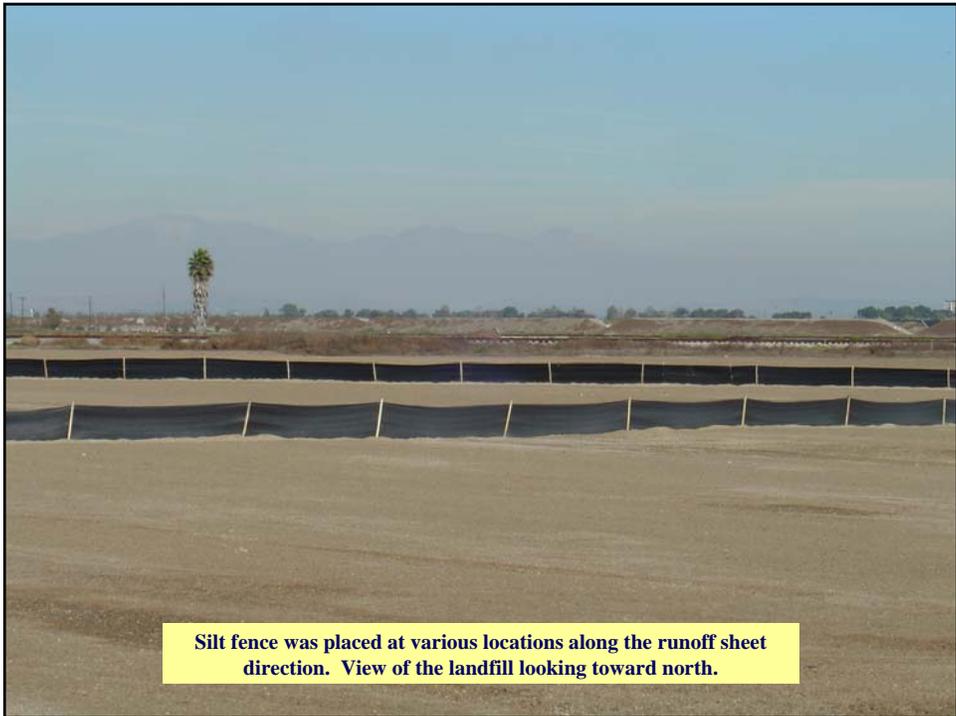
A John Deere JD750 dozer was used for grubbing and regrading. View of the landfill looking toward northeast.
