Battlefield Evaluation of Ewa Field,
by AECOM, Charlottesville, VA
and
Inventory and Historic Contexts
by Mason Architects Inc., Honolulu, HI

March 2011

Part 1: Ewa Field Battlefield Evaluation

Part 2: Ewa Field Inventory & Evaluation

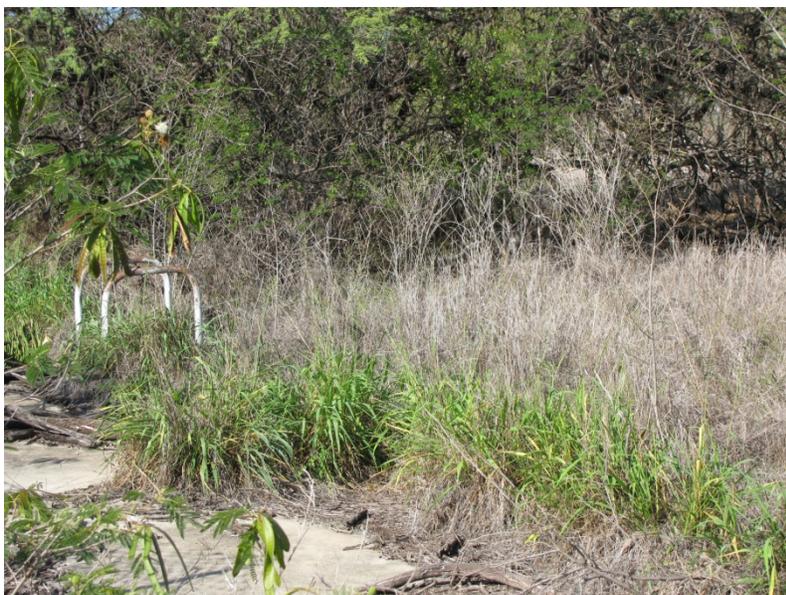
Figure 11. The swimming pool site, 2010. (AECOM)

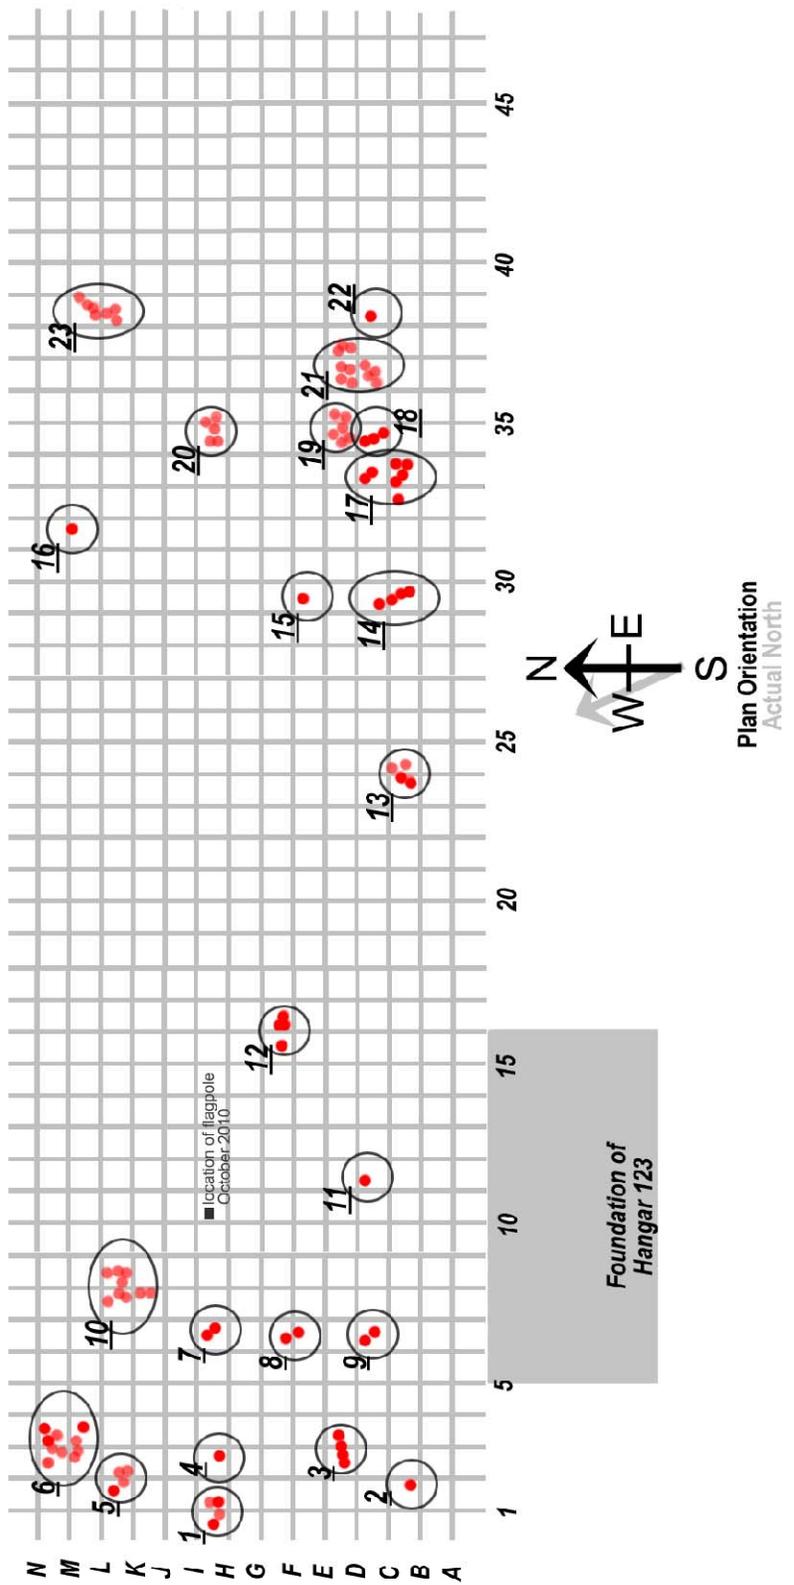
OVERVIEW DIAGRAM

The overview diagram of the damage shows a representation of the aircraft warm-up platform with its 20' square slabs numbered and lettered to form grid coordinates. The individual locations of the damage are indicated, circled, and numbered. The pages following the overview diagram show a more detailed sketch of each damaged area. All these individual sketches are oriented with plan north at the top of the sketch, and each represents one or more 20' square slabs and centered tie down, with damage shown in red. At the top of each individual sketch is the grid location nearest the damaged area and the orientation from the grid coordinate to the damage.
