**Priority Areas Lead Testing and Corrective Action
Kinnick High School- Bldgs 3365 (Community Readiness Center 2nd Floor) 2020 Test Results**

Kinnick High School

(2nd Floor Community Readiness Center)

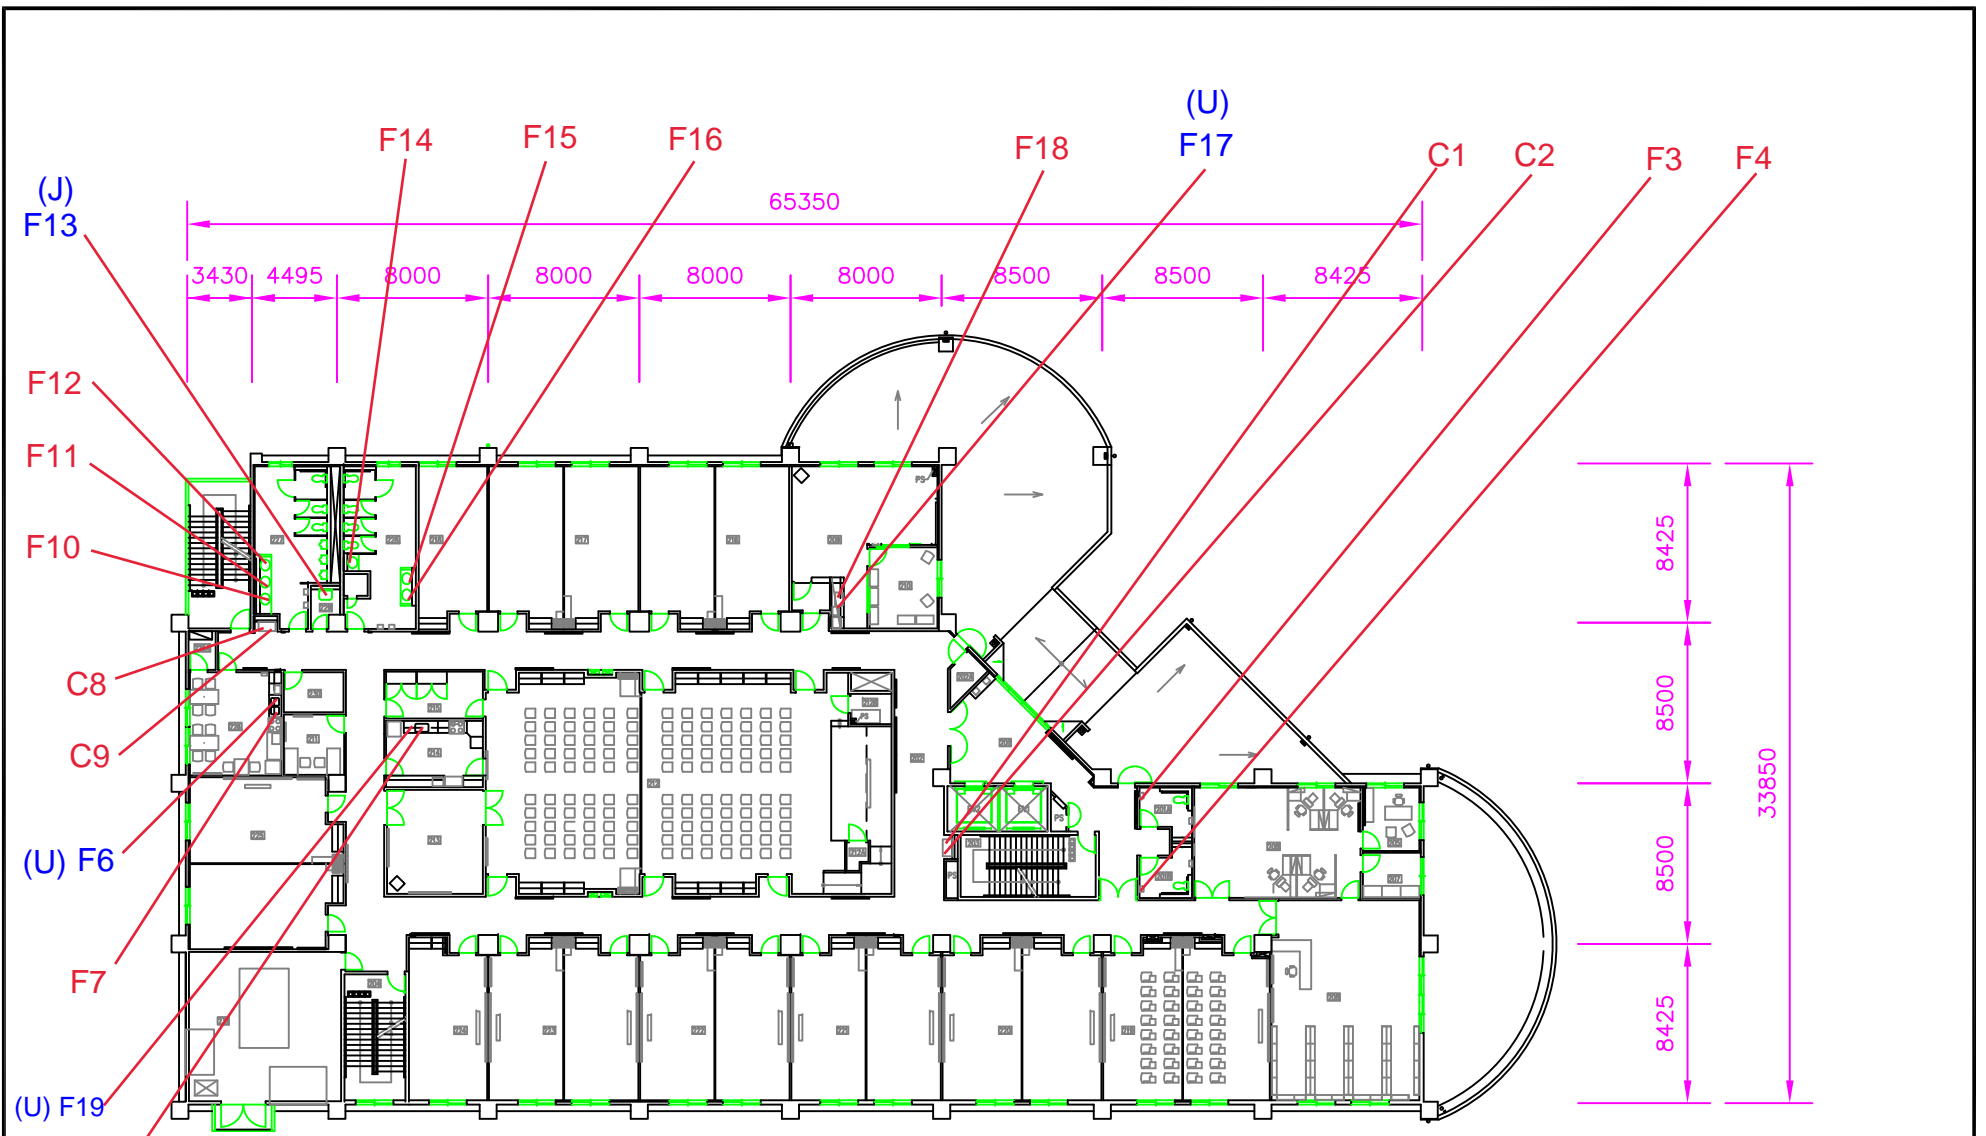
2ND FLOOR PLAN

Samples will not be collected from following non-drinking outlets:
 J: Janitor
 U: Utility outlet for dishwasher
