Testing Results for Lead in Drinking Water for *SUBASENLON CDC (Buildings CT186, CT383 and CT386)*

Priority Areas Lead Testing and Corrective Actions (OCTOBER 2013)
SUBASENLON, Child Development Center
CT186, CT383, CT386

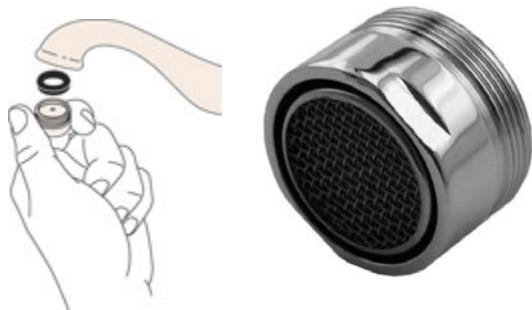
These four outlets were all located in CT186. Two of the outlets that exceeded the EPA recommended level of 20 ppb were hand washing sinks located in the bathroom of the Pre-School 1-1 classroom, which tested at 23 ppb and 35 ppb, respectively. Another hand washing sink in the bathroom of the Pre-Toddler 2-1 classroom tested at 79 ppb, however this classroom has not been used since June of 2013. The last outlet was a kitchen sink that has not been in use which tested at 20 ppb. All four of these outlets were secured and re-tested in accordance with established protocols, which involved removing any faucet aerators in use. A **faucet aerator** (or tap aerator) is often found at the tip of modern indoor water faucets. Without an aerator, water

usually flows out of a faucet as one big stream. An aerator spreads this stream into many little droplets, which helps save water and reduce splashing. However, the aerator and screen can trap debris which can accumulate lead.

After removing any faucet aerators, retesting showed that all the sinks except that one in the kitchen were below the EPA-recommended level. Although the kitchen sink was not in use, it was capped to ensure it is not used as a source of water. Aerators in the bathroom sinks in the Pre-School 1-1 classroom were replaced and the bathroom faucet in the Pre-Toddler 2-1 classroom was replaced.
